New Point Comfort Lighthouse Mathews, Virginia Site Assessment Plan

Site Assessment Report

**Shoreline Studies Program
Department of Physical Sciences
Virginia Institute of Marine Science
College of William & Mary
Gloucester Point, Virginia**

February 2008

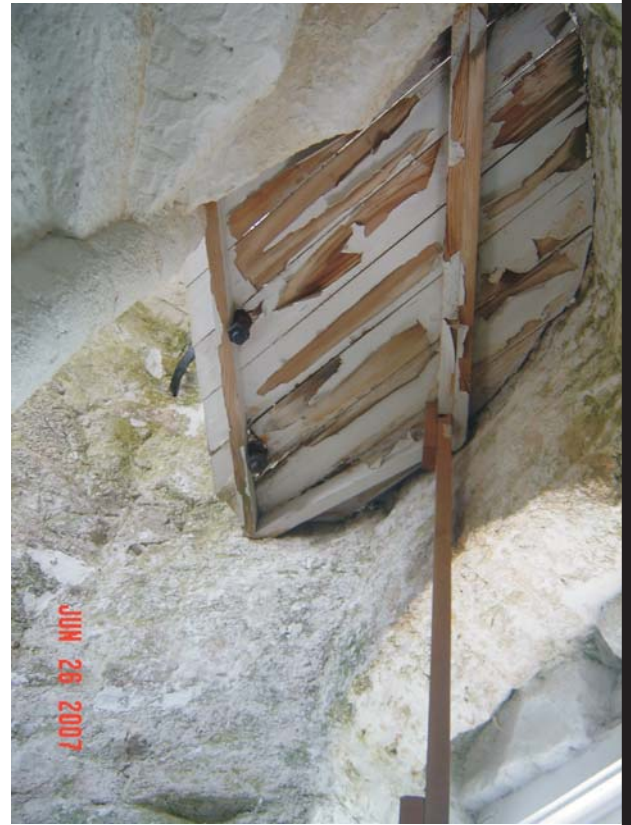
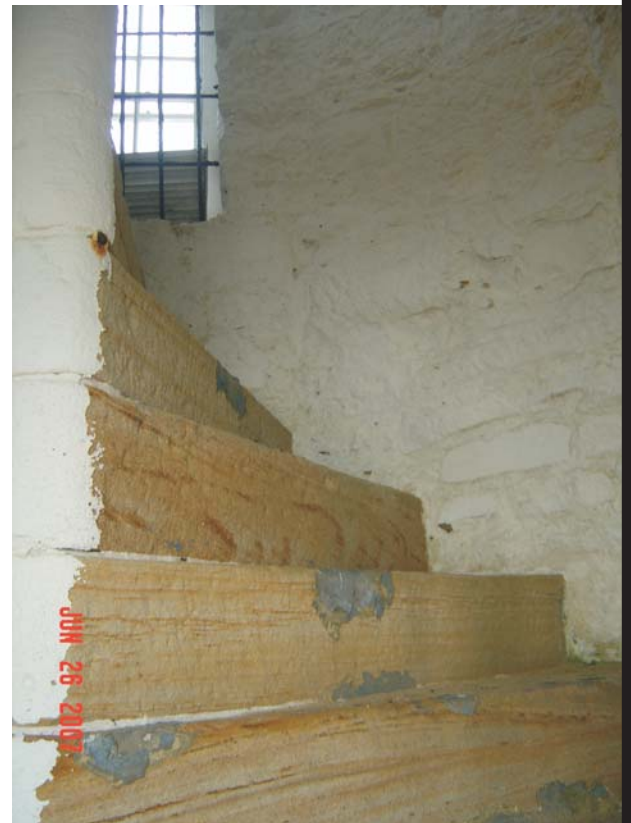
Figure 15. Photos depicting the present state of the interior of the lighthouse. The sandstone steps are exposed to the elements and eroding. The upper level platform is only being held up by a 2x4.

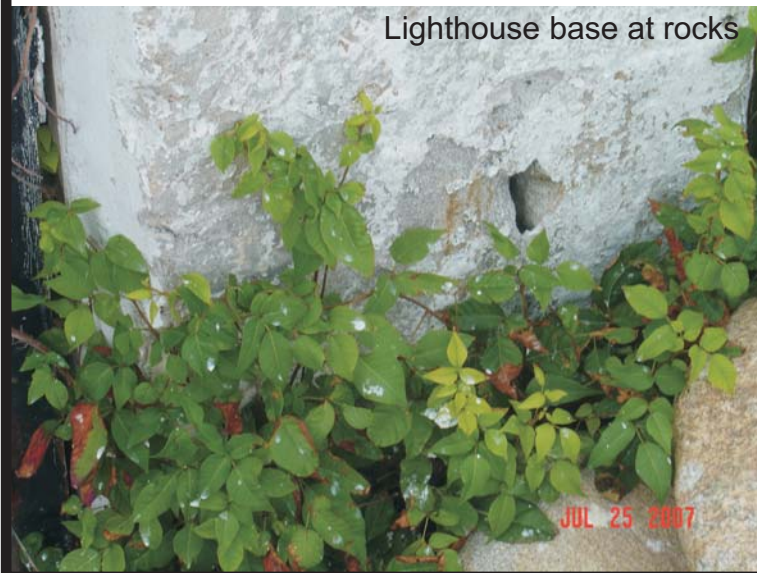
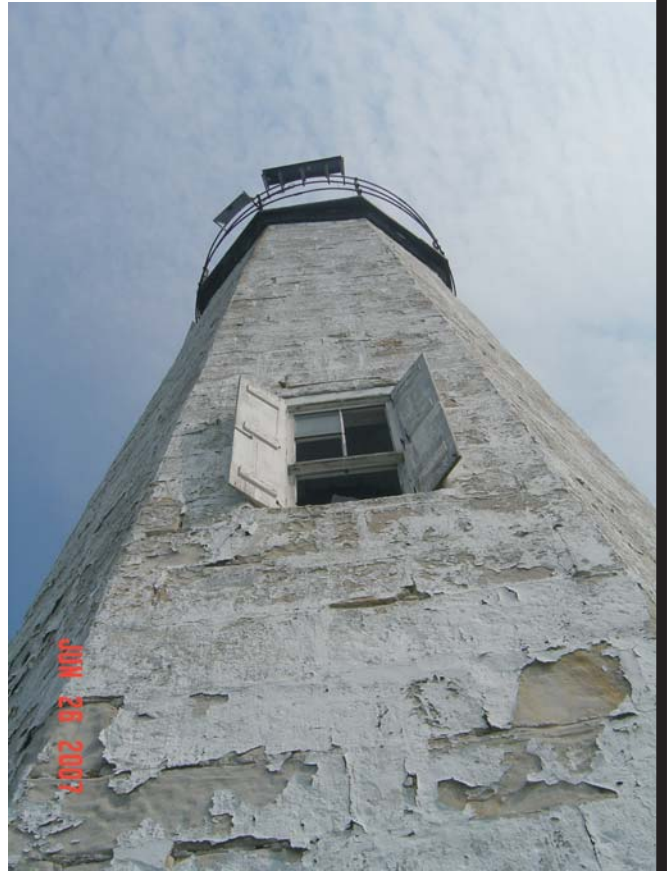
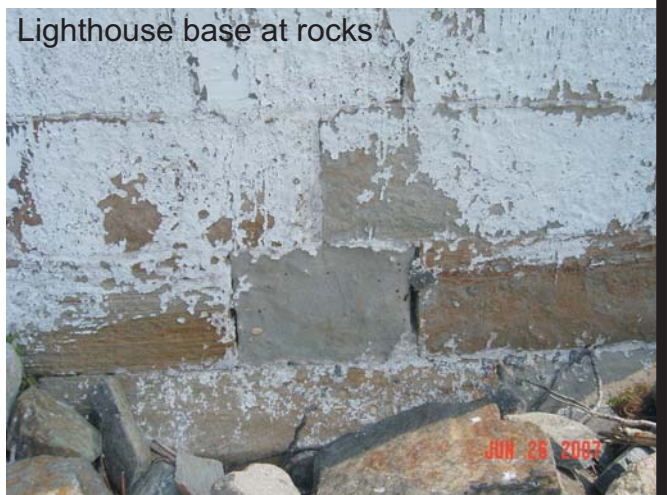
Figure 16. Damage to the structure is occurring due to the elements. Peeling and chipping paint, vegetation, and broken windows is exposing the soft sandstone structure and damaging the mortar joints.
