Living Shoreline Sea-Level Resiliency: Performance and Adaptive Management of Existing Sites

November 2018

Living Shoreline Sea-Level Resiliency: Performance and Adaptive Management of Existing Sites Summary Report

Shoreline Studies Program
Virginia Institute of Marine Science
William & Mary

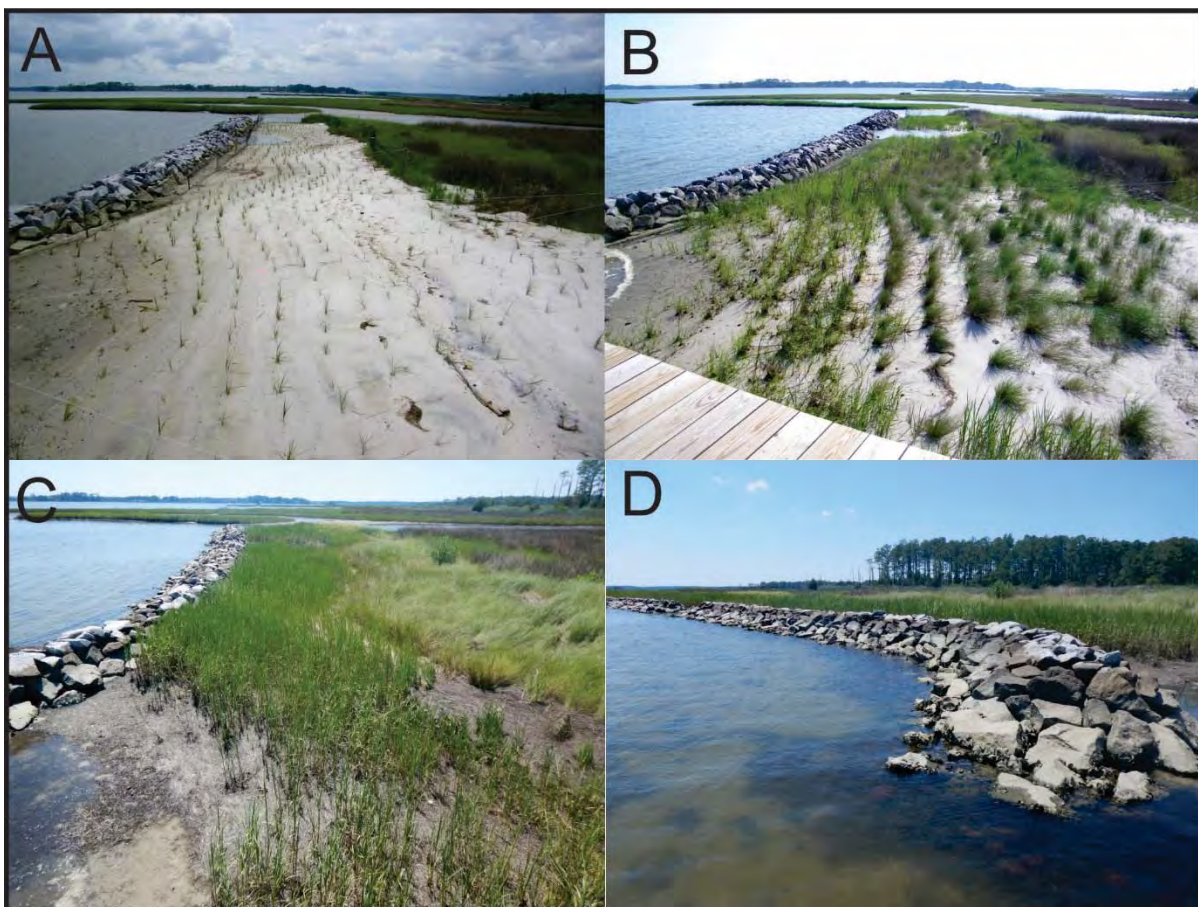
The site was planted in the spring of 2016, and due to subgrade adjustment, the *S. patens* planting was concentrated on the nearfield washover (Figure 4-1-5A). After one year the planting were very much intact (Figure 4-1-5B), and by 2018 had grown into a full width system (Figure 4-1-5C). The rock sill provides a hard substrate for oyster growth along the lower tide zone (Figure 4-1-5D).

Figure 4-1-5. Photos of Captain Sinclair A) Just planted, 2 June 2016; B) One year post planting, 10 May 2017; C) Two years post-planting, 10 July 2018; D) Oysters line the rock sill shown at low water, 10 July 2018. Photo credit: Shoreline Studies Program.

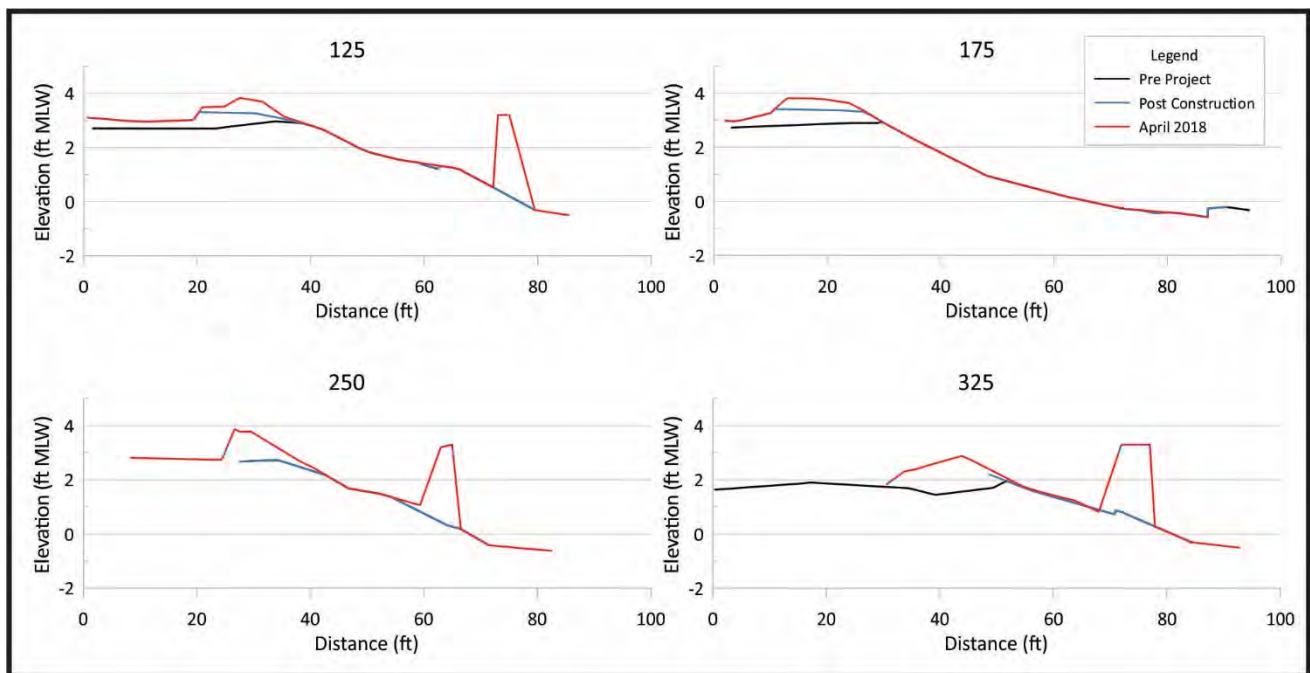
Site surveys show the main change is in backshore elevation (Figures 4-1-6 and 4-1-7). The backshore berm has increased in height and apparently not at the expense of the lower beach face. It appears that elevation changes are due mostly to vertical growth of the high marsh, *S. patens*, along the entire length of the project. An increase of almost one foot at profile 250. This bodes well for future adaptation to SLR.

Figure 4-1-7. Cross-sections of survey data for Captain Sinclair.

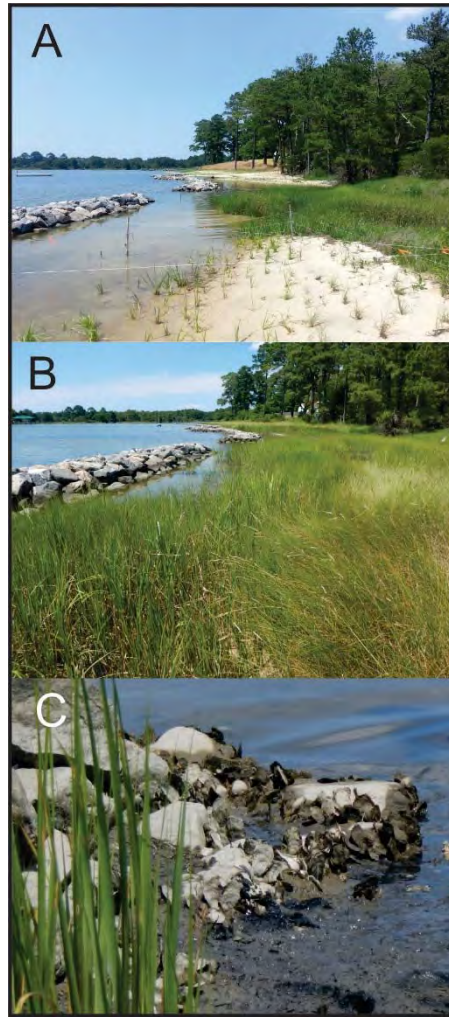
Figure 4-2-5. Photos of reach 2 at Occohannock on the Bay A) after planting (May 2013), B) after 5 years (July 2018), C) after 5 years there is abundant oyster growth around the end and outside of the rock sills.

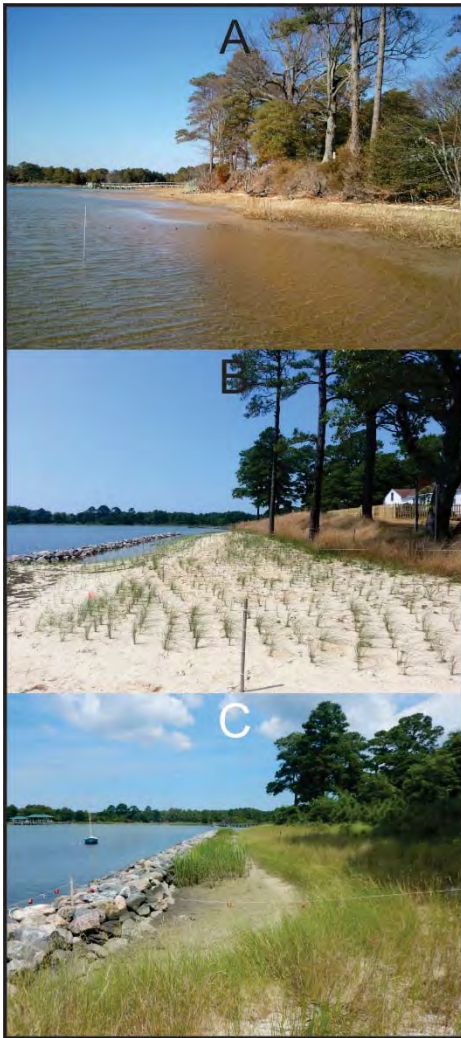
Figure 4-2-6. Photos of reach 3 at Occohannock on the Bay A), before construction (March 2013), B) after planting (May 2013), C) after 5 years.

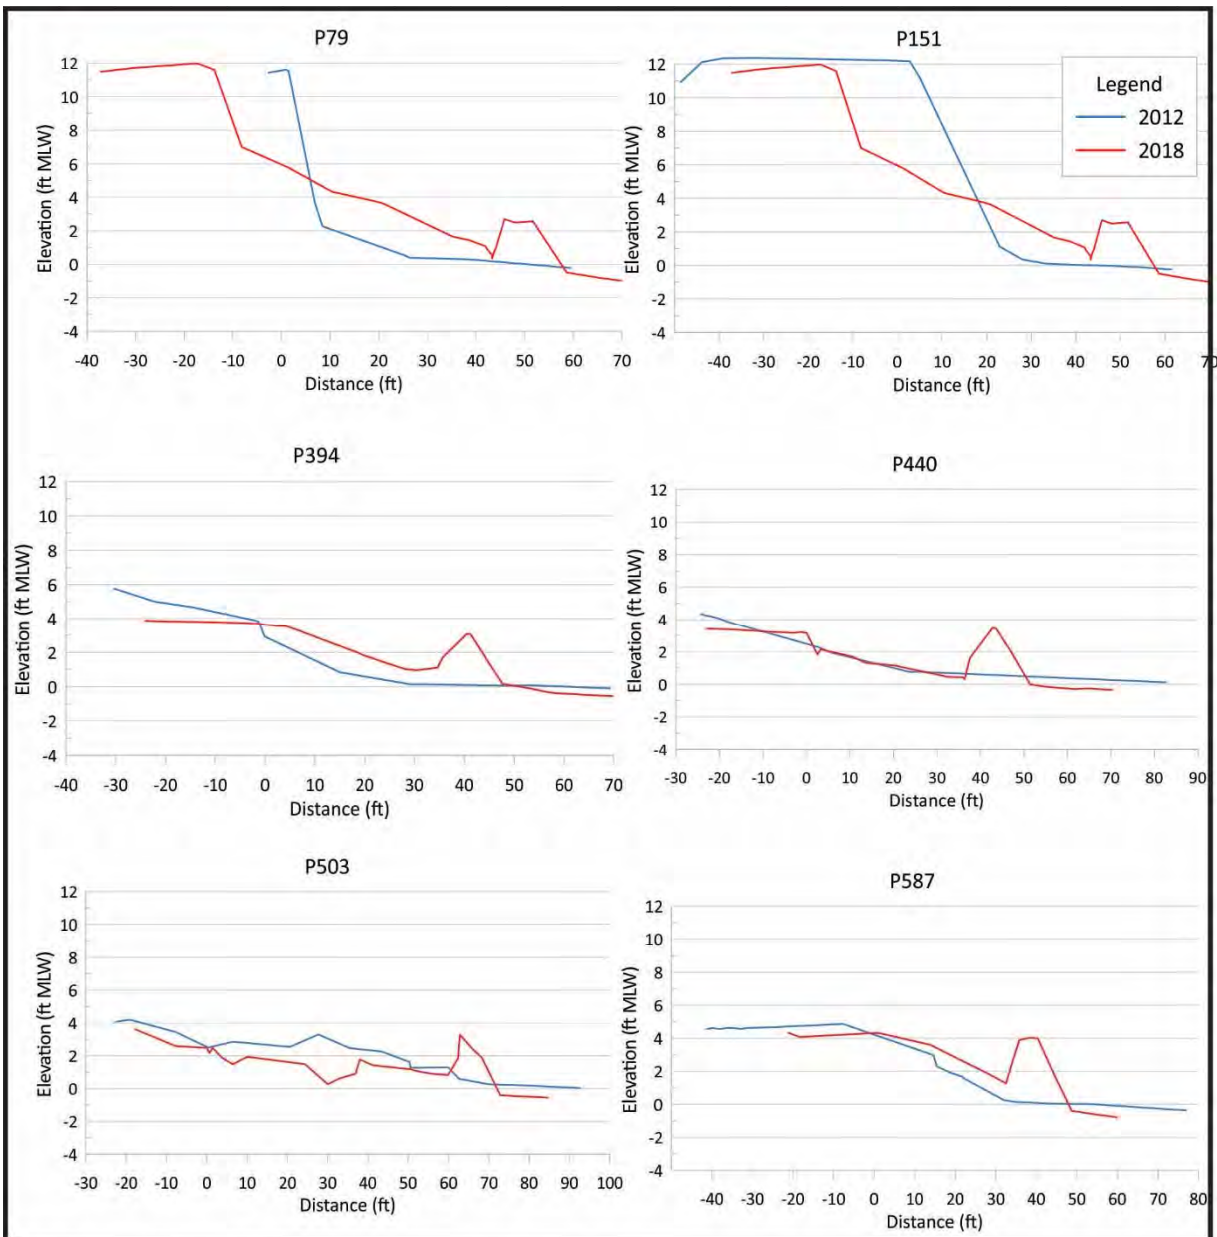
Survey data shows Reach 1 sill (ZZ) with elevated substrate from the sand fill in sections P587 (Figure 4-2-7 and Figure 4-2-8). The upland bank edge was graded slightly to the back of the sand fill. Reach 2, Sill 1 shows the mouth of the tidal creek has shifted and deepened slightly (P503). The tidal creek flat behind sill # 3, P440 has remained relatively stable transitioning to the sand fill going north, P 394. Reach 3 sections P151 and P79 show the graded bank and wide stable sand fill.

Figure 4-2-8. Cross-sectional profiles at Occohannock taken before the living shoreline project was installed and in 2018.

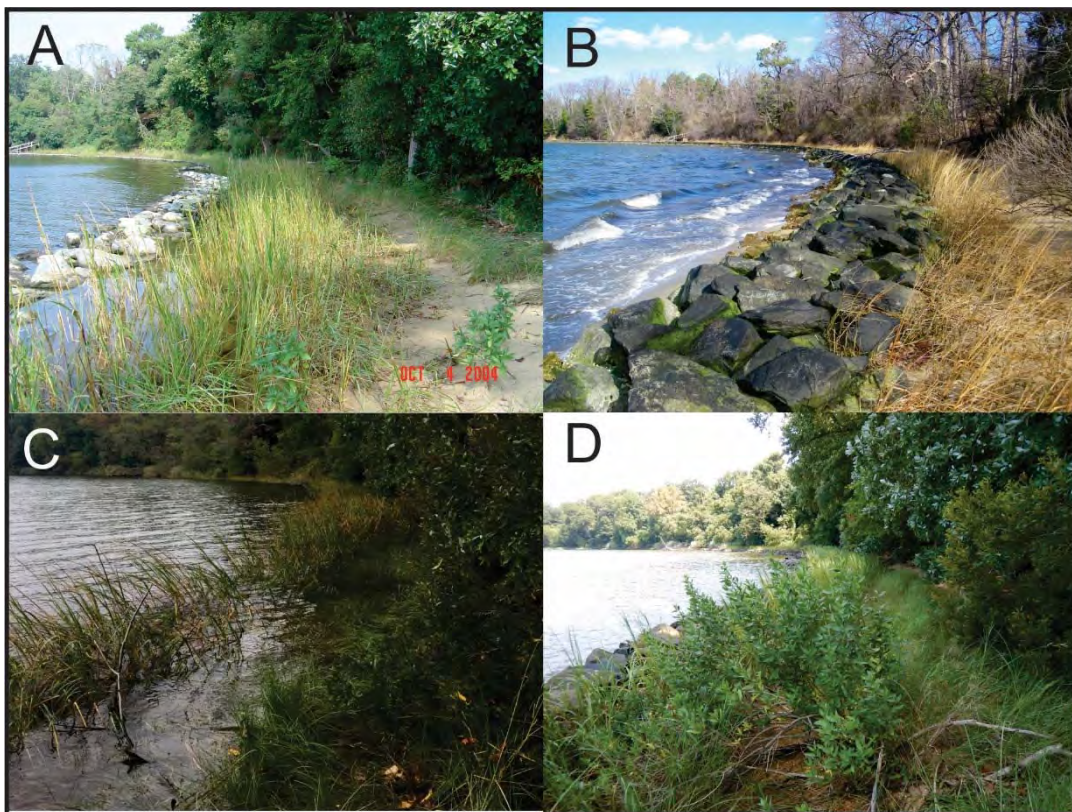
Access to the site is easiest down the hill to Sill #1. A series of photos show how that section of the project has evolved over time Figures 4-3-4A to 4-3-4D. Two years after construction, the low marsh is relatively intact. Tree limbs along the base of the bank had been cut back during construction

and began to grow back over time often shading the marsh. Elevation changes allowed salt bush and Phragmites to become established (Figure 4-3-4D).

Figure 4-3-4. Photos of St. Mary's A) two years after construction (4 Oct 2004), B) 11 years after construction (1 Feb 2013), C) 15 years after construction (13 Oct 2017), D) 16 years after construction (15 Aug 2018).

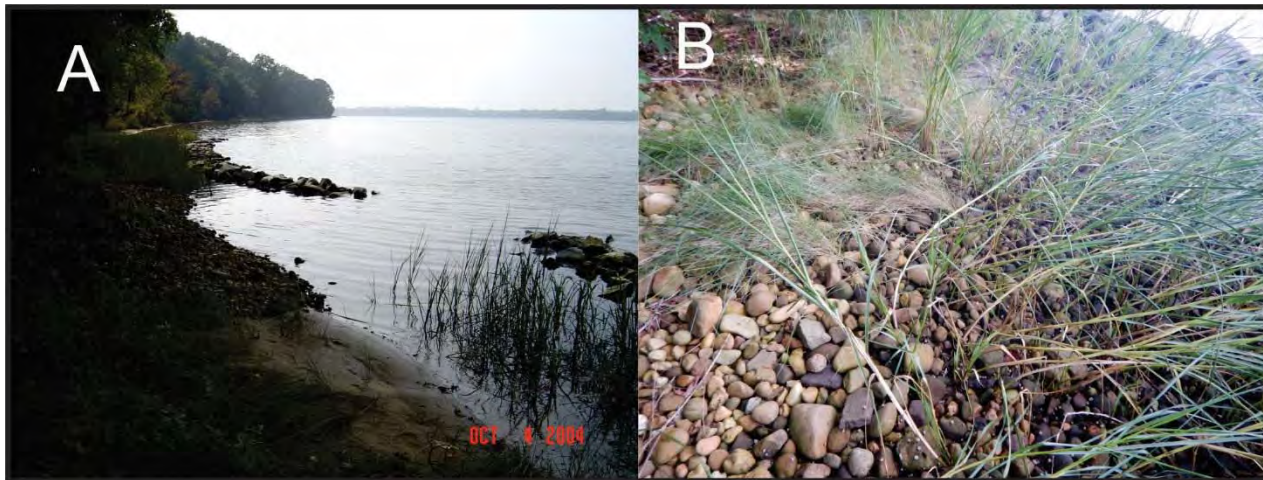
An element to the original project was experimenting with different type of sill (windows) openings in order to reduce sand attached maintain “flushing” behind the sill (Hardaway et al., 2007). In Window #1 the stable cobble substrate allowed low marsh to become established (Figure 4-3-5A and Figure 4-3-5B).

Figure 4-3-5. Gap at St. Mary's A) two years after construction, B) 16 years after construction (15 Aug 2018).

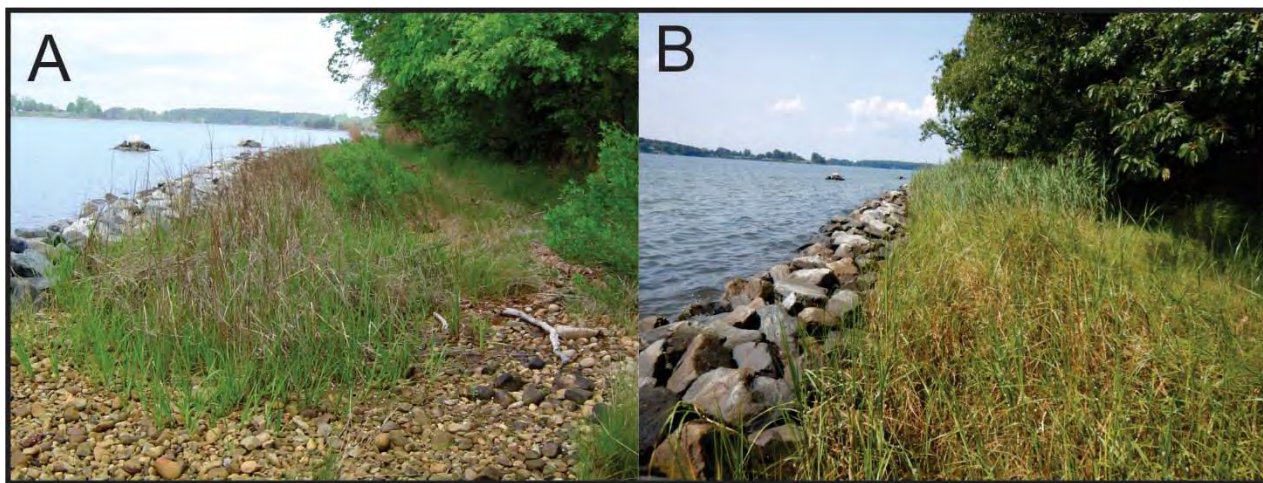
The evolution of the site vegetation over time can be seen in along Sill #7 looking north toward Window #8 with the offshore breakwater defined by two sentinel stones (Figure 4-3-6A). In 2007, the high and low marsh fringe is intact with a few salt bushes coming in and modest tree limb cover. By 2018 the low marsh in the foreground is very robust, but *Phragmites* has overcome both species farther along shore and significant limb growth occurs such that the shading inhibits any vegetation growth under that canopy.

Figure 4-3-6. Gap and sill at St. Mary's A) five years after construction (9 May 2007), B) 16 years after construction (15 Aug 2018).

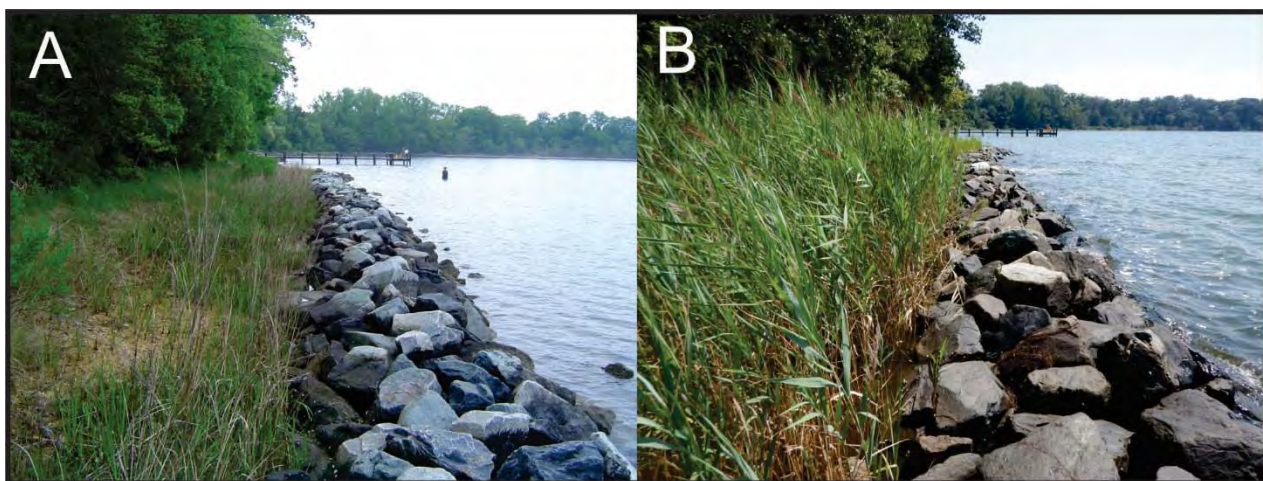
More evidence of vegetation change is seen from the same point but looking south, the same survey pier can be seen. In 2007, (Figure 4-3-7A), 5 years after construction, the marsh fringe is robust with both species intact, an occasional salt bush and a few slightly overhanging limbs. By 2018, (Figure 4-3-7B), *Phragmites* has completely taken over this section of marsh with heavy overhanging trees.

Figure 4-3-7. Sill at St. Mary's A) five years after construction (9 May 2007), B) 16 years after construction (15 Aug 2018). Phragmites has colonized behind the structures.

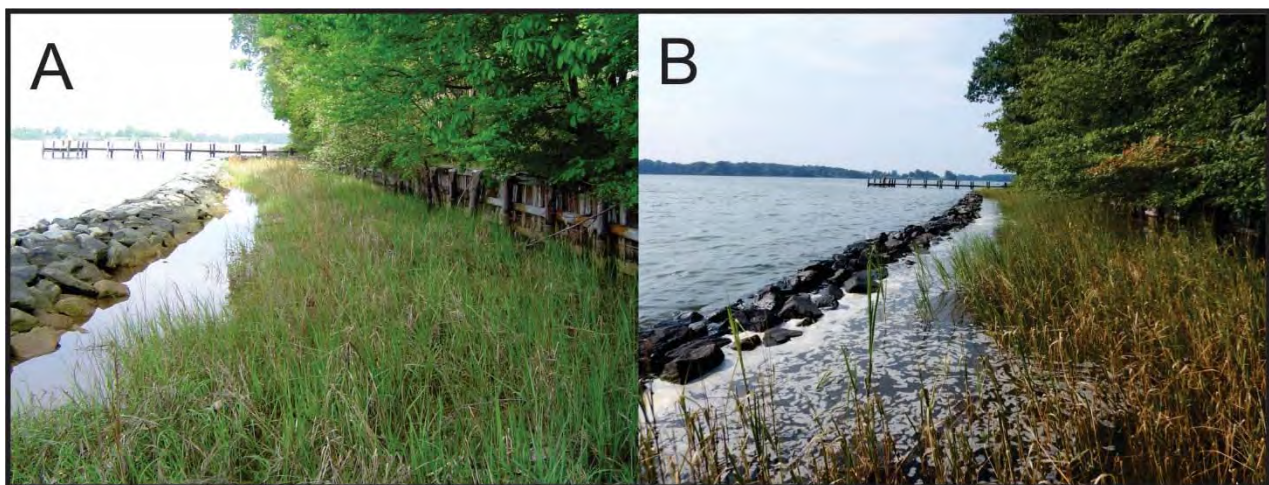
This was not the case everywhere especially in front of the one segment of existing bulkhead where on low marsh was planted in 2002, and by 2007 had become well established (Figure 4-3-8A). The fringe remained robust in 2018 with a few overhanging limbs but no *Phragmites* (Figure 4-3-8B). *Phragmites* does not tolerate regular tidal flooding in brackish water. Black needle rush is another species that has colonized St. Mary's shoreline (Figure 4-3-9A); it is often found with the intertidal snail (*Littorina littorina*). It occupies the zone where high and low marsh transition.

Figure 4-3-8. Sill backed by bulkhead at St. Mary's A) five years after construction (9 May 2007), B) 16 years after construction (15 Aug 2018). No change in the plants occurred.

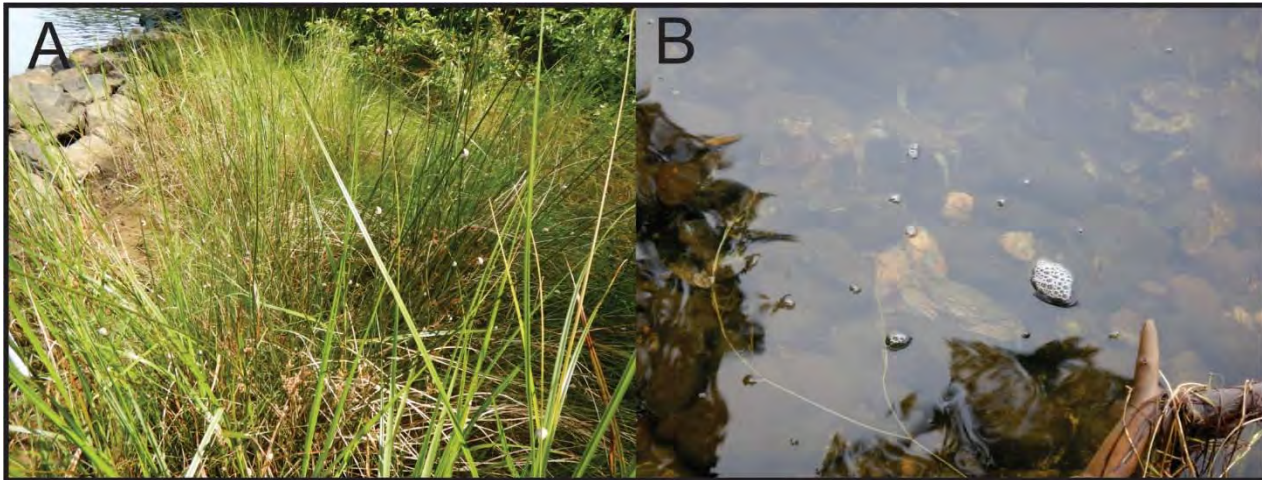
From a faunal habitat perspective, the St. Mary's City project had shown significant fish and crab usage (Hardaway et al., 2007). Qualitatively, this does appear to continue (Figure 4-3-9B). The vegetative communities may have changed slightly, but fish function appears to continue. The one stable element in the sill system is the rock sill itself. Even if it becomes submerged with SLR it will remain a fish haven.

Figure 4-3-9. Sill at St. Mary's (15 Aug 2018) A) Needlerush has colonized some sections, B) blue crabs are prevalent along the shore.

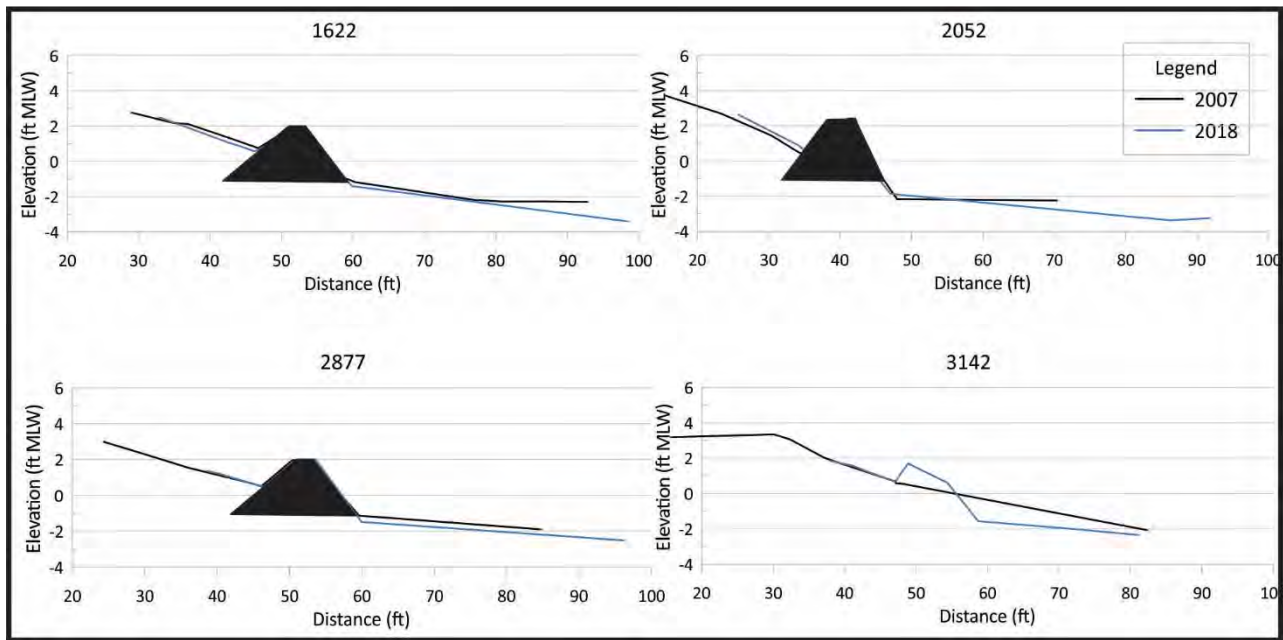
The survey showed that there were gradient adjustments between construction and the 2008 survey, but since then the net change across the stable vegetated backshore has very been little with some areas of reduction usually between +1 ft and +2 ft. This is the high water swash zone, where grasses are under the most stress from wave impact. Changes are in the order of 0.1 to 0.3 ft. Little new sediment enters the system either from the upland banks because they are very stable or from offshore due to the rock sill barrier.

Along Sill #1, there were slight decreases in the lower limit of *S. alterniflora* and in the nearshore (1622). Sill #2 (P1955), the backshore remained stable while behind Sill #3 (P2052) there was a slight increase, +0.3 ft from the back of the sill to about +2.5 ft at the edge of the heavy backshore vegetation. Further up at Sill #6 (P3142) shows no change across the backshore. We estimate almost 10

Figure 4-3-11. Selected cross-sectional profiles showing the shoreline in 2007, 5 years after construction and in 2018.

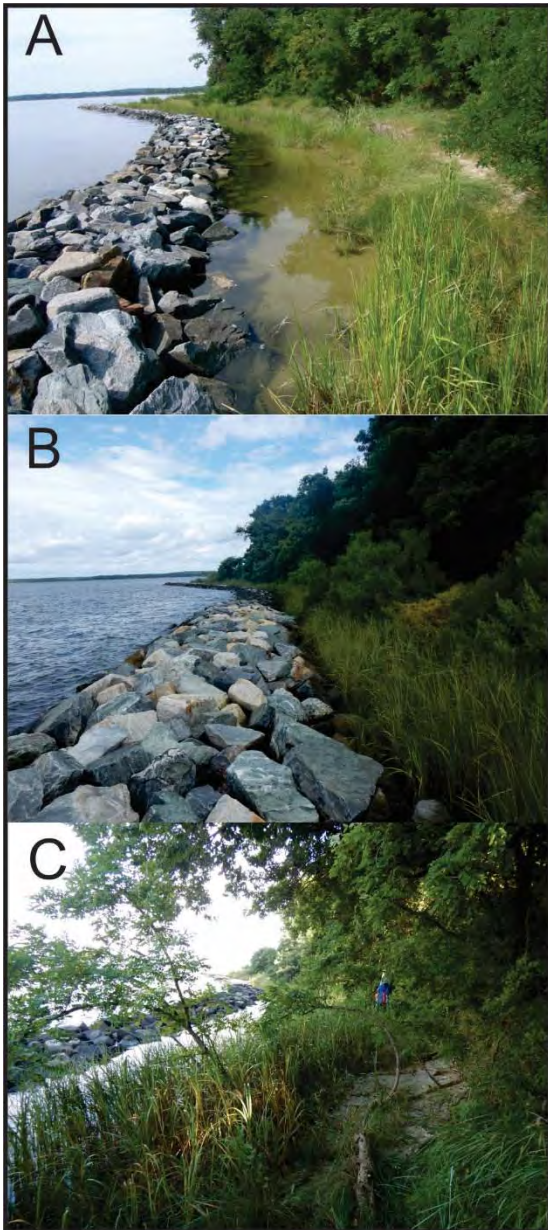
Figure 4-4-4. Photos of Sill #4 at Jefferson Patterson on 20 Aug 2018 A) along the low weir section, B) higher section of sill, C) along the backshore.

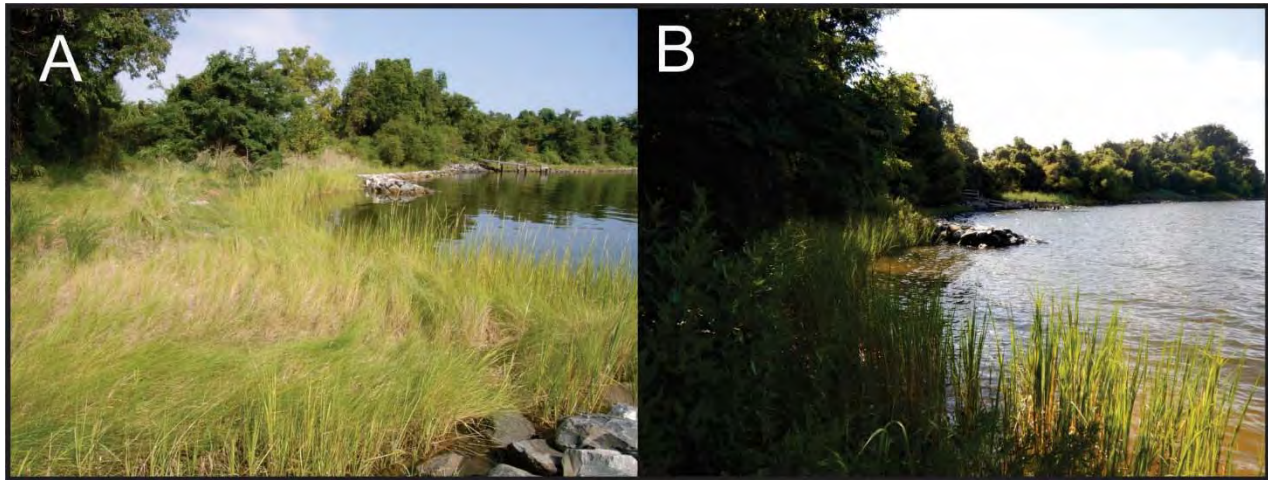
Looking downriver toward from the end of Sill #4 toward Sill #3-3, wetland growth was good in 2008 that became very shaded by 2018 (Figure 4-4-5A and 4-4-5B). Also, extensive patches of Phragmites can be seen in the distance alongshore. Moving upriver from Sill 5-1, Phragmites was

Figure 4-4-5. Photos at Jefferson Patterson looking from sill #4 downriver toward sill #3-3 in A) 2008 and B) 2018 where extensive Phragmites is visible.

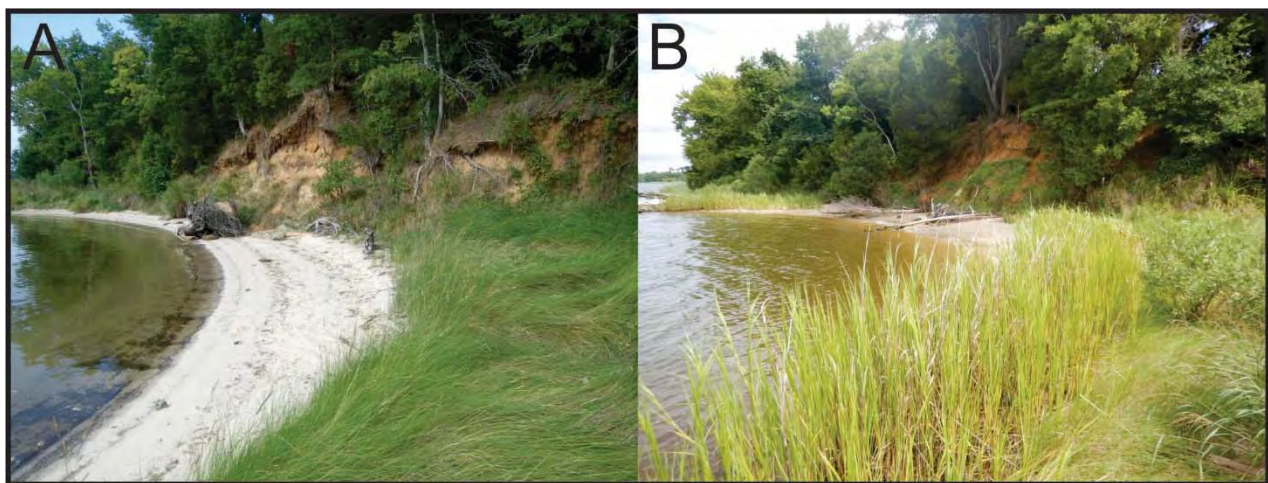
Figure 4-4-7. Photos at Jefferson Patterson of the embayment between BW4 and Sill 5-1 in A) 2008 and B) 2018 where Phragmites is visible.

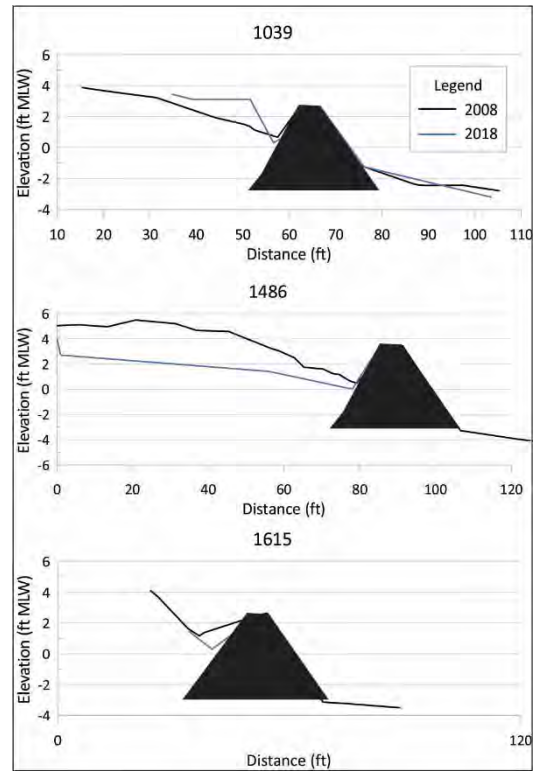
Survey results indicate a relatively stable substrate over time due in part to very significant *Phragmites* invasion (Figure 4-4-8 and Figure 4-4-9). It is estimated that from the upriver end of Sill #5 down to BW 3 that *Phragmites* has overtaken about 30% -40% of the backshore terrace above high water. Shading from limbs compounds high marsh grass growth as well. The reduced surveyed area showed accretion behind BW 4 (P1039) and erosion at the upriver end of Sill # 4 (P1486). The central weir section of Sill #4 (P1615) got a little deeper at high tide as MHW expanded landward. The MHW position remained fairly stable in the three surveyed embayments supporting the original design template.

Figure 4-4-9. Cross-sectional profiles at Jefferson Patterson.

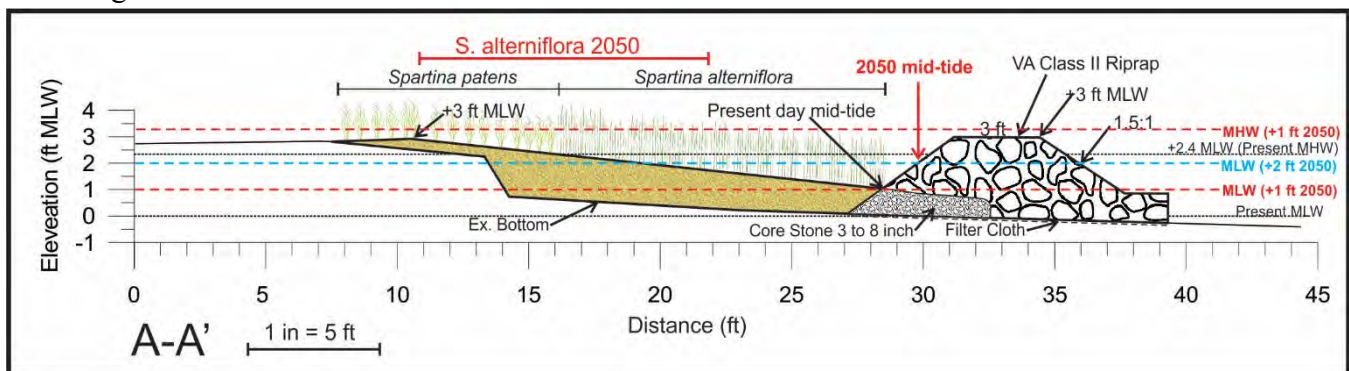
Based on the model at Captain Sinclair, the lower limit of *S. alterniflora* will be about 8 feet landward of the sill (5-1-1) because mid-tide, which is the lower limit of *S. alterniflora*, extends farther inland. The *S. patens* along the back berm will be replaced by *S. alterniflora*. The sill will become submerged at MHW thereby slightly reducing its wave attenuation capability but also becoming more of reef type structure. Adding rock to the sill is not an option because this low bank shore will be flooded. If this system is able to migrate vertically and horizontally either naturally or with the addition of sand, by 2050, it will have preserved about 0.14 acres of marsh habitat.

Beyond 2050 (or increased rate of SLR), the marsh system will begin to drown. At an increase of 2 ft in sea level, the system will become almost subtidal and the wide marsh behind the sills will be impacted. The rock sill will become a fully submerged reef which will still reduce wave energy impacting the shoreline, but it will not provide effective shore protection. Once the system is subtidal, SAV might move into the old marsh substrate.

Figure 5-1-1. Sea-level rise scenarios modeled at Captain Sinclair and depicted on a typical cross-section.

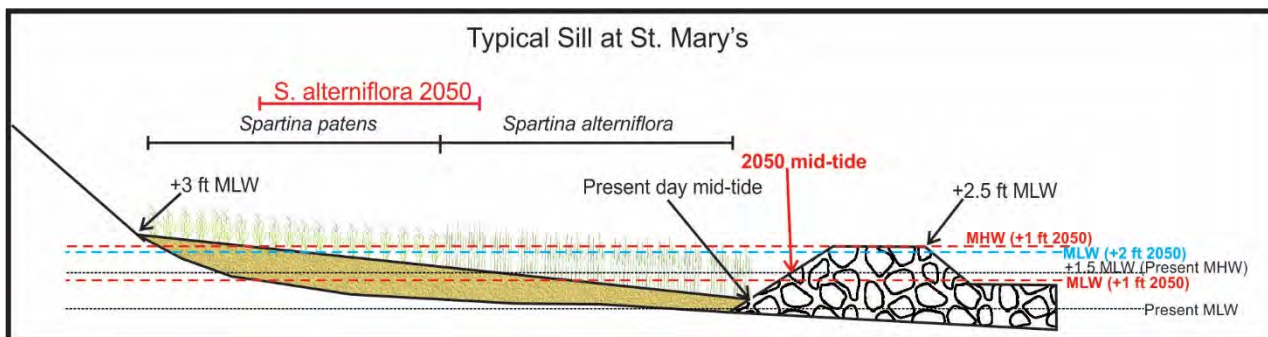
Figure 5-3-1. Sea-level rise scenarios modeled at St. Mary's and depicted on a typical cross-section.

Presently, the system is working to provide shore protection to the high bank coast along this relatively low fetch shoreline. However, this site maybe a candidate for SLR modifications in the future due in part to ease of accessibility by water which will allow barges to bring in material and to be used in construction. One scenario would be to add proportionate rock and sand to the system and replant after cutting back the overhanging limbs (Figure 5-3-2). The existing marsh fringe would be completely covered, and the project would start all over again at a higher elevation. Before this could be implemented, it would be important to dig out all the Phragmites and commit to a maintenance plan.

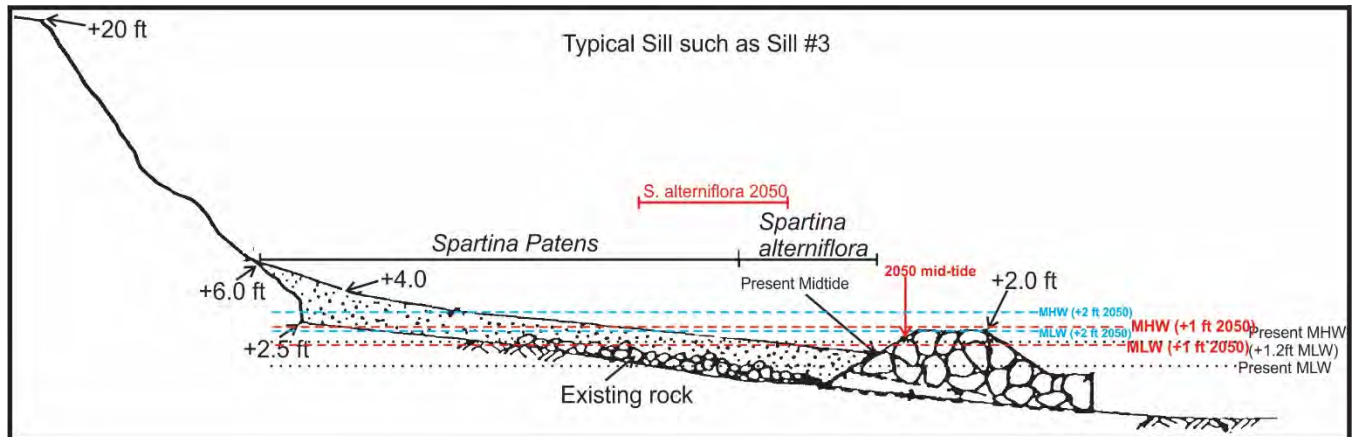
With a one-foot rise in sea level, *S. alterniflora* would migrate upland leaving a wider non-vegetated intertidal zone. The sill would be submerged at high water (Figure 5-4-1) The extensive Phragmites already covers much of the sill system and would persist even with a 2-foot rise in sea level. This system would be a good candidate site for just adding rock to the sill to protect the base of bank from wave attack (Figure 5-4-2). Adding sand could be done too but at additional costs. Again these options are viable because of barge access for construction.

Figure 5-4-1. Sea-level rise scenarios modeled at Jefferson Patterson and depicted on a typical cross-section.
