REPORT OF TRIP TO INVESTIGATE AREA AROUND
HERON ISLAND BAR IN THE POTOMAC RIVER

Paul C. Kendall and Dexter S. Haven

10 July 1981

Marine Resource Report #81-8

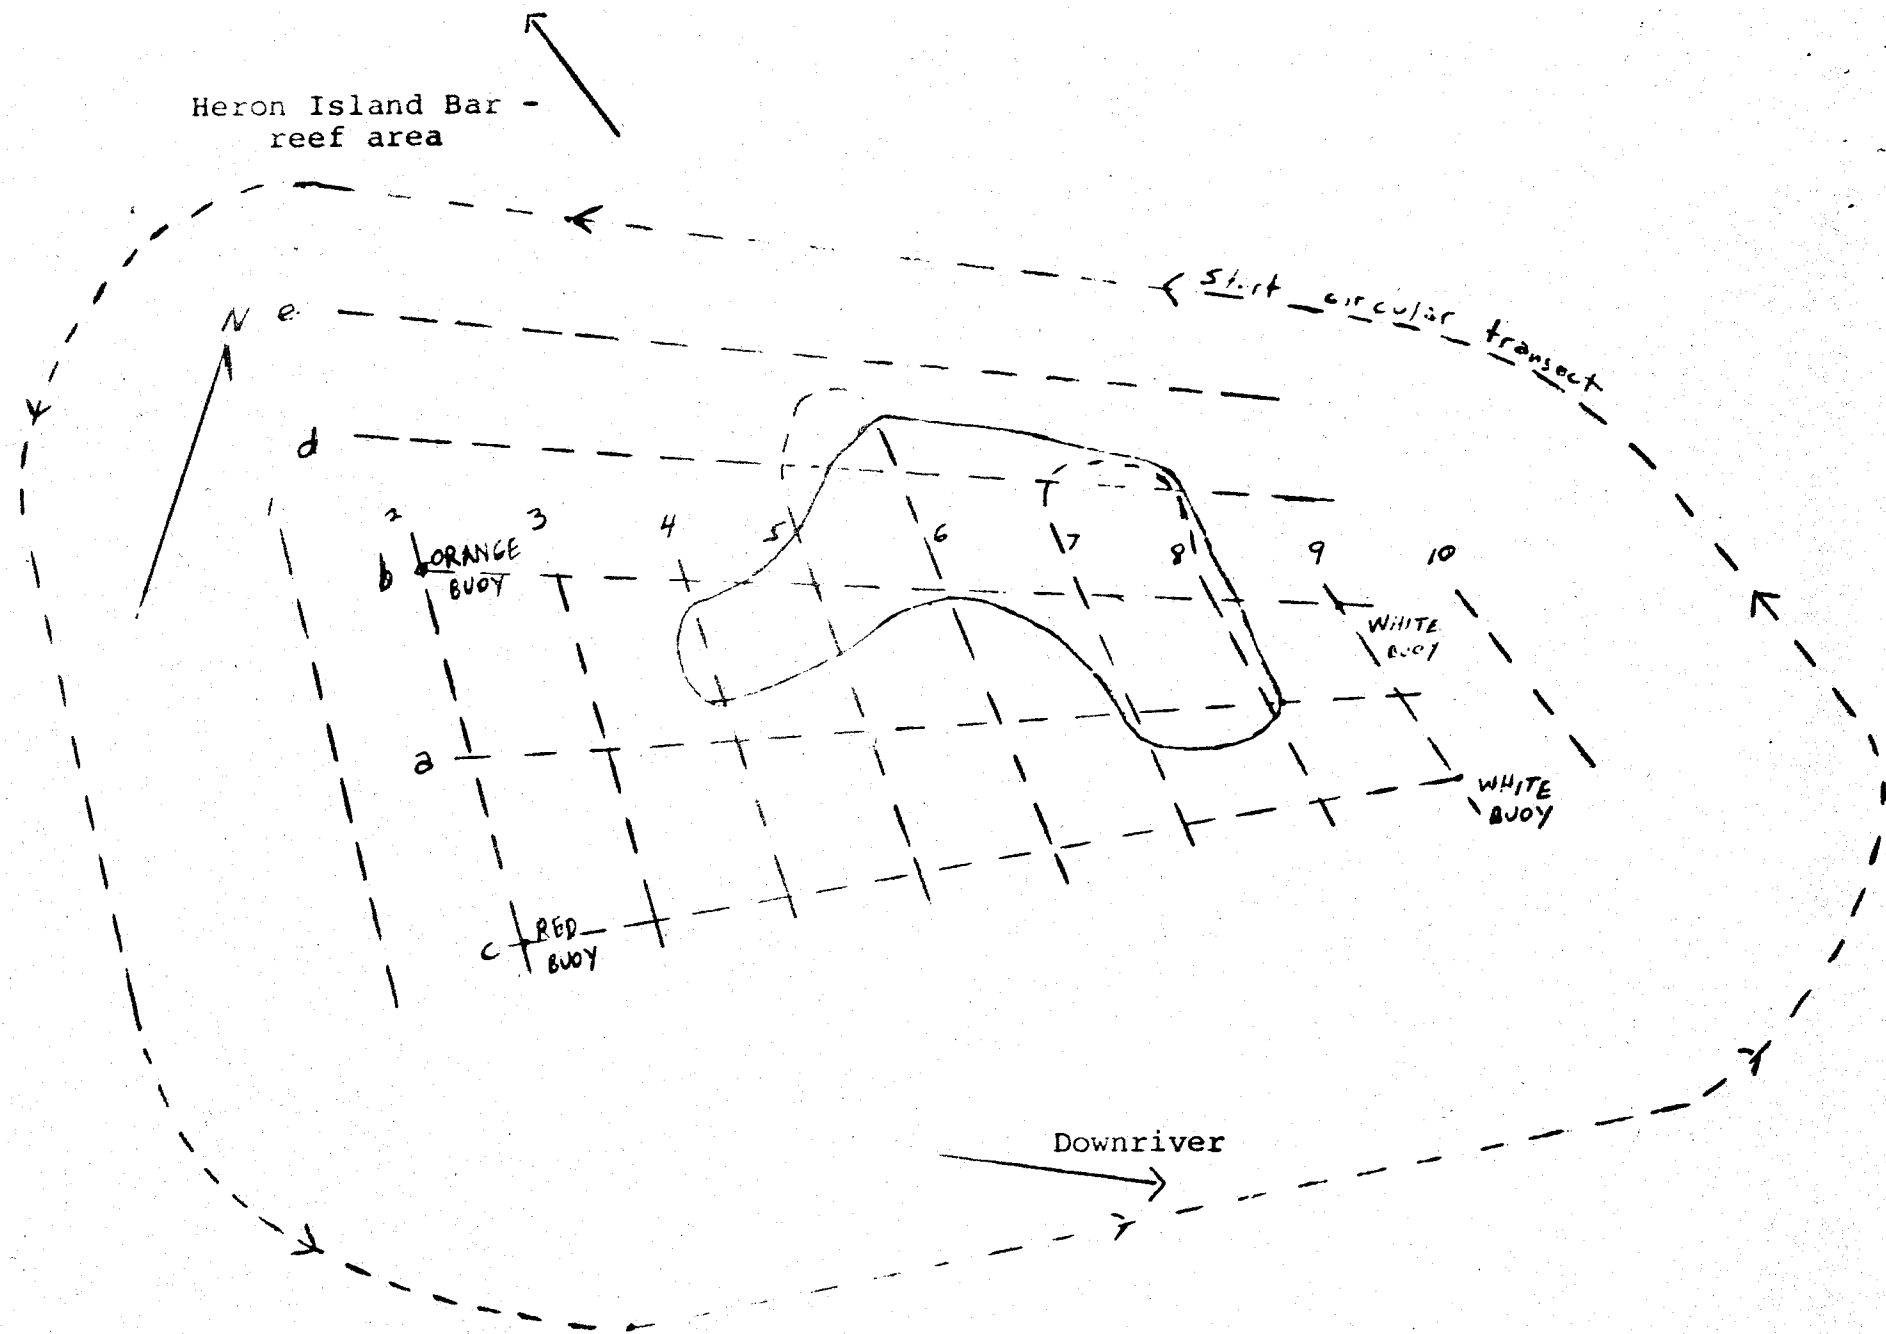
Figure 2. Key to transects covered with fathometer 6/17/81. Dashed lines represent transects. Area with irregularities enclosed by solid line. Scale: 1 inch = 129 feet.

All of the previously-mentioned bottom anomalies occurred in close proximity to each other; the locations are shown on Figure 2 as a single area enclosed by the solid line. The bottom surrounding this area was smooth and even. The size of the area where disturbance was suggested was measured with a polar planimeter and found to contain 1.26 acres.

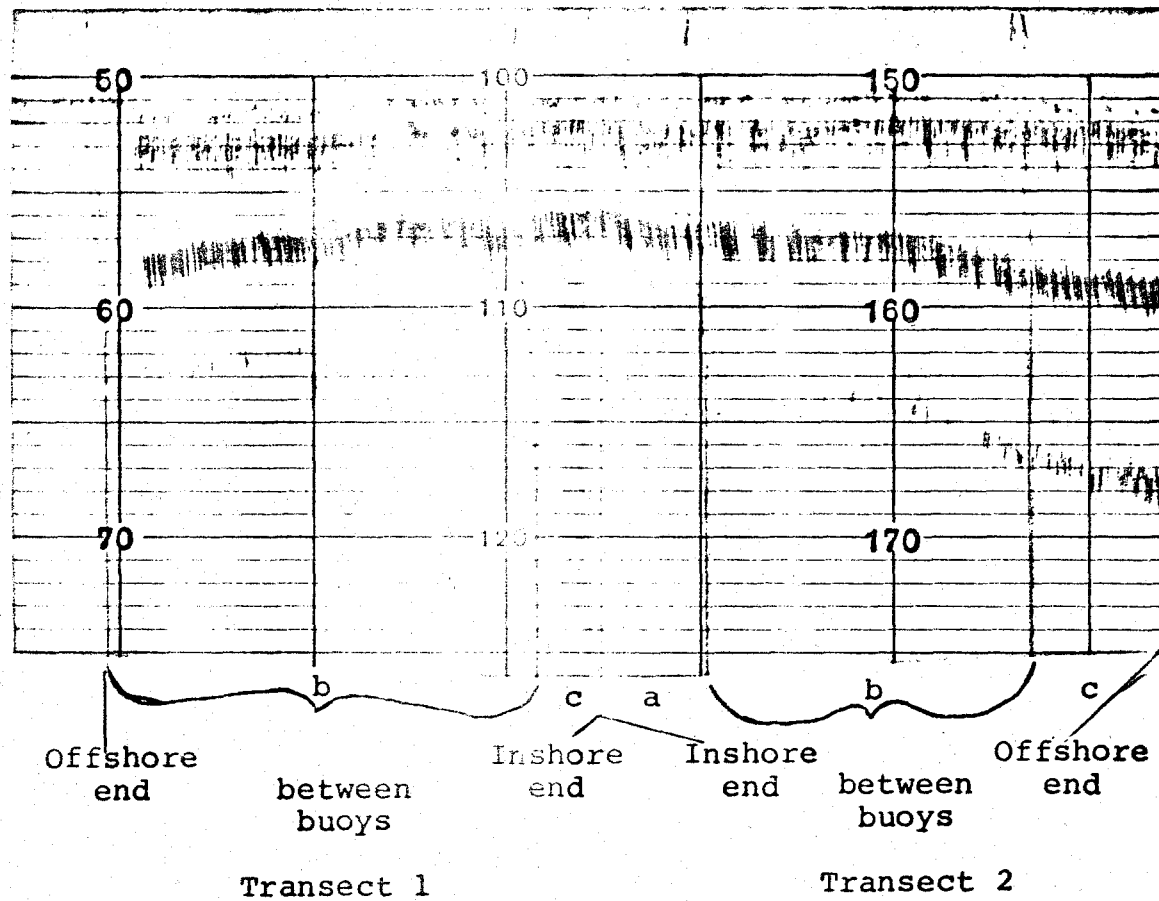
Figure 3. Fathometer tracing of the bottom along transects 1 and 2 in the Potomac River near Heron Island Bar; made 6/17/81.

Transect 1 - This transect was about 90 feet upriver of the buoyed location and was run from the offshore buoy to the inshore buoy (Figure 2). The trace (Figure 3) shows a smooth, even line, indicating a smooth, even bottom.

Transect 2 - This transect was along the upriver line of buoys and was run from the inshore end to the offshore end (Figure 2). A smooth even bottom was indicated by the fathometer (Figure 3).

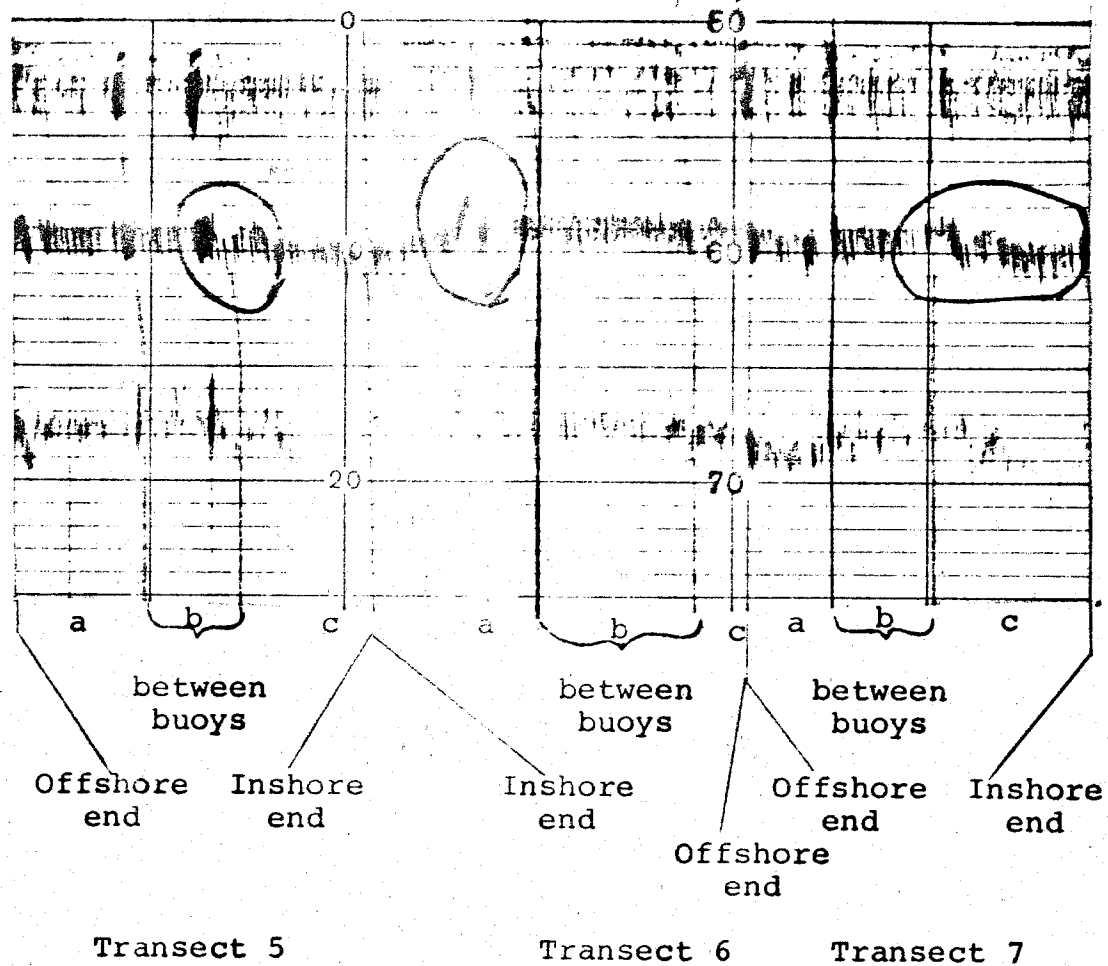
Figure 5. Fathometer tracing of the bottom along transects 5, 6 and 7 in the Potomac River near Heron Island Bar; made 6/17/81, circled portions are suggestions of recent disturbance.

shore to the inshore end (Figure 2). The trace of the fathometer is mostly smooth except at and beyond the inshore end of the transect (5b and c on Figure 5) where a depression with peaks or mounds of material on both sides was indicated. The depression is, at most, one half foot below the surrounding bottom, and the mounds or peaks are approximately one half foot above the surrounding bottom for a total difference in height of one foot from the bottom of the depression to the tops of the mounds. These features (which are circled on Figure 5) suggest a recent disturbance because of their irregularity, closeness and magnitude. We were unable to calculate the distance on the bottom over which the disturbance occurred.¹

Transect 6 - This transect was run starting at the inshore end (Figure 2). On the inshore end of this transect (6a on Figure 5) the fathometer indicated a mound which measured one to two feet high and a depression adjacent (these features

are circled on Figure 5). The steep slope of the mound suggested that it was made by a recent disturbance; disturbance was suggested over 129 feet of the bottom. Over the remainder of the transect the fathometer indicated a smooth bottom.

Transect 7 - The fathometer revealed an uneven and rapidly changing bottom beginning at the inshore end of this transect and proceeding toward the reef of Heron Island Bar and downriver to the beginning of the next transect (Transect 7c on Figure 5). On this trace the bottom varied in depth from $8\frac{1}{2}$ to $9\frac{1}{2}$ feet, a difference of one foot. The tracing suggests disturbance; because of stalling in the movement of the recording paper the distance of the disturbance could not be calculated. For the remainder of the transect (7a&b) a smooth bottom was indicated.

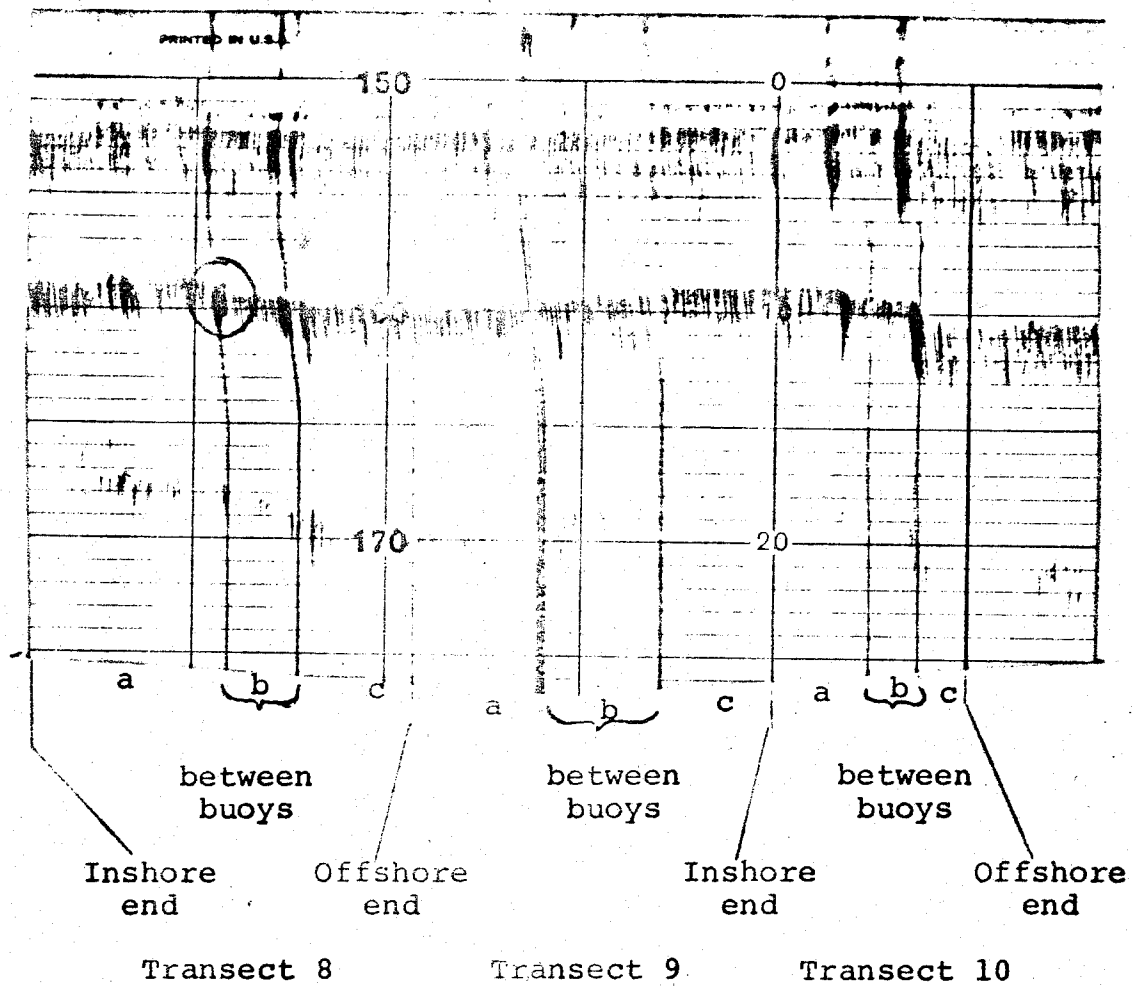
Figure 6. Fathometer tracing of the bottom along transects 8, 9 and 10 in the Potomac River near Heron Island Bar; made 6/17/81. Circled portion is suggestion of recent disturbance.

Transect 8 - On this transect, which was about 90 feet downriver from the previous one, an abrupt change of about one half foot in the depth of the bottom was revealed near the inshore end; the remaining offshore portion (transect 8c) had a smooth bottom (Figures 2 and 6). The abrupt change in the surface of the bottom near the inshore

end of the transect suggests that it was caused by a recent disturbance. The extent of the disturbance could not be calculated due to the malfunction of the recording fathometer.

Transect 9 - This transect lay along the downriver line of buoys and was 90 feet from transect 8 (Figure 2). The fathometer trace revealed a smooth, even bottom with no sign of disturbance (Figure 6).

Transect 10 - About 90 feet downriver of transect 9 this transect was run (Figure 2). The fathometer trace shows a smooth, even bottom (Figure 6).

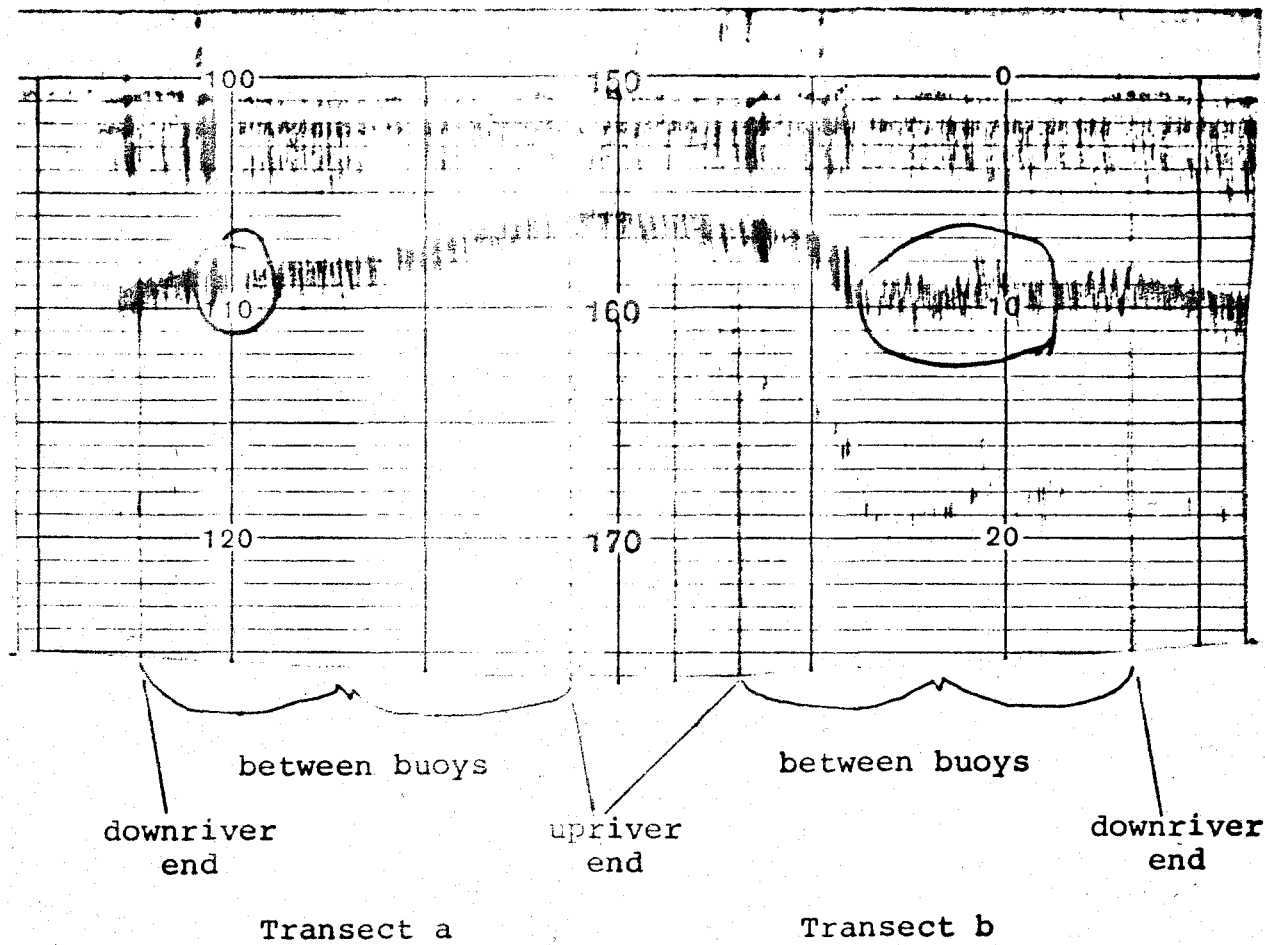
Figure 7. Fathometer tracing of the bottom along transects a and b in the Potomac River near Heron Island Bar; made 6/17/81. Circled portions are suggestions of recent disturbance.

Transect a - This transect was run through the middle of the buoyed area, beginning at the downriver end of the area and going upriver (Figure 2). The fathometer tracing is smooth with one exception; near the downriver (from near transect 8 to near transect 7) end is a slight depression and an adjacent mound (Figure 7) which suggest a recent disturbance. The disturbed bottom continued for about 111 feet.

Transect b - Transect b was run along the inshore line of buoys beginning at the upriver end of the area (Figure 2). The tracing is rough and irregular for approximately half the length of the transect or

336 feet, which suggests that this portion of the bottom was recently disturbed (Figure 7); the remaining portions of the transect appear smooth.

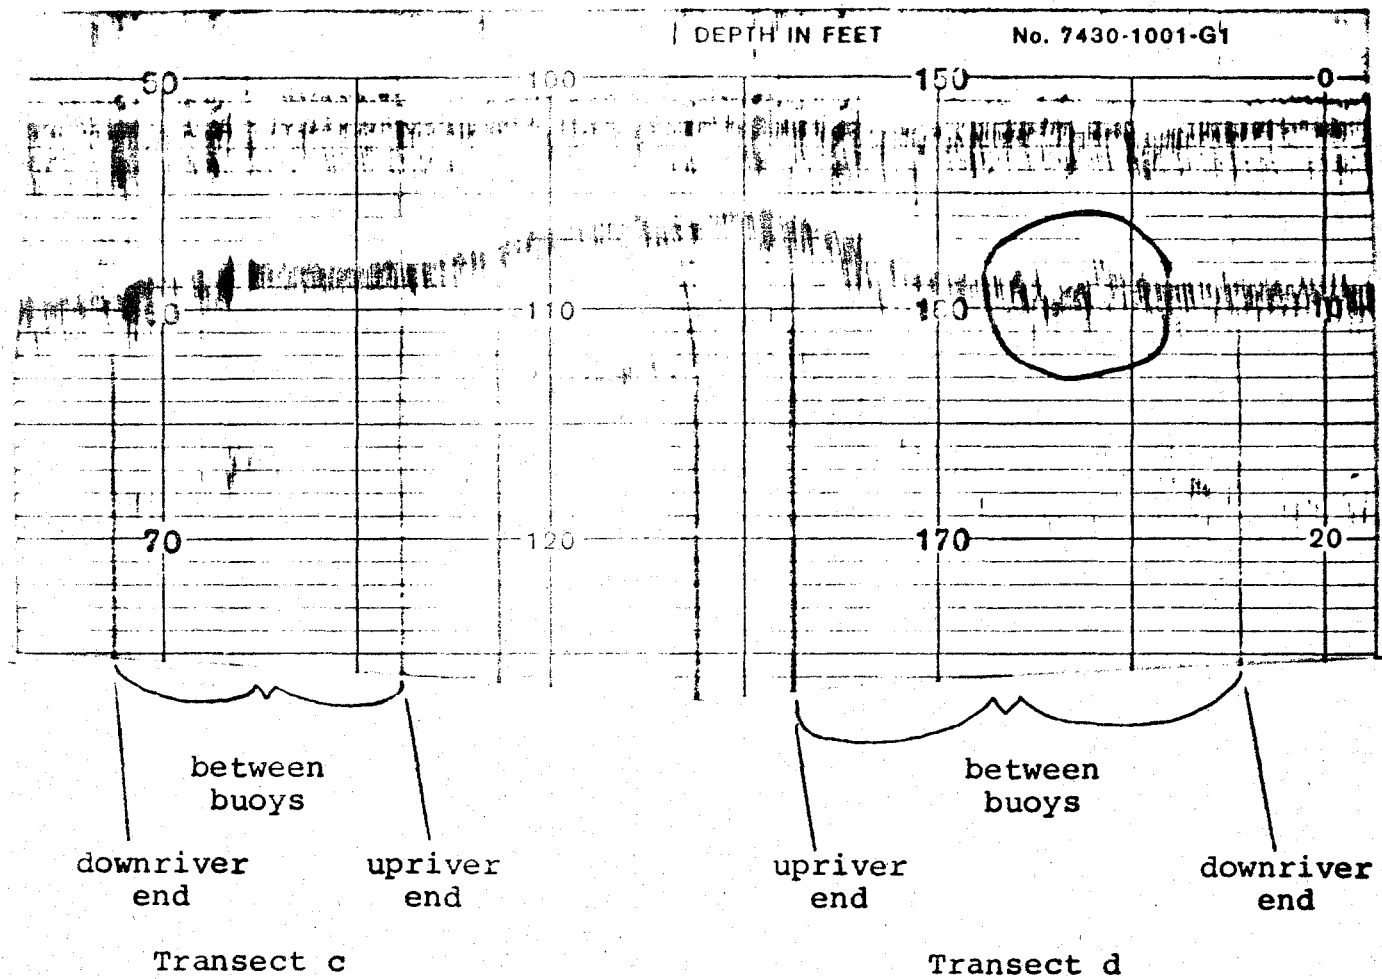
Figure 8. Fathometer tracing of the bottom along transects c and d in the Potomac River near Heron Island Bar; made 6/17/81. Circled portion is suggestion of recent disturbance.

Transect c - Between the two offshore buoys where this transect was run (Figure 2) the fathometer produced a tracing that was mostly smooth. The one rough area shown on the fathometer trace is not subject to interpretation since the movement of the paper stalled at that point and left no clear picture of the bottom (Figure 8).

Transect d - This transect was run approximately 90 feet inshore of the buoyed area (Figure 2). A smooth bottom is indicated for the most part; near the middle of the transect (roughly, between transects 5 and 8) is a depression and an adjacent mound. The height difference between the top of the mound and the bottom of the depression is a little less than one and a half feet (Figure 8). This feature just mentioned suggests recent disturbance; the disturbance continued for 241 feet.

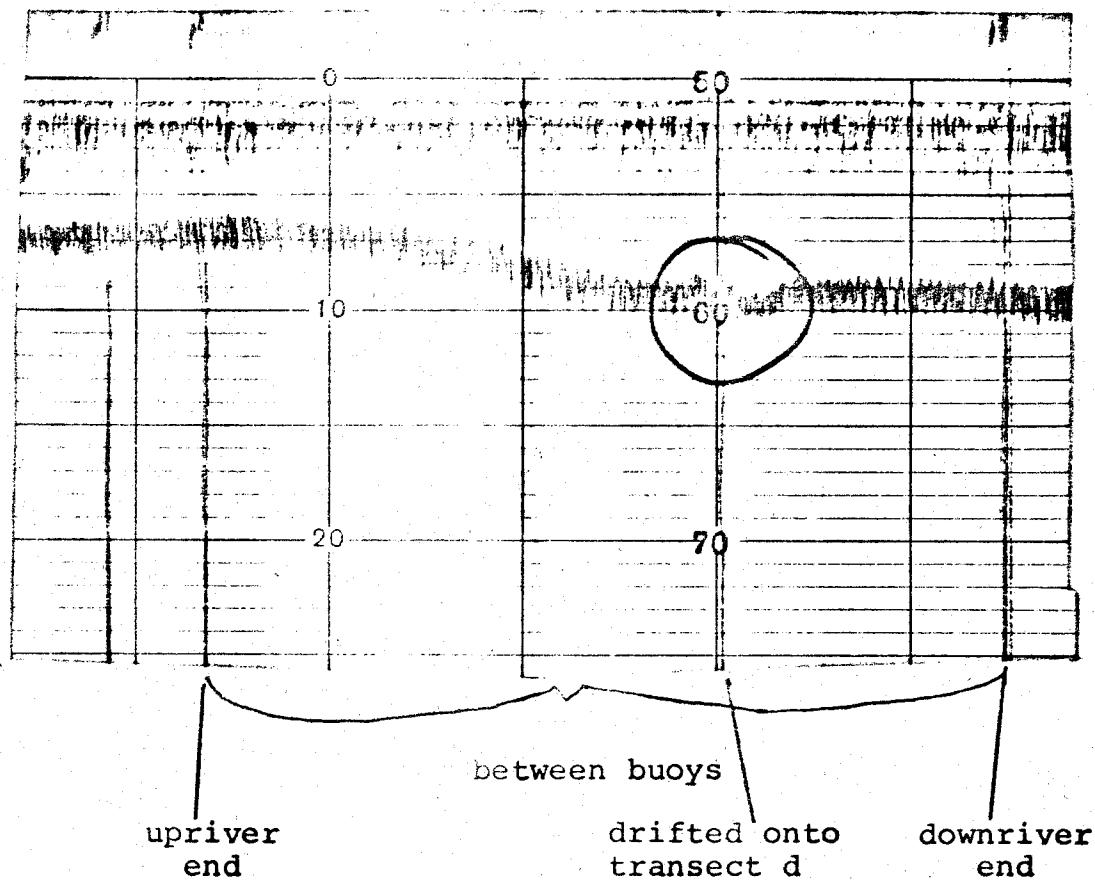
Figure 9. Fathometer tracing of the bottom along transect e in Potomac River near Heron Island Bar; made 6/17/81. Circled portion is suggestion of disturbance.

Transect e - This transect was approximately 180 feet inshore of the buoyed area (Figure 2). The trace is smooth and regular except for a mound and a depression 1/2 to 2/3 of the distance along the

trace; this happened when the boat was crabbed sideways by the wind onto transect d. That portion of the trace on transect e was smooth (Figure 9).

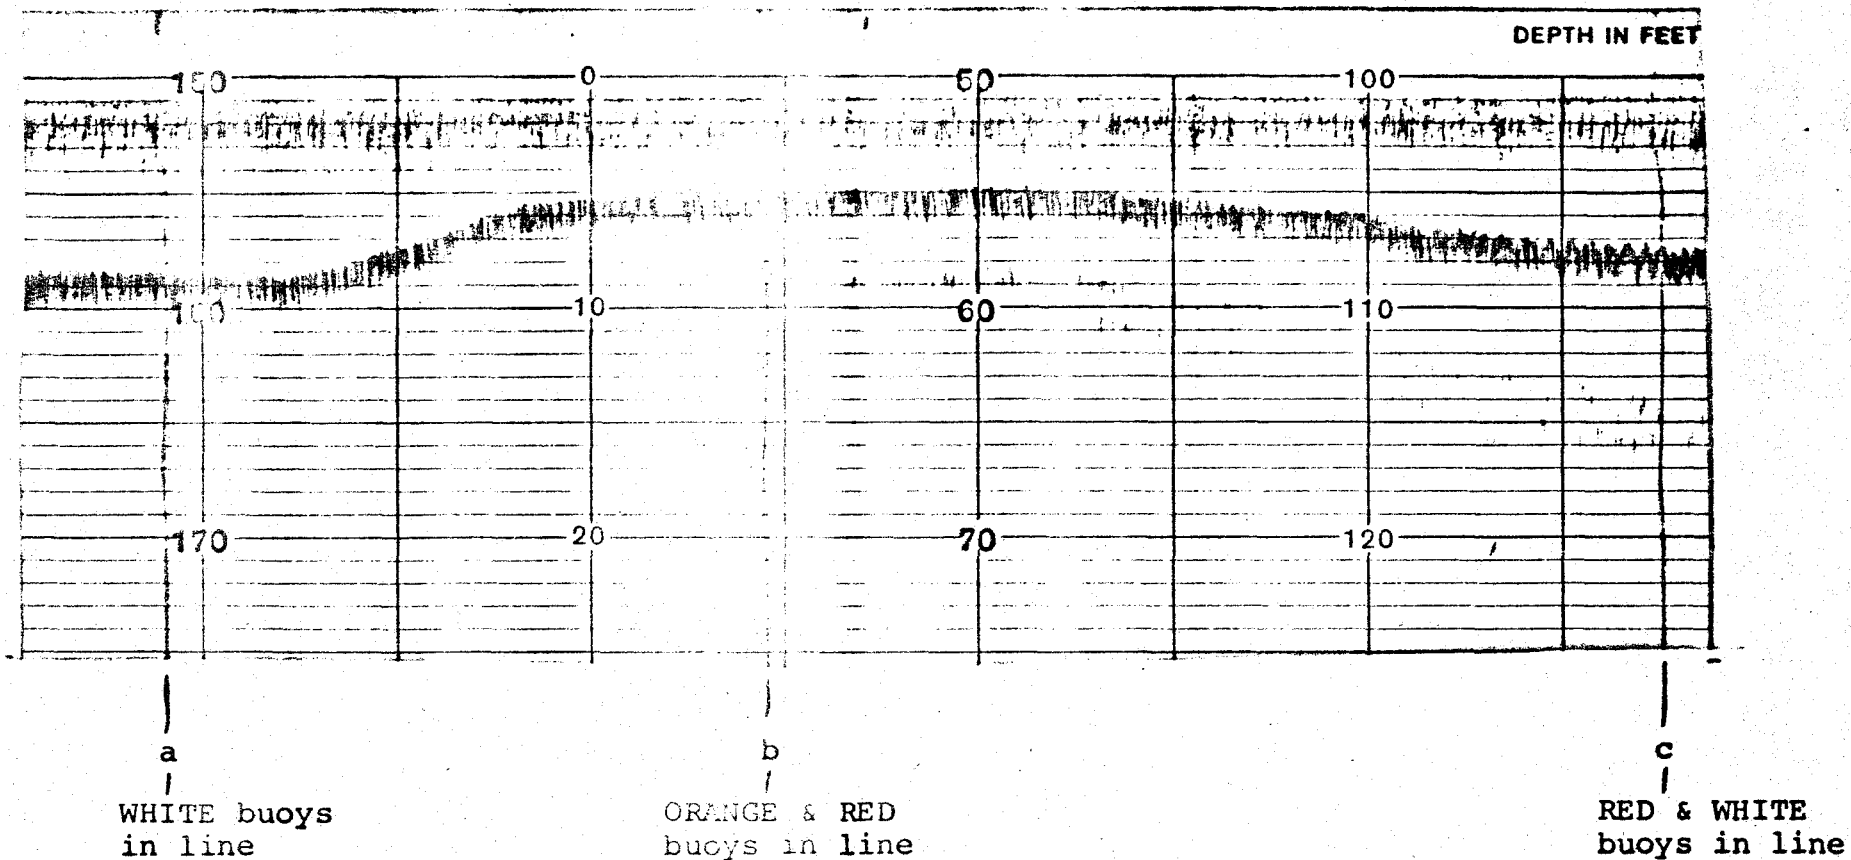
Figure 10a. Fathometer tracing of the bottom along circular transect about 300 feet from buoys near Heron Island Bar in the Potomac River; made 6/17/81.

Circular transect - This transect was run in a counter-clockwise direction around the buoyed area (Figure 2) at a distance of about 300 feet. The first part (Figure 10a) shows the tracing produced over that portion of bottom inshore of and parallel to the two inshore buoys (a to b); also shown is that portion of the bottom upriver of the buoyed area (b to c). Figure 10b shows the portions of bottom offshore (d to e) and downriver (f to h) of the buoyed area. All along the circular transect the fathometer revealed a smooth, even bottom.

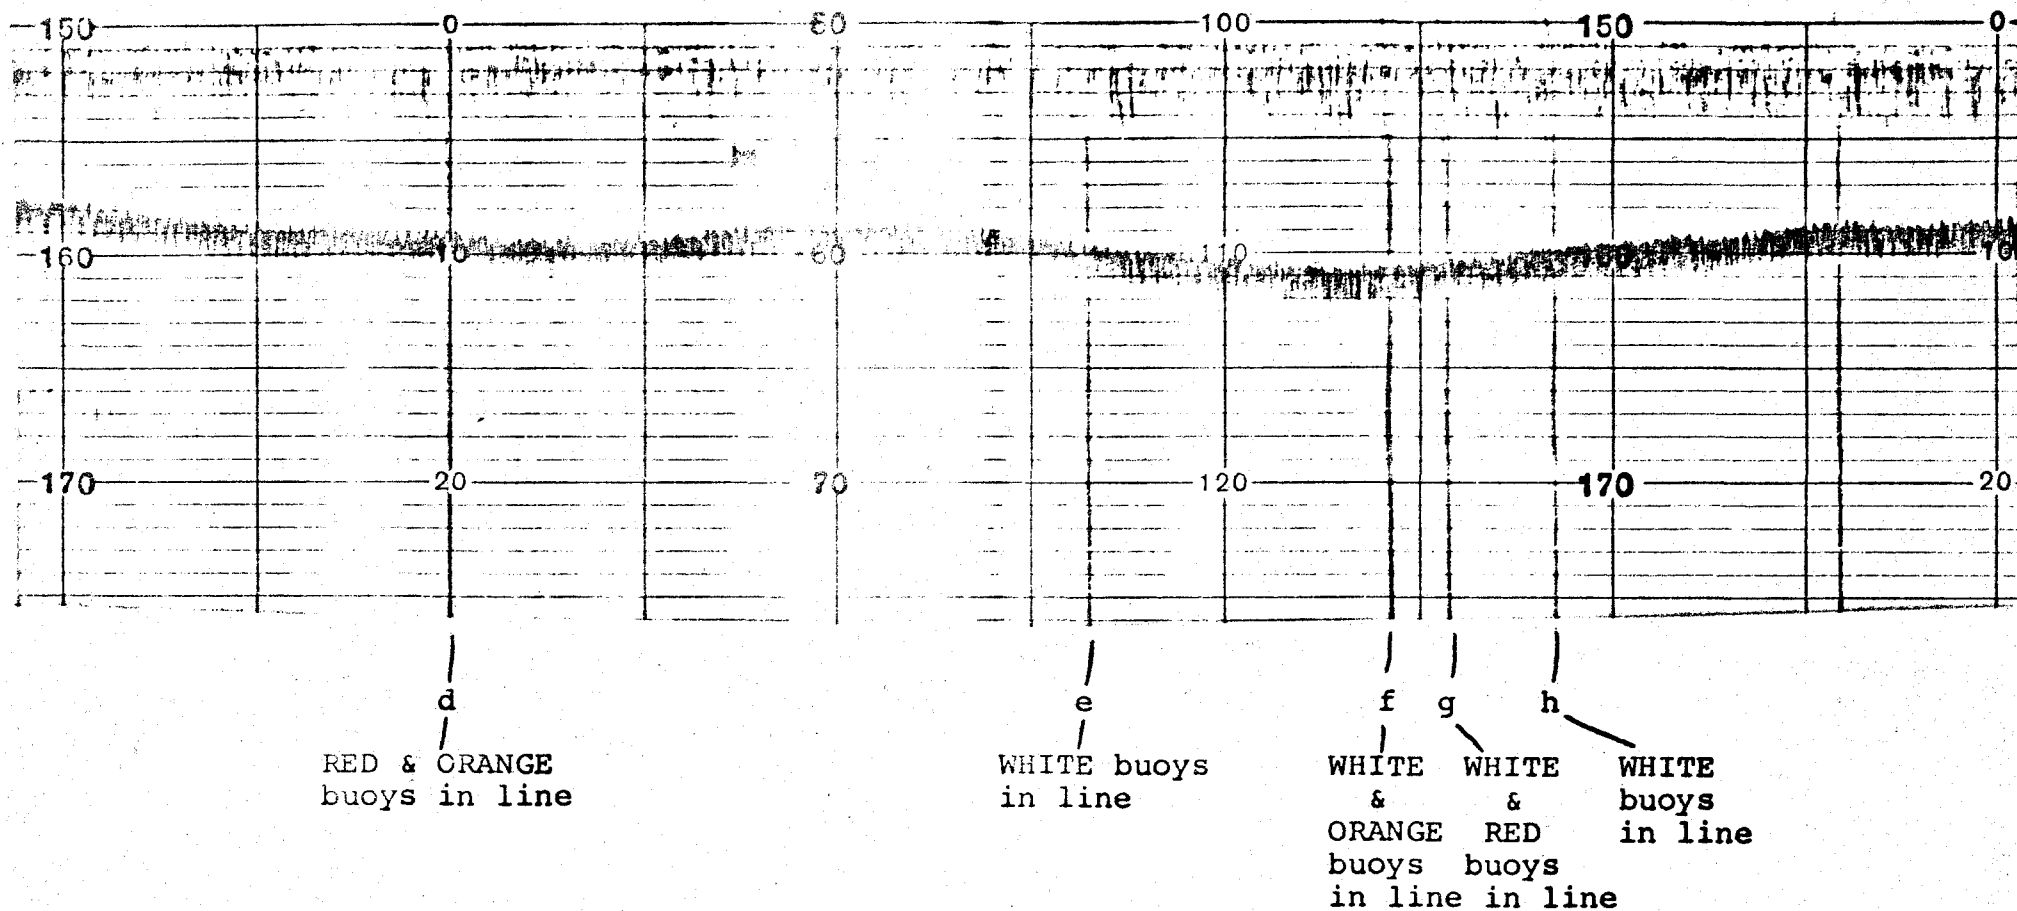
Figure 10b. Fathometer tracing of the bottom along circular transect about 300 feet from buoys near Heron Island Bar in the Potomac River; made 6/17/81.
