*Living Shoreline  
Sea-Level Resiliency:  
Performance and Adaptive  
Management of Existing Sites*

*November 2018*

# Living Shoreline Sea-Level Resiliency: Performance and Adaptive Management of Existing Sites Summary Report

Shoreline Studies Program  
Virginia Institute of Marine Science  
William & Mary

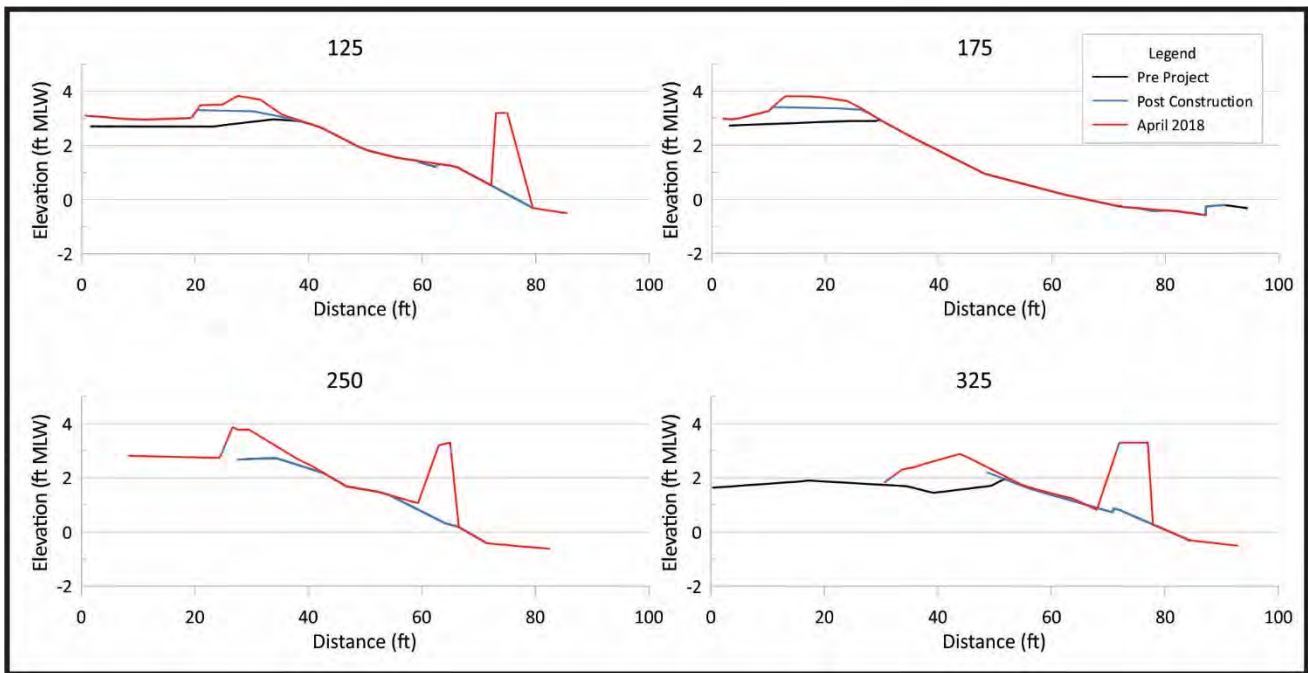
Site surveys show the main change is in backshore elevation (Figures 4-1-6 and 4-1-7). The backshore berm has increased in height and apparently not at the expense of the lower beach face. It appears that elevation changes are due mostly to vertical growth of the high marsh, *S. patens*, along the entire length of the project. An increase of almost one foot at profile 250. This bodes well for future adaptation to SLR.

Figure 4-1-7. Cross-sections of survey data for Captain Sinclair.

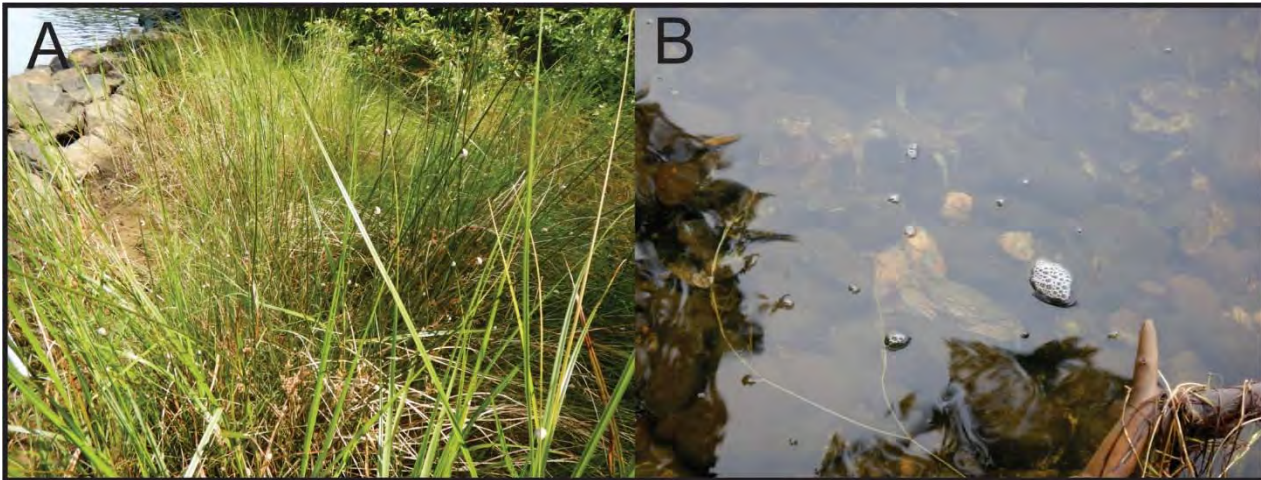
From a faunal habitat perspective, the St. Mary's City project had shown significant fish and crab usage (Hardaway et al., 2007). Qualitatively, this does appear to continue (Figure 4-3-9B). The vegetative communities may have changed slightly, but fish function appears to continue. The one stable element in the sill system is the rock sill itself. Even if it becomes submerged with SLR it will remain a fish haven.

Figure 4-3-9. Sill at St. Mary's (15 Aug 2018) A) Needlerush has colonized some sections, B) blue crabs are prevalent along the shore.

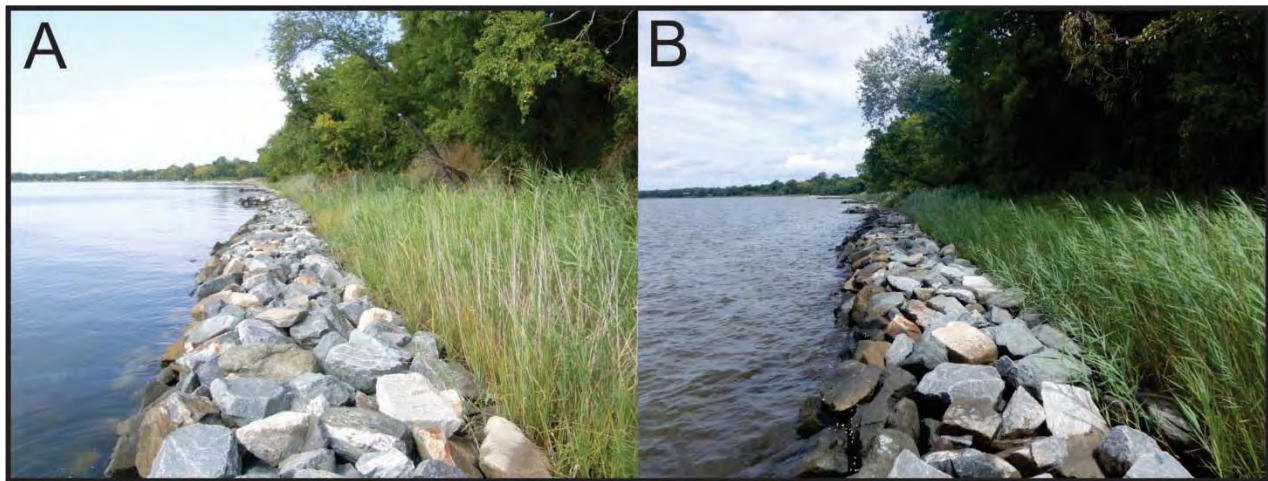
present in 2008 and continues in 2018 (Figure 4-4-6A and Figure 4-4-6B) indicating a relatively stable condition regarding maintaining elevation relative to daily tidal incursion.

Figure 4-4-6. Photos at Jefferson Patterson looking from sill #5-1 and beyond in A) 2008 and B) 2018 where extensive Phragmites is visible.

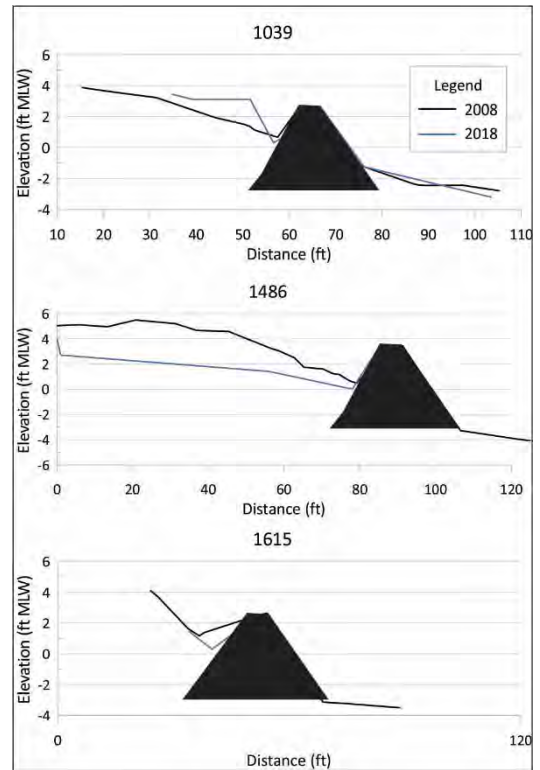
Survey results indicate a relatively stable substrate over time due in part to very significant *Phragmites* invasion (Figure 4-4-8 and Figure 4-4-9). It is estimated that from the upriver end of Sill #5 down to BW 3 that *Phragmites* has overtaken about 30% -40% of the backshore terrace above high water. Shading from limbs compounds high marsh grass growth as well. The reduced surveyed area showed accretion behind BW 4 (P1039) and erosion at the upriver end of Sill # 4 (P1486). The central weir section of Sill #4 (P1615) got a little deeper at high tide as MHW expanded landward. The MHW position remained fairly stable in the three surveyed embayments supporting the original design template.

Figure 4-4-9. Cross-sectional profiles at Jefferson Patterson.

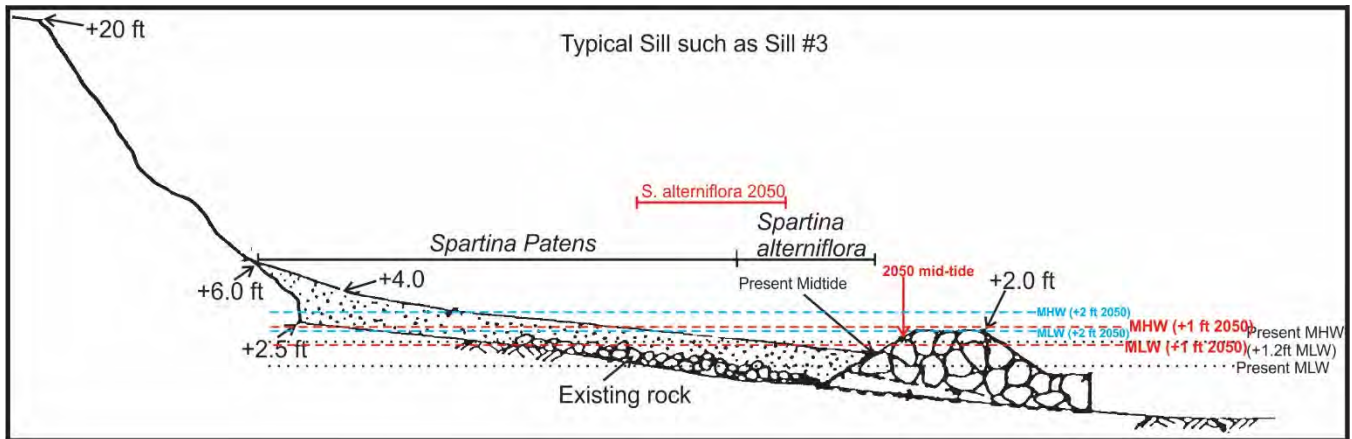
With a one-foot rise in sea level, *S. alterniflora* would migrate upland leaving a wider non-vegetated intertidal zone. The sill would be submerged at high water (Figure 5-4-1) The extensive Phragmites already covers much of the sill system and would persist even with a 2-foot rise in sea level. This system would be a good candidate site for just adding rock to the sill to protect the base of bank from wave attack (Figure 5-4-2). Adding sand could be done too but at additional costs. Again these options are viable because of barge access for construction.

Figure 5-4-1. Sea-level rise scenarios modeled at Jefferson Patterson and depicted on a typical cross-section.

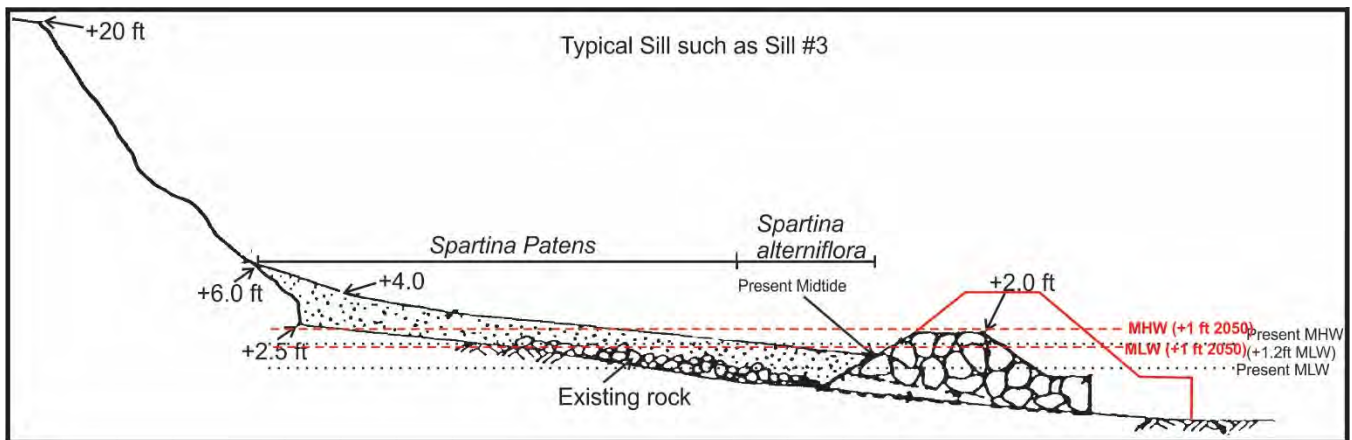
Figure 5-4-2. Sea-level rise scenarios modeled at Jefferson Patterson. Also shown is the adaptive management strategy coastal resiliency of the living shoreline. Rock could be added to the sill to protect the base of the bank.
