## Report of Trip to Investigate Area Around Heron Island Bar in the Potomac River

Paul C. Kendall  
*Virginia Institute of Marine Science*

10 July 1981

Marine Resource Report #81-8

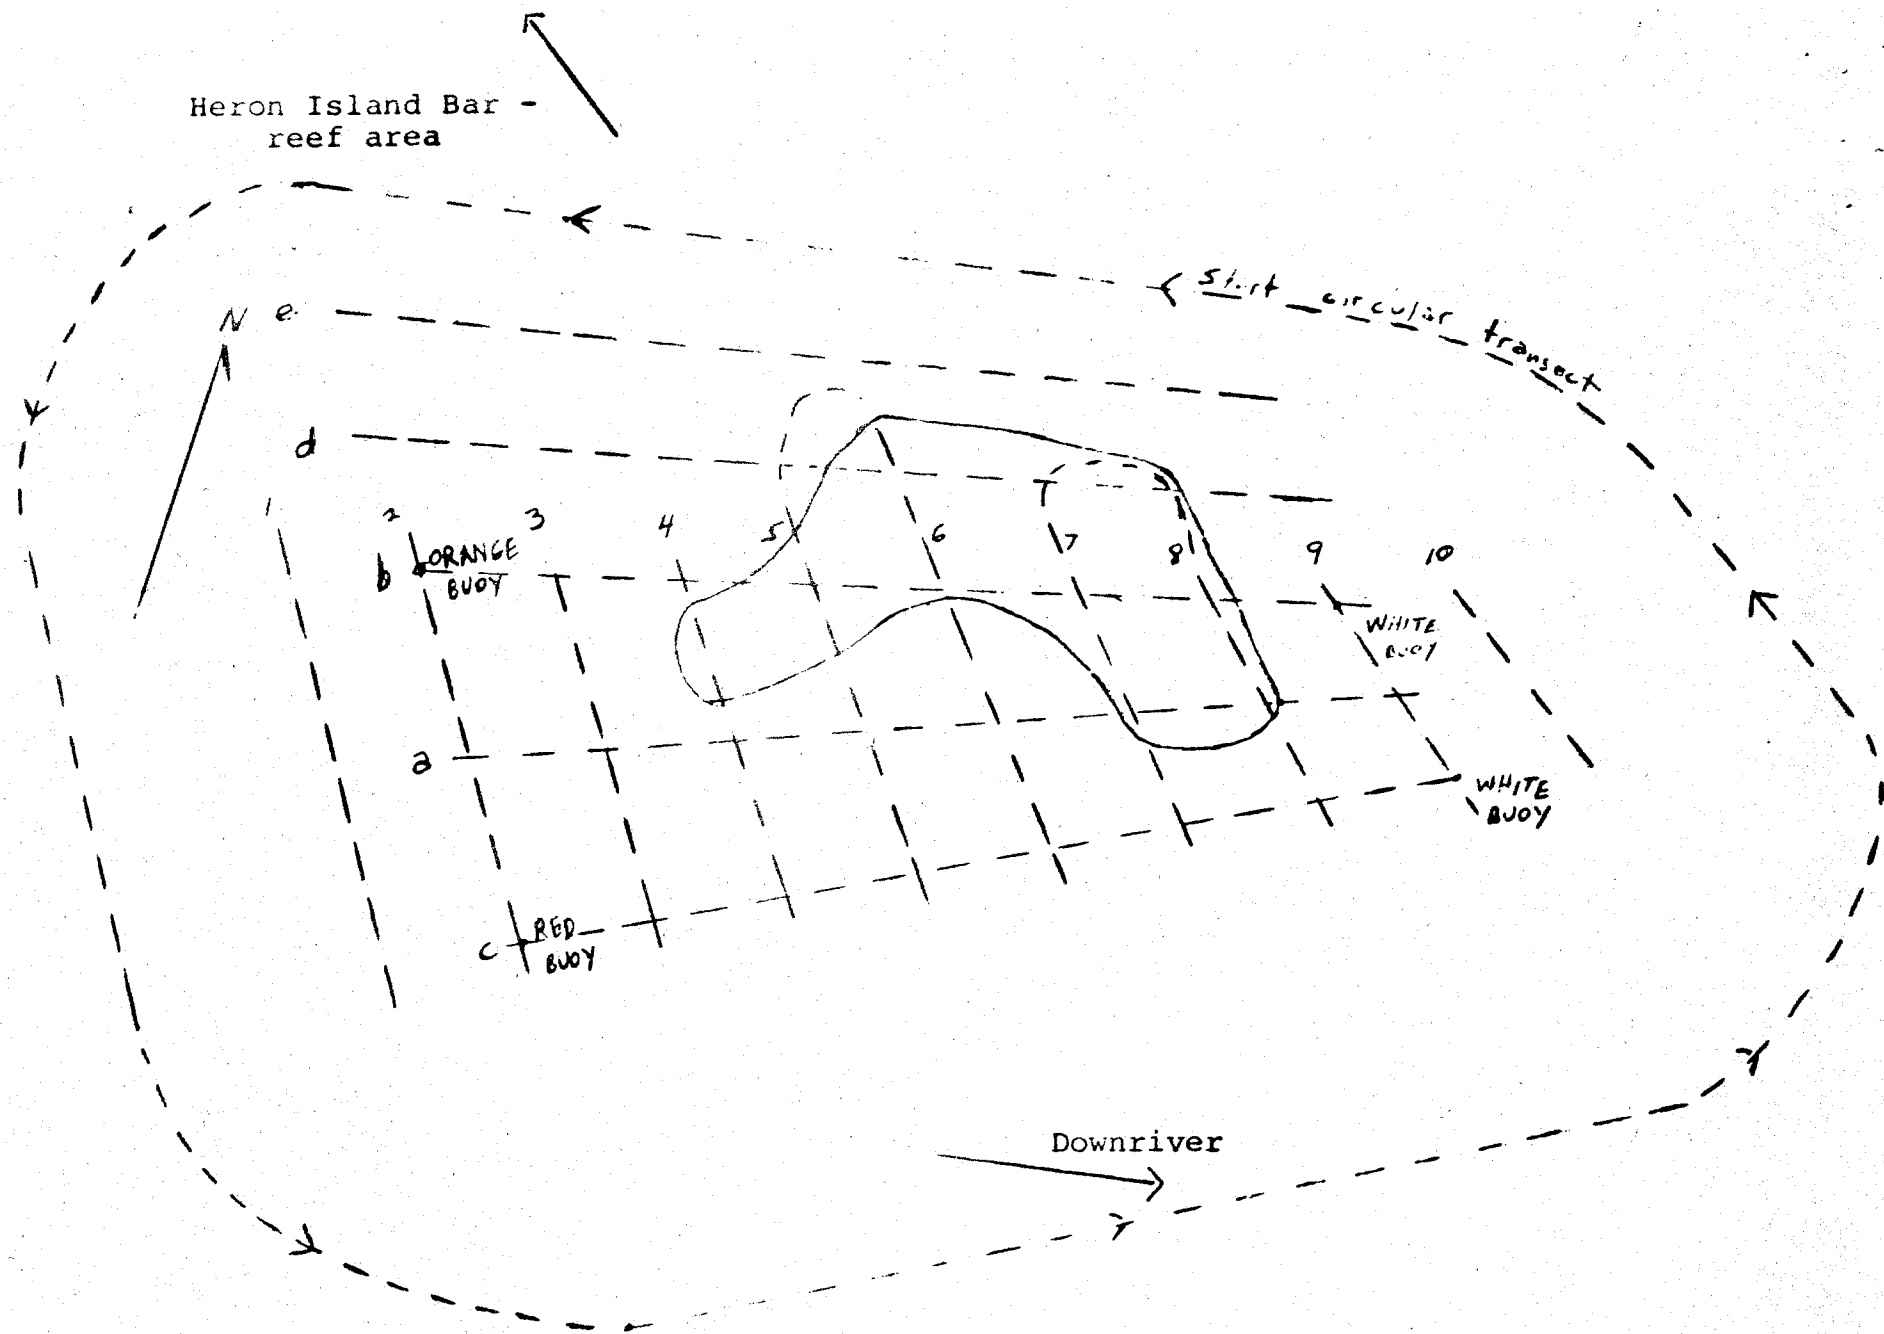
Figure 2. Key to transects covered with fathometer 6/17/81. Dashed lines represent transects. Area with irregularities enclosed by solid line. Scale: 1 inch = 129 feet.

All of the previously-mentioned bottom anomalies occurred in close proximity to each other; the locations are shown on Figure 2 as a single area enclosed by the solid line. The bottom surrounding this area was smooth and even. The size of the area where disturbance was suggested was measured with a polar planimeter and found to contain 1.26 acres.

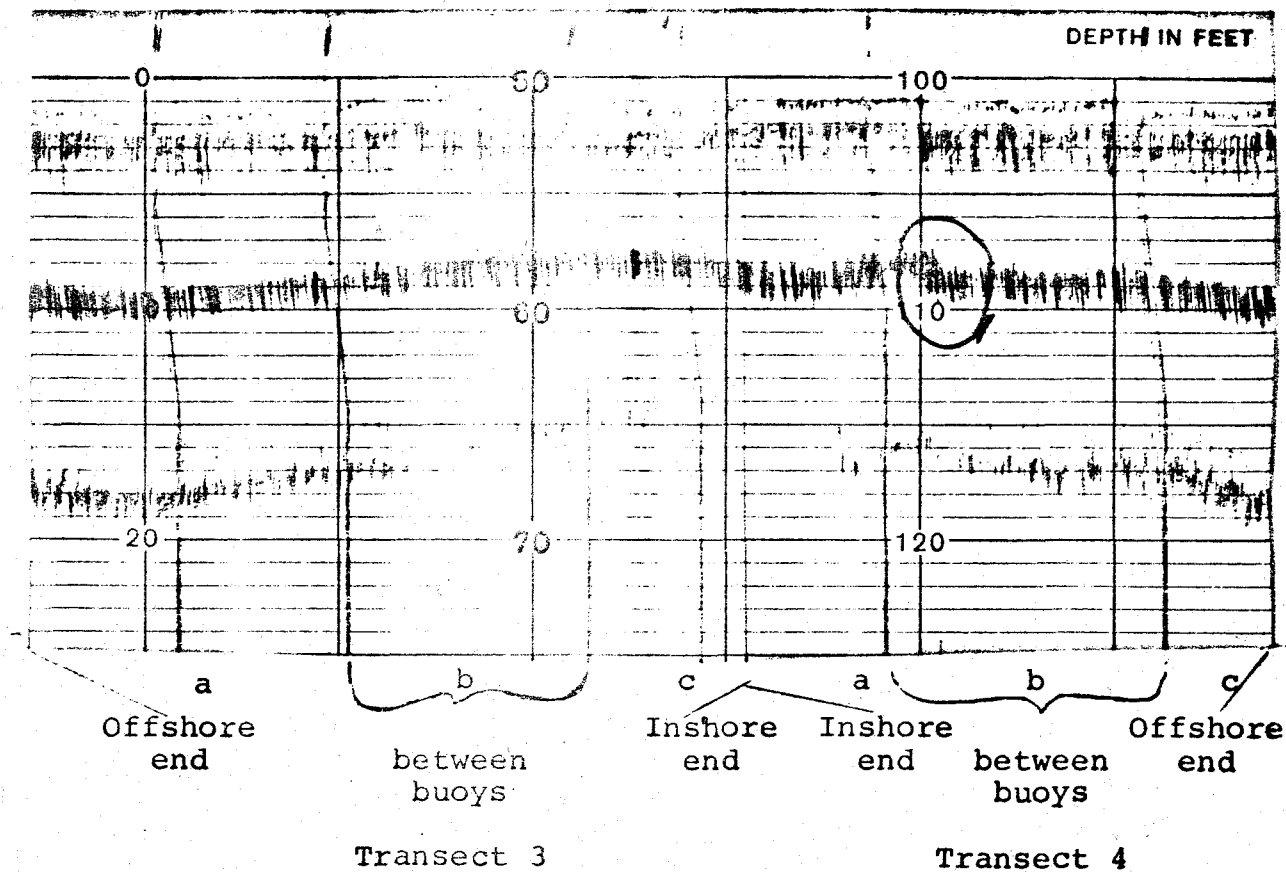
Figure 4. Fathometer tracing of the bottom along transects 3 and 4 in the Potomac River near Heron Island Bar; made 6/17/81. Circled portion is suggestion of recent disturbance.

**Transect 3** - A smooth, even sloping bottom is shown on this trace (Figure 4). This transect was about 90 feet downriver of the previous transect (Figure 2).

**Transect 4** - On this transect which was about 90 feet downriver of transect 3 (Figure 2) there appeared an abrupt one-foot change in the bottom near the inshore buoy (transect 4b); this alteration of the bottom occurred over a distance of 70 feet. The abruptness and magnitude of the change (which is circled in Figure 4) suggests that it was caused by a recent disturbance. The rest of the bottom appeared smooth and even.

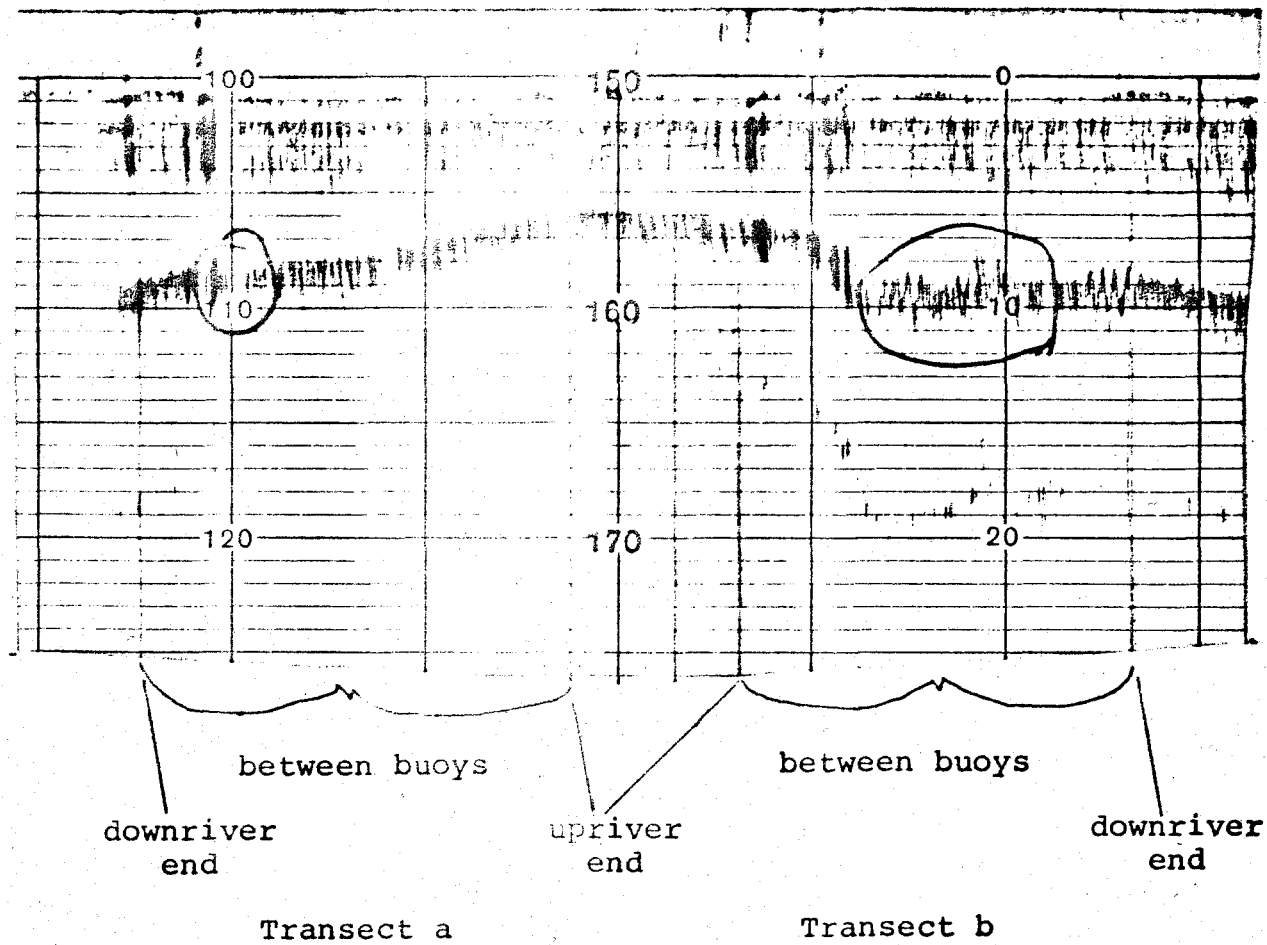
Figure 7. Fathometer tracing of the bottom along transects a and b in the Potomac River near Heron Island Bar; made 6/17/81. Circled portions are suggestions of recent disturbance.

Transect a - This transect was run through the middle of the buoyed area, beginning at the downriver end of the area and going upriver (Figure 2). The fathometer tracing is smooth with one exception; near the downriver (from near transect 8 to near transect 7) end is a slight depression and an adjacent mound (Figure 7) which suggest a recent disturbance. The disturbed bottom continued for about 111 feet.

Transect b - Transect b was run along the inshore line of buoys beginning at the upriver end of the area (Figure 2). The tracing is rough and irregular for approximately half the length of the transect or

336 feet, which suggests that this portion of the bottom was recently disturbed (Figure 7); the remaining portions of the transect appear smooth.

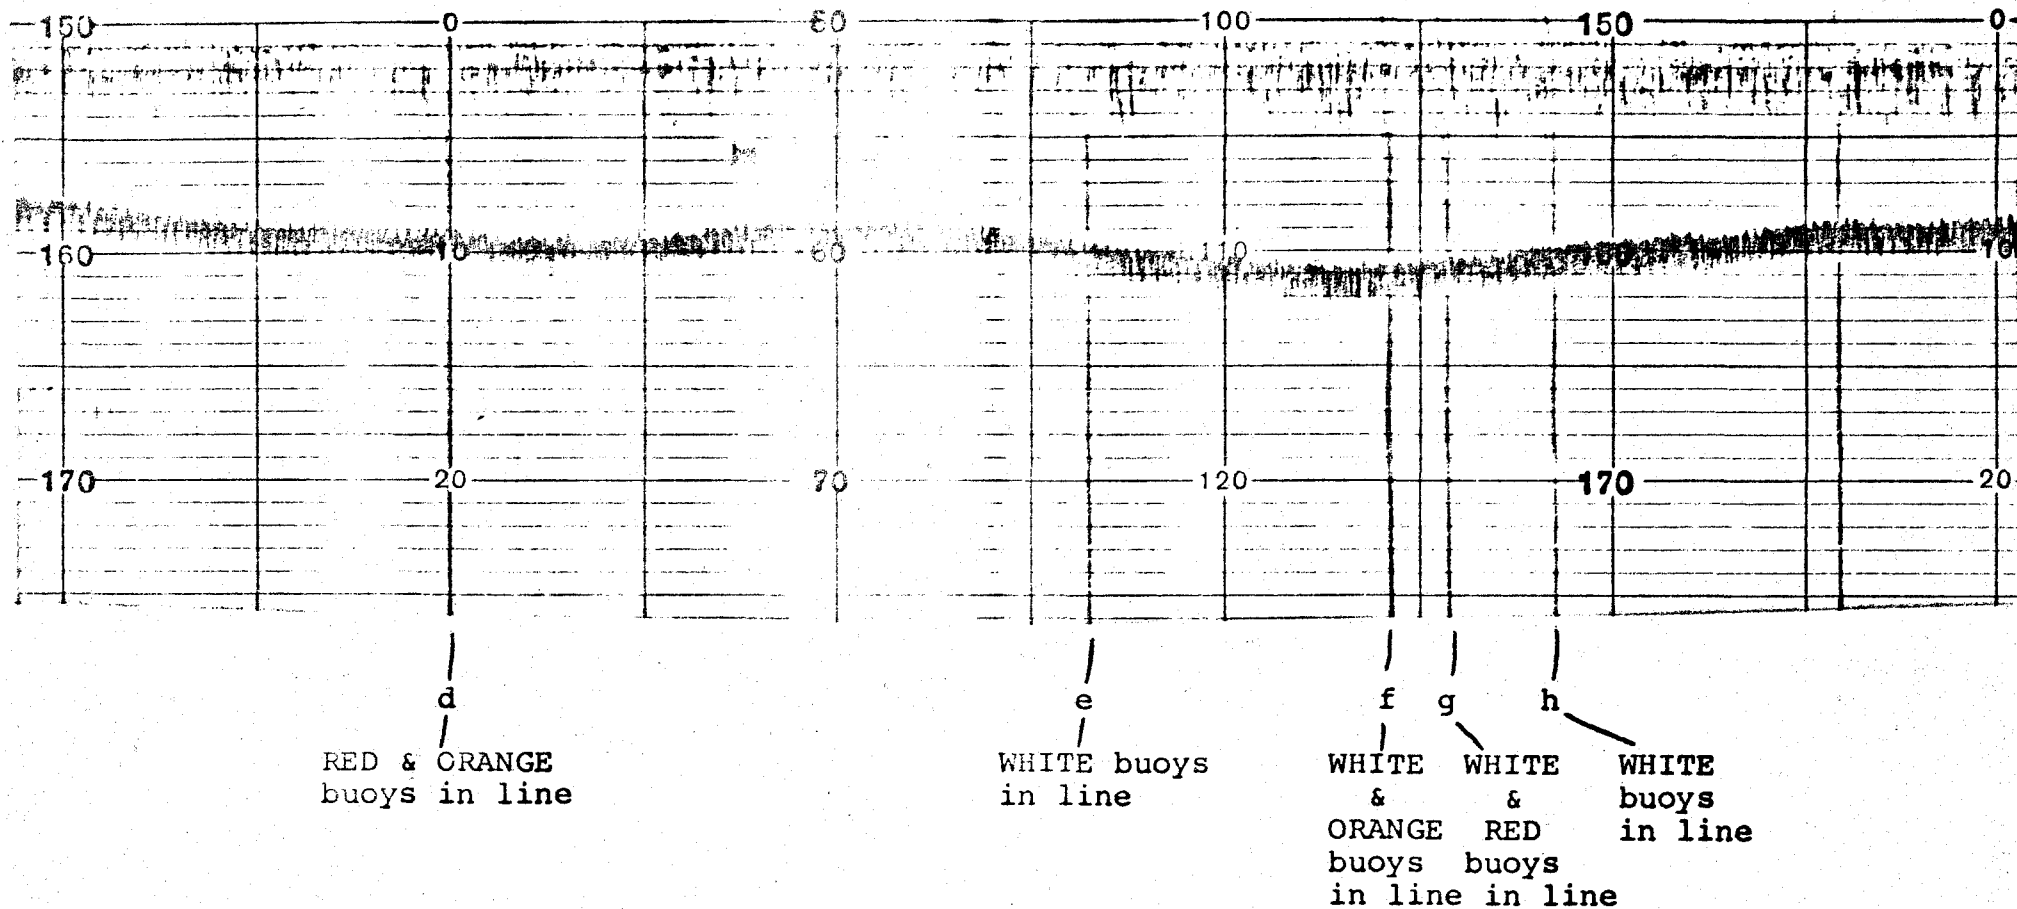
Figure 10b. Fathometer tracing of the bottom along circular transect about 300 feet from buoys near Heron Island Bar in the Potomac River; made 6/17/81.

Circular transect - This transect was run in a counter-clockwise direction around the buoyed area (Figure 2) at a distance of about 300 feet. The first part (Figure 10a) shows the tracing produced over that portion of bottom inshore of and parallel to the two inshore buoys (a to b); also shown is that portion of the bottom upriver of the buoyed area (b to c). Figure 10b shows the portions of bottom offshore (d to e) and downriver (f to h) of the buoyed area. All along the circular transect the fathometer revealed a smooth, even bottom.
