A Survey of the Effectiveness of Existing Marsh Toe Protection Structures in Virginia

Final Report to the Keith Campbell Foundation for the Environment, Inc.

July 2006

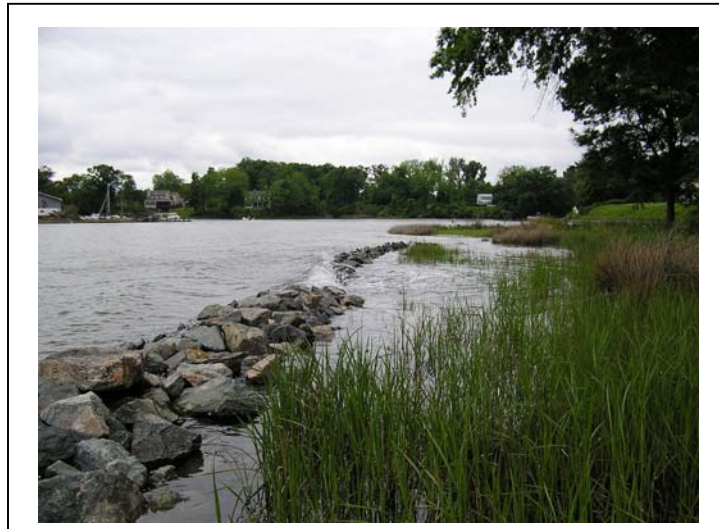
Figure 2. Boat wakes were observed washing over this marsh toe protection structure located in close proximity to a navigation channel. Boat wakes influence the wave climate in low energy settings.

It appears that fetch alone may not be a reliable factor to determine if a structure is necessary to support a vegetated marsh sufficient for erosion protection. Shoreline orientation and boat wakes also have an influence on determining the need for a structure, especially where the marsh is located in close proximity to a navigation channel (Figure 2).
