## Shore Status, Evolution, and Storm Vulnerability Assessments for George Washington Birthplace National Monument

## **Shore Status, Evolution, and Storm Vulnerability Assessments**

## Technical Report

May 2009

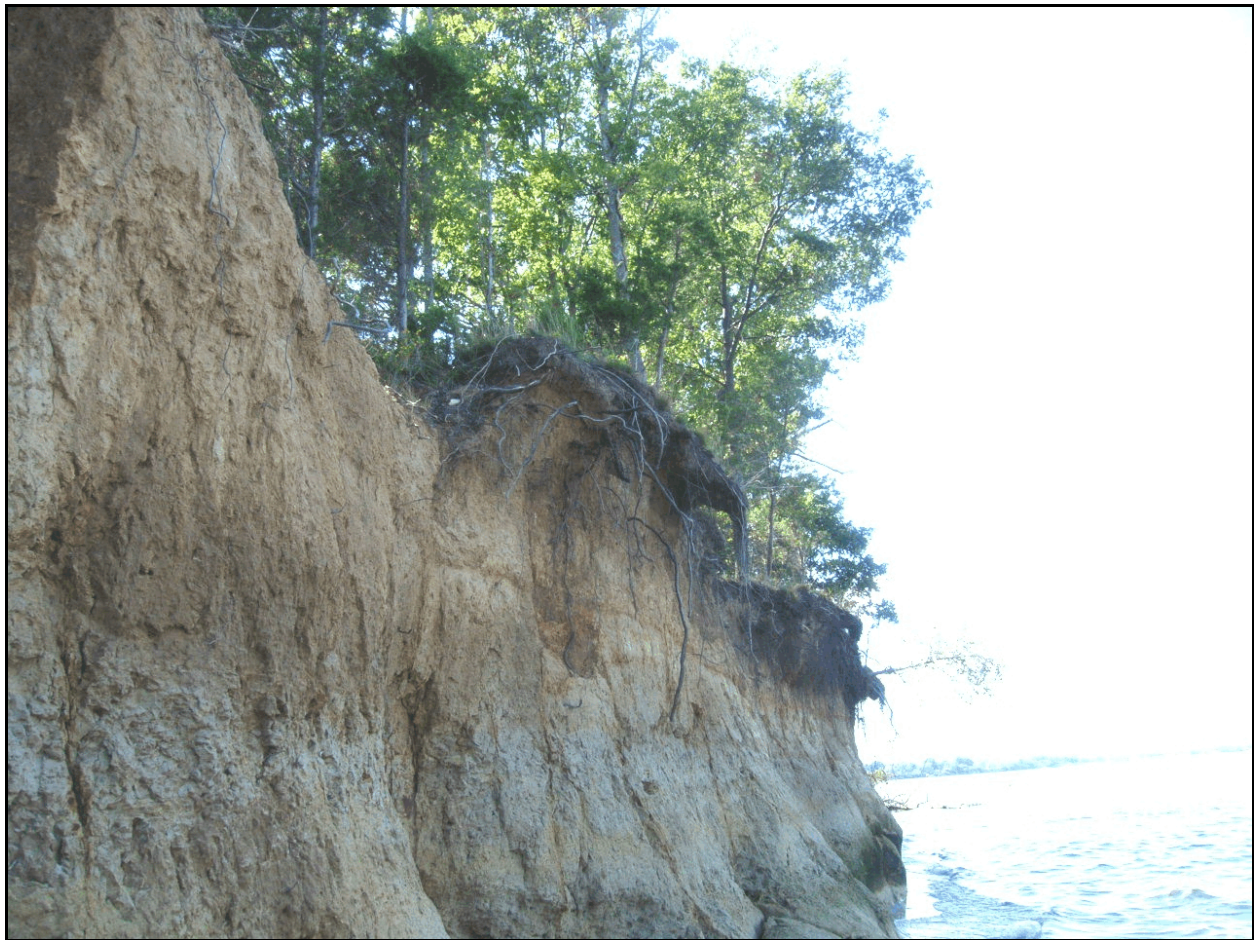
Eroding high banks along the Potomac River at the George Washington Birthplace National Monument on 18 September 2008.  
Photography by: Shoreline Studies Program, Virginia Institute of Marine Science

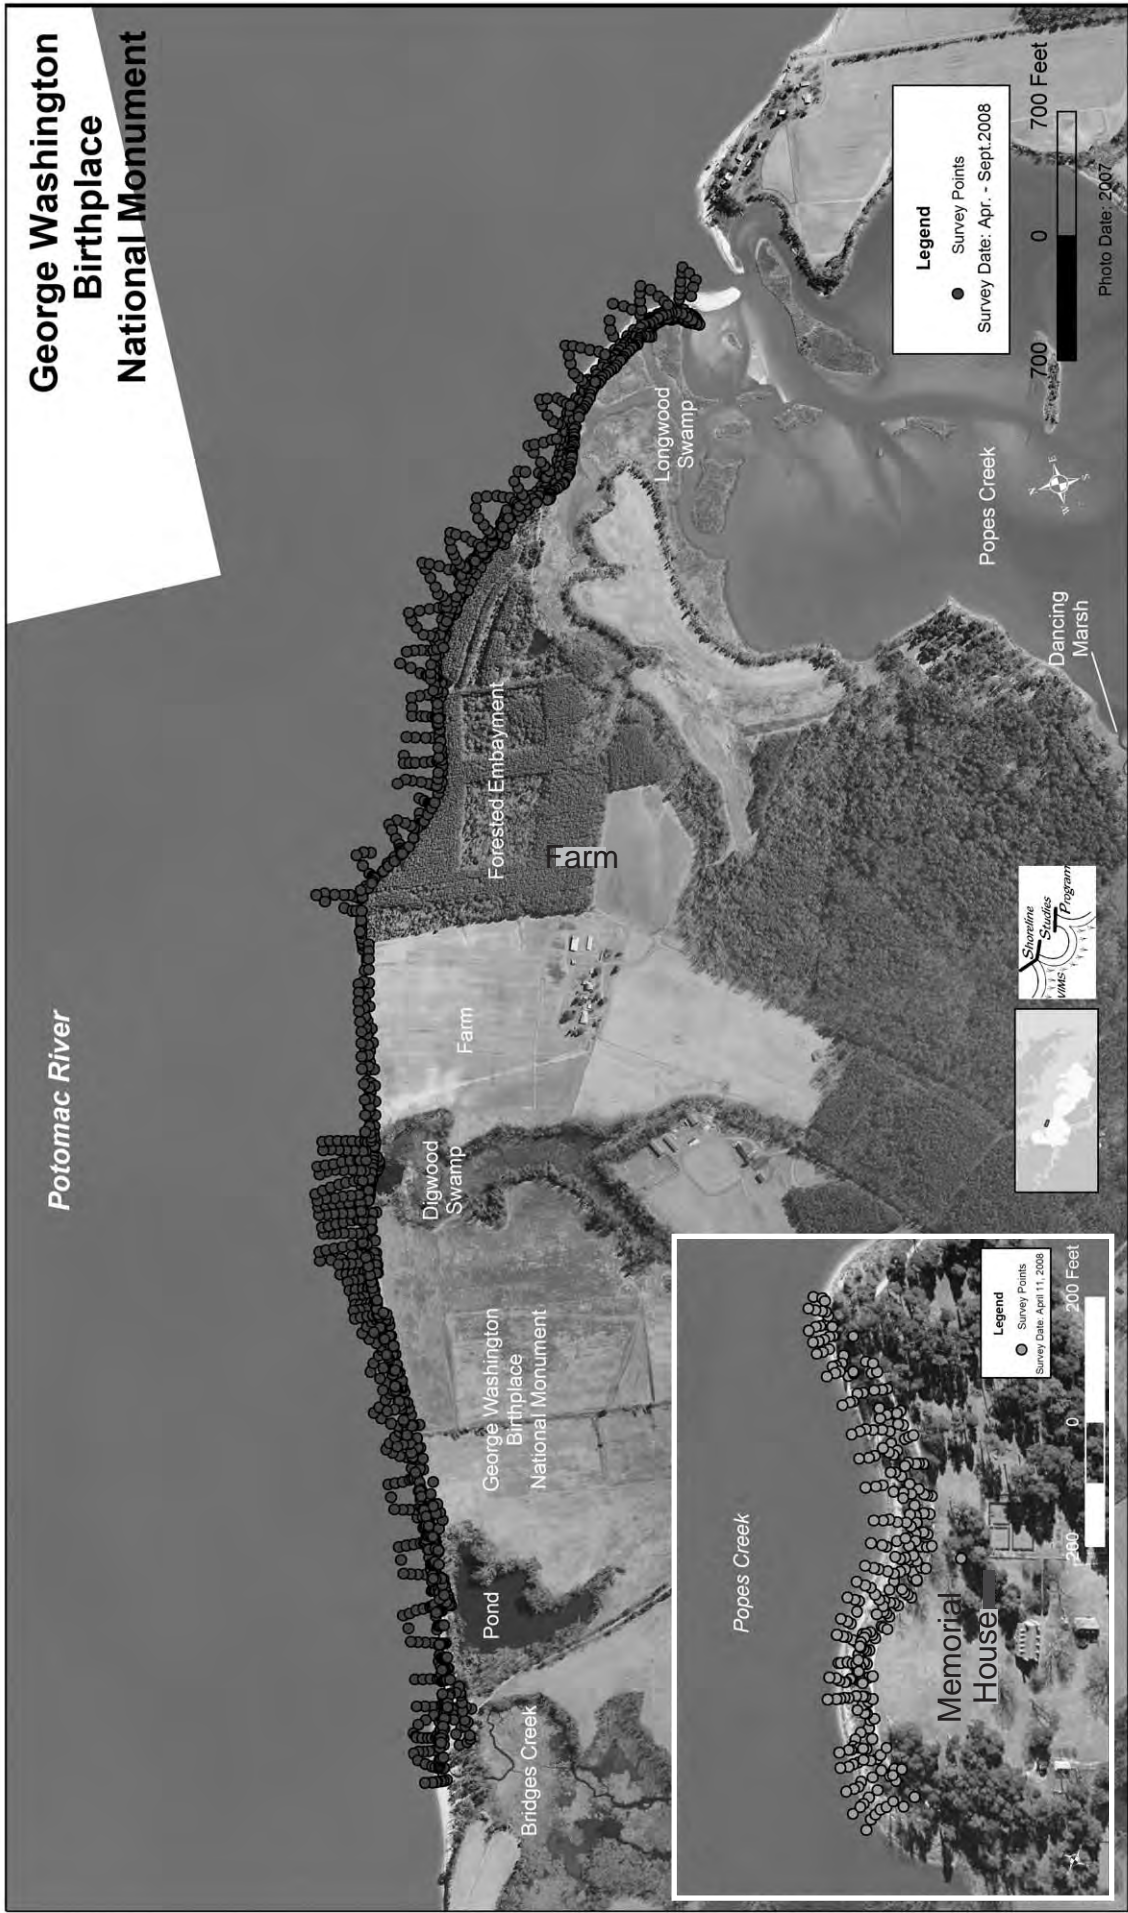
Figure 3. Location of Real-Time Kinematic GPS and robotic total station survey points taken along the Potomac River shoreline between April and September 2008 and (inset) at the Memorial House on Popes Creek in April 2008.

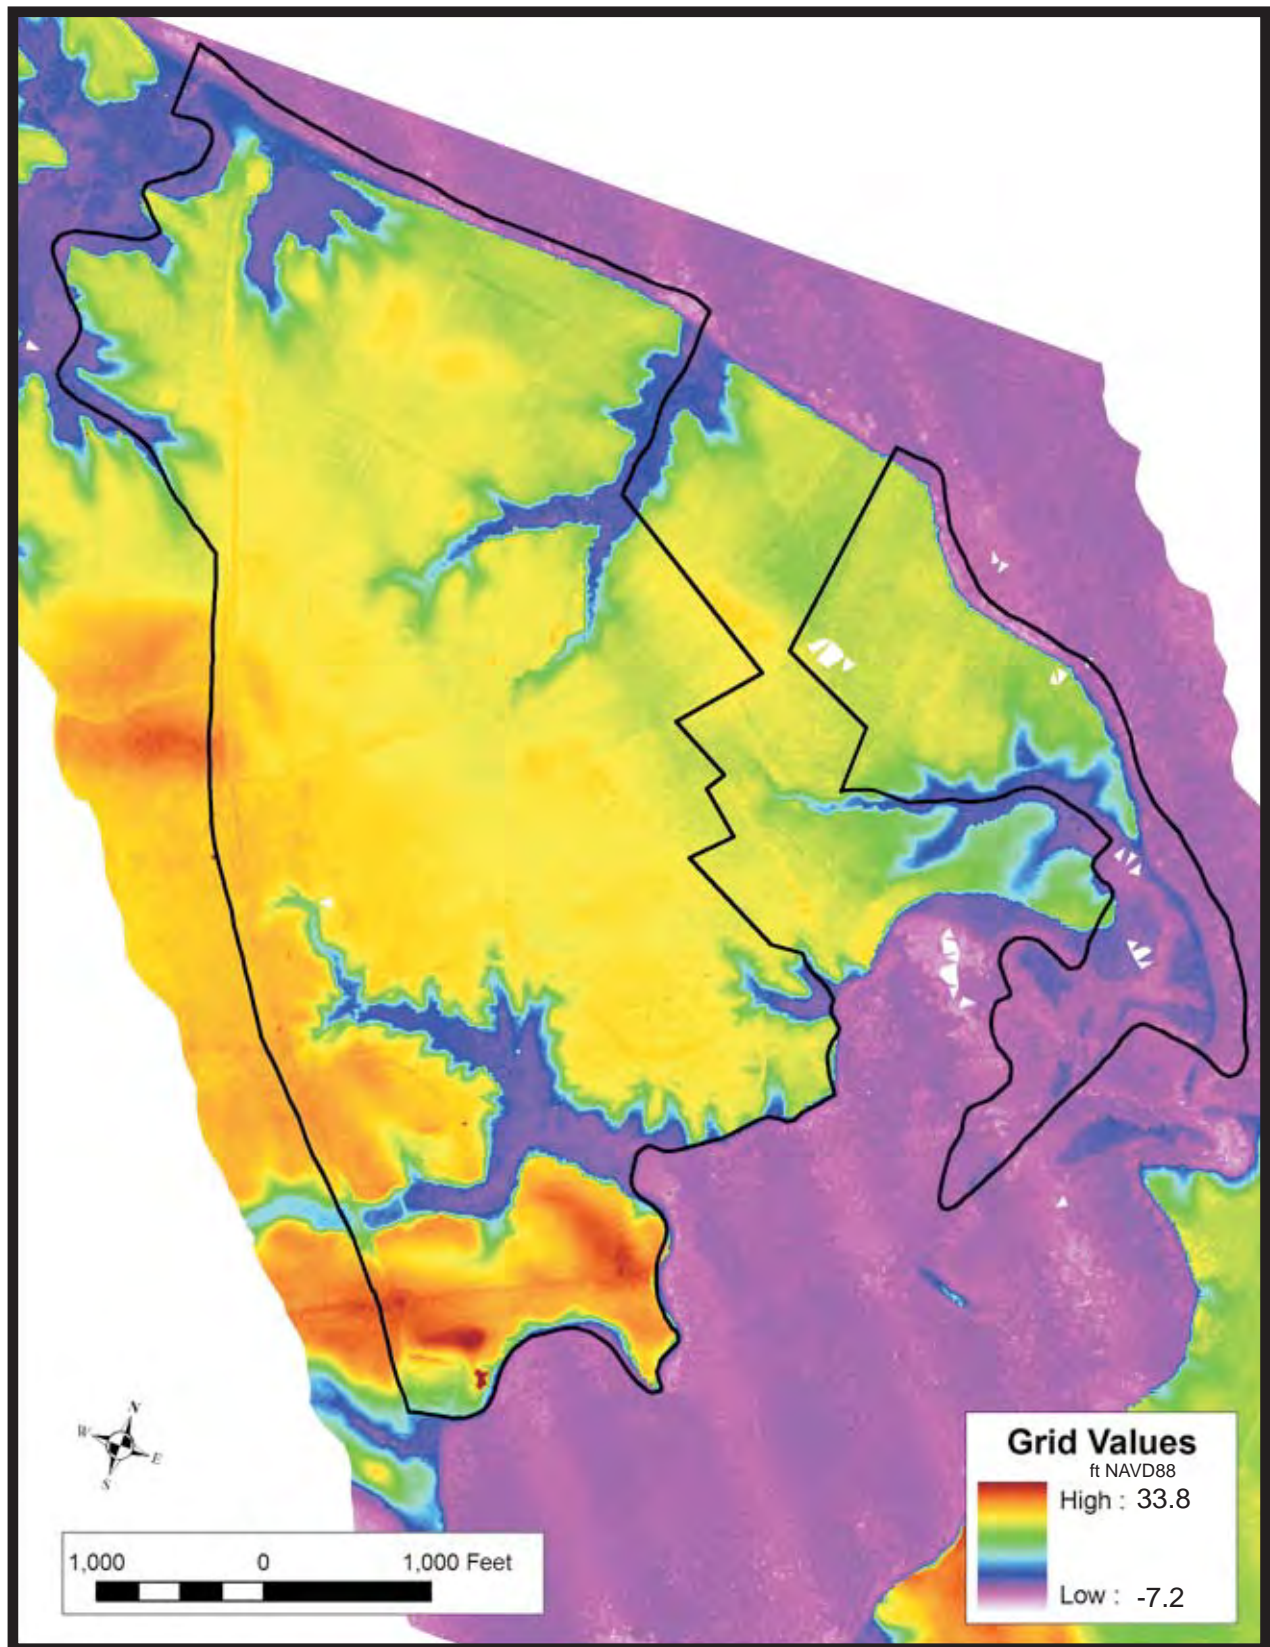
Figure 6. Digital Elevation Model of the 2008 LIDAR data.

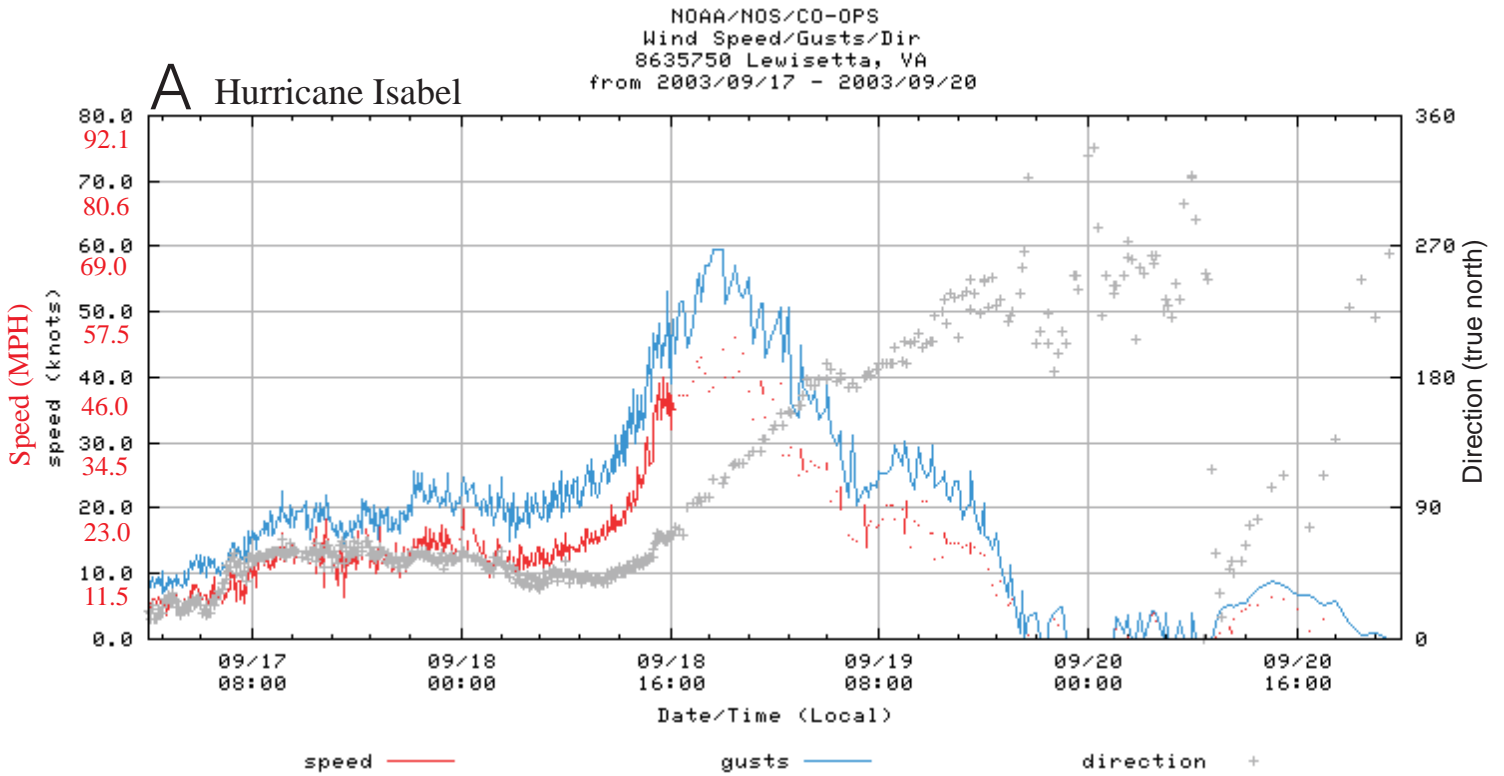
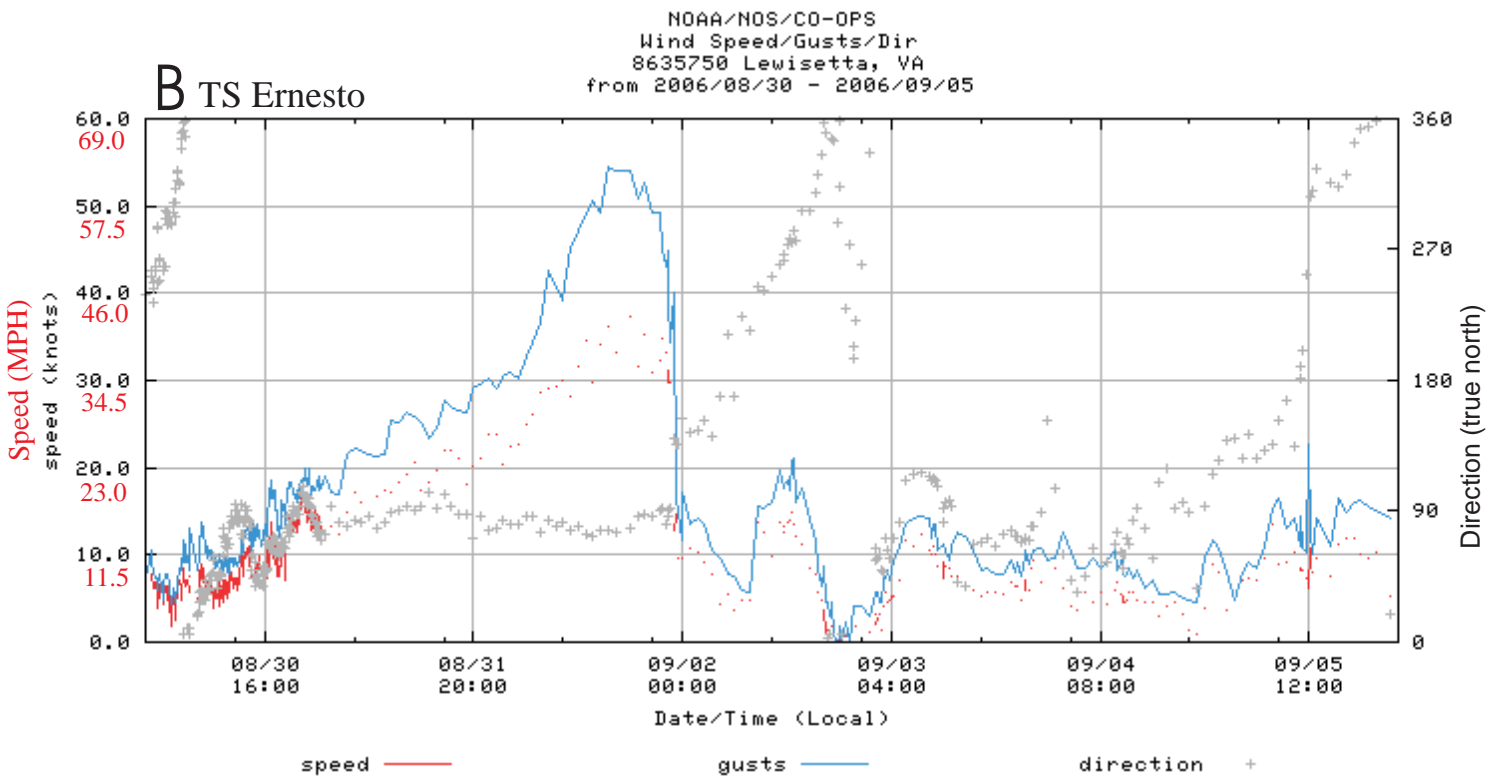
Figure 8. Wind speeds and directions at Lewisetta during A) Hurricane Isabel and B) Tropical Storm Ernesto.

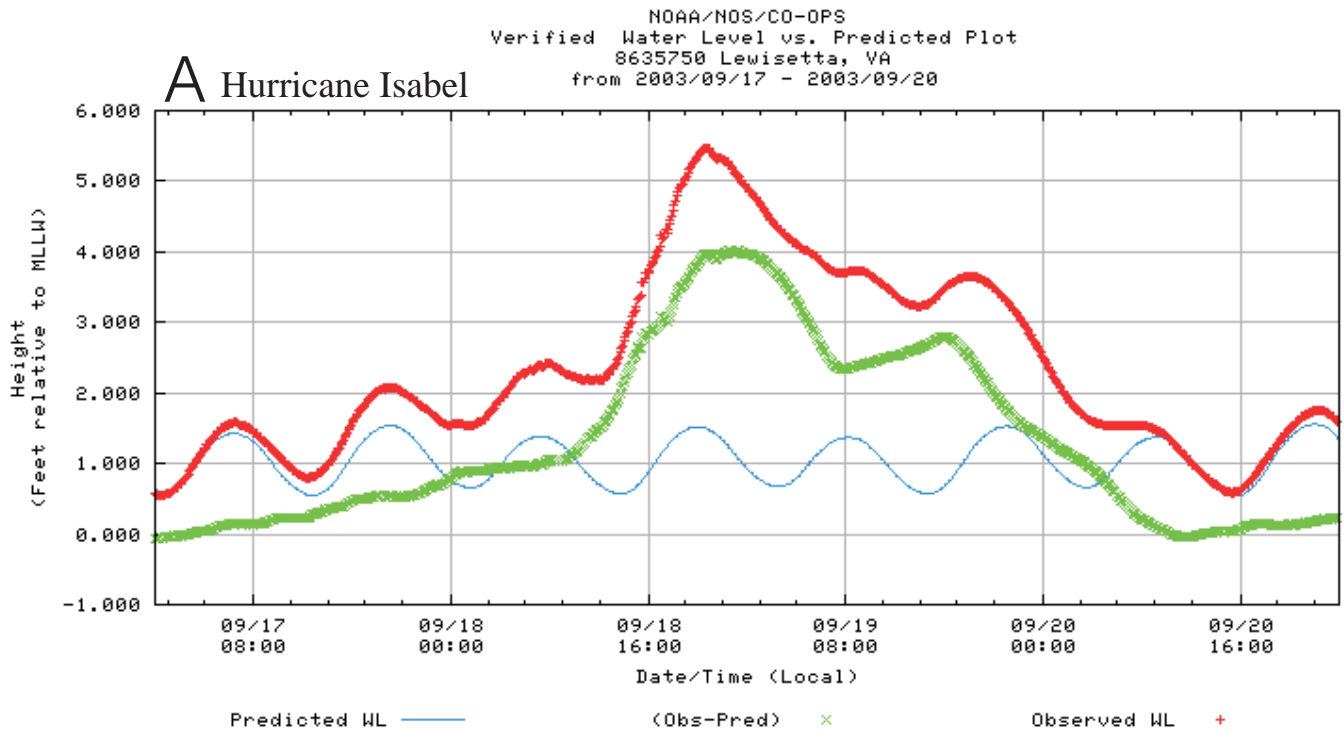
Figure 9. Tide gauge data at Lewisetta, Virginia during A) Hurricane Isabel and B) Tropical Storm Ernesto. The red line shows the measured water level in feet relative to MLLW; the blue line represents the predicted tide; the green line shows the difference between the observed and predicted water levels and is commonly referred to as the storm surge.

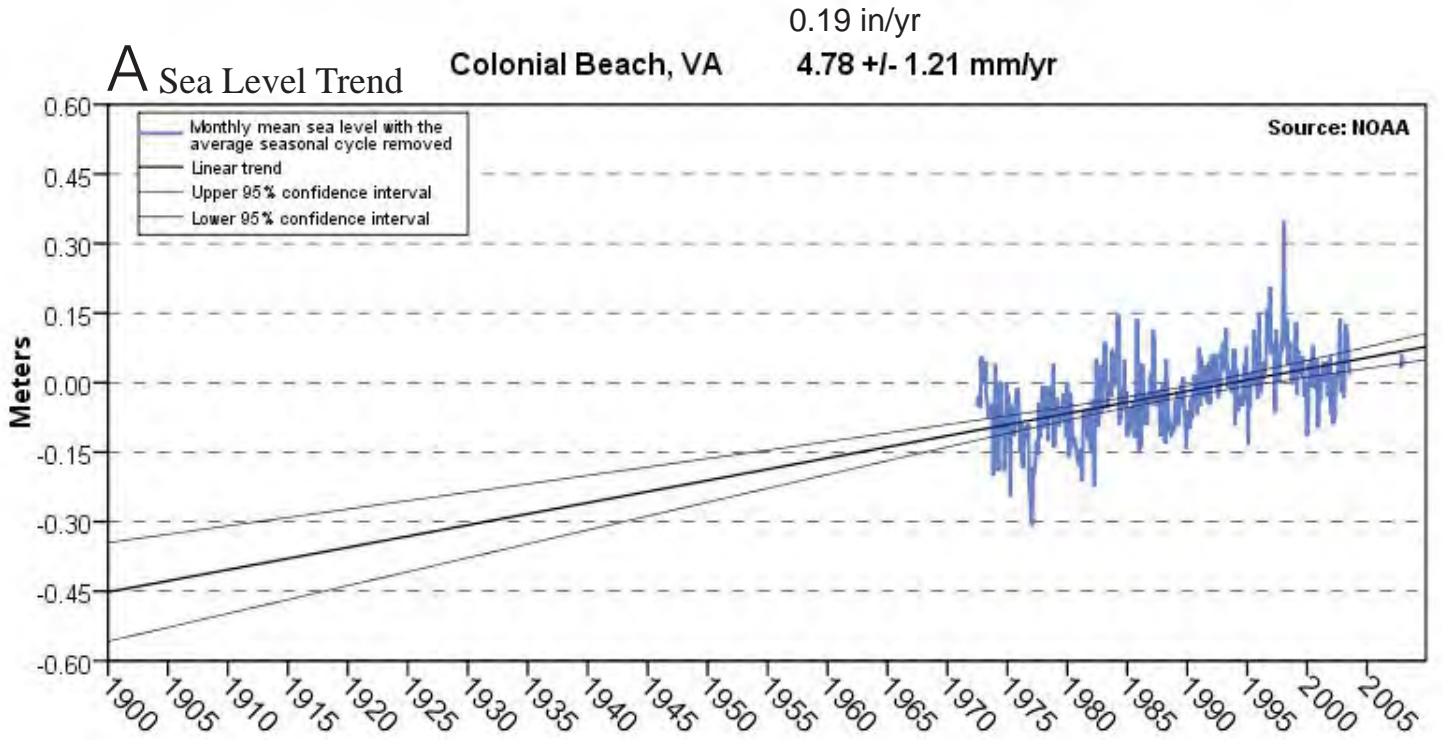
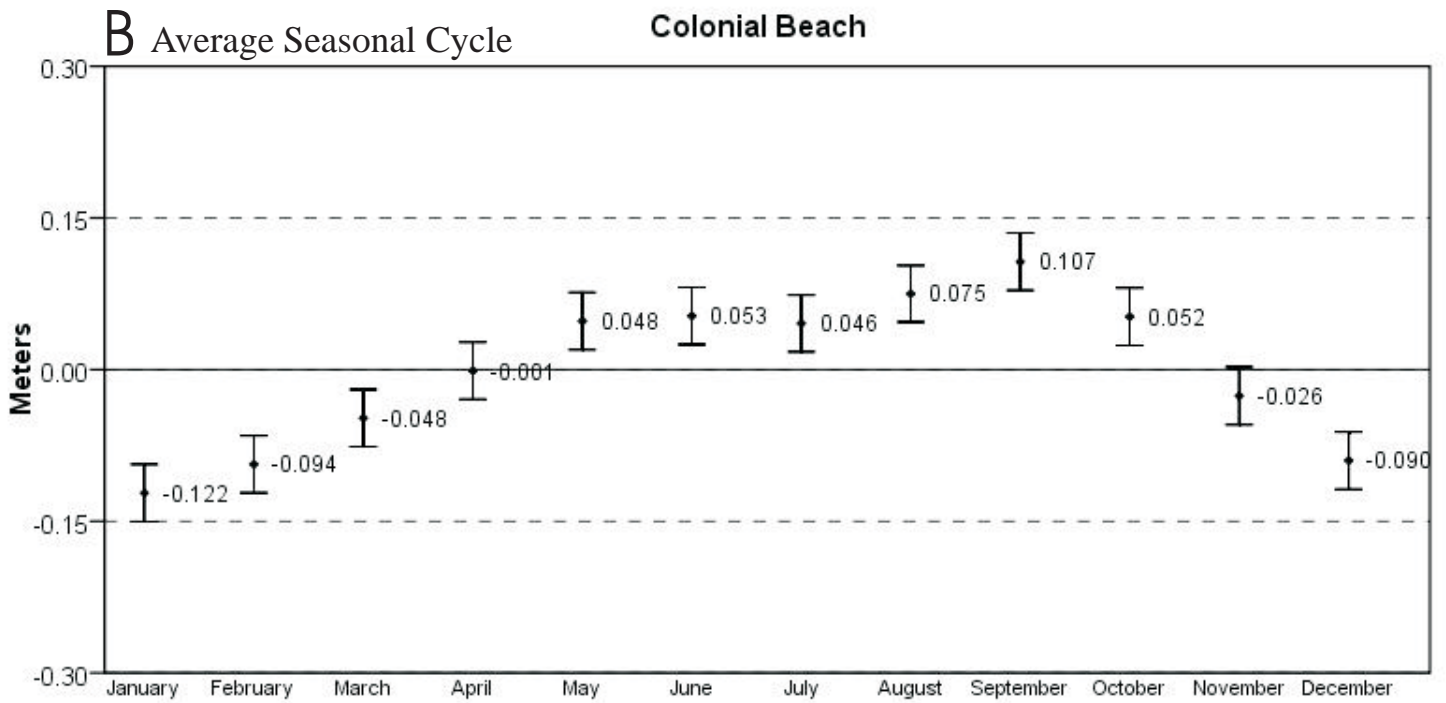
Figure 10. A) The long-term linear sea level trend and its 95% confidence interval at Colonial Beach, Virginia and B) the Average Seasonal Cycle in mean sea level. The plotted values are relative to the most recent mean sea level datum established by CO-OPS (1983-2001).

The average seasonal cycle of mean sea level, caused by regular fluctuations in coastal temperatures, salinities, winds, atmospheric pressures, and ocean currents, is shown in [Figure 10B](#) along with each month's 95% confidence interval. These data indicate a higher mean sea level in the summer and fall; these months correspond to the highest risk of extratropical activity along the East Coast and Chesapeake Bay. Superimposed on the storm surge and astronomical tide, long-term sea level change can significantly increase the reach of storm waters (Boon 2003).

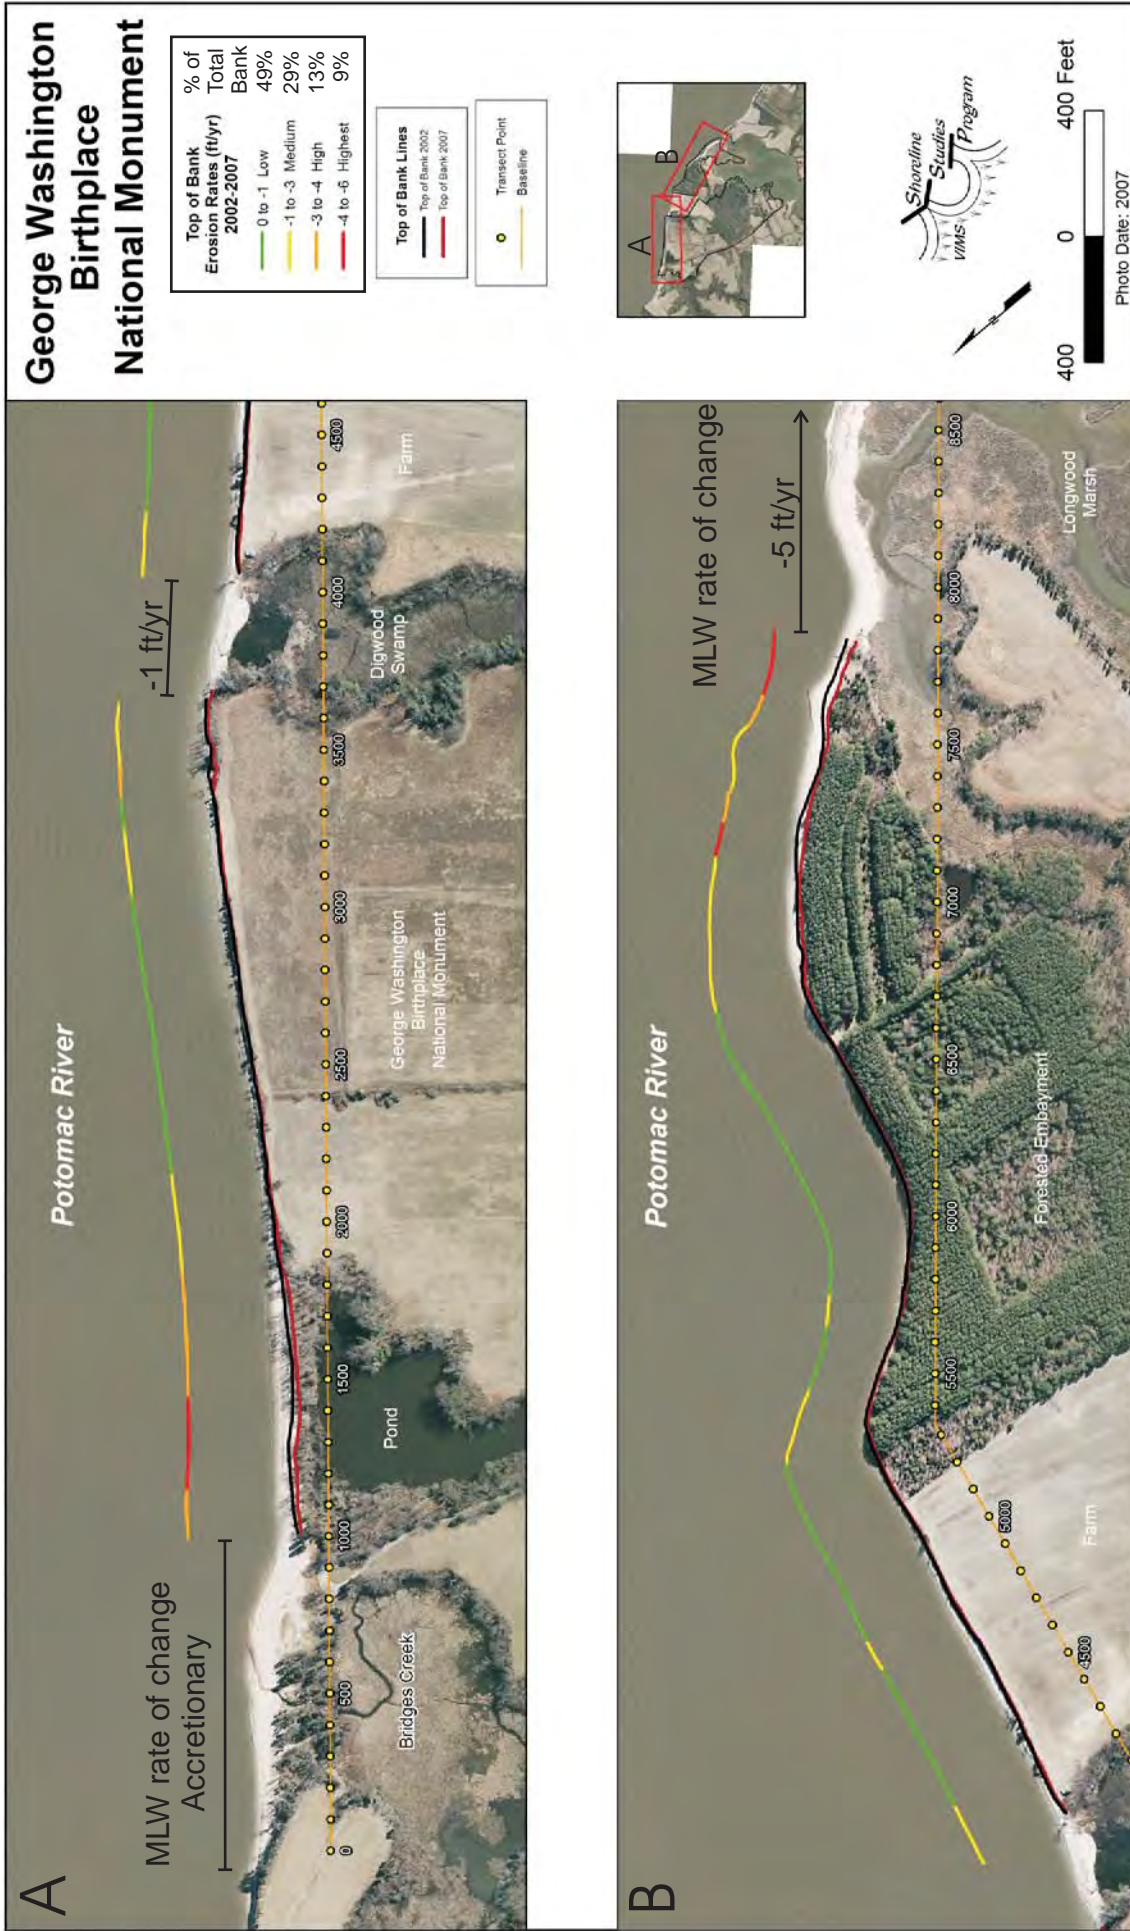
Figure 18. Top of bank digitized from 2002 and 2007 ortho-rectified aerial photos showing the cumulative impact to the shoreline of Hurricane Isabel and Tropical Storm Ernesto. Also shown on the images are the calculated rate of change averaged along the shore at MLW for areas that do not have banks. See Figure 17 for detailed rates in these areas.

The rate of bank change from 2002 and 2007 ([Figure 18](#)) reflects the storm impact of Hurricane Isabel, Tropical Storm Ernesto, and the northeast storms of October 6 and November 22, 2006. While an individual storm may have a peak 50-year return frequency, the hydrodynamics or wave power actually go through the 10 and 25 year events on each side of the peak for each storm. The top of the bank showed the highest rates of loss in front of the Pond and along the shore with the deteriorated bulkhead. These sections of the shore have lower banks that likely were not overtopped by storm surge, but the waves were breaking on them. The low bank in front of the Pond has a narrow beach, but it apparently did little to attenuate wave action from these storms. Bank losses on either side of Digwood Swamp were modest but most occurred where the high bank transitions to a lower bank.

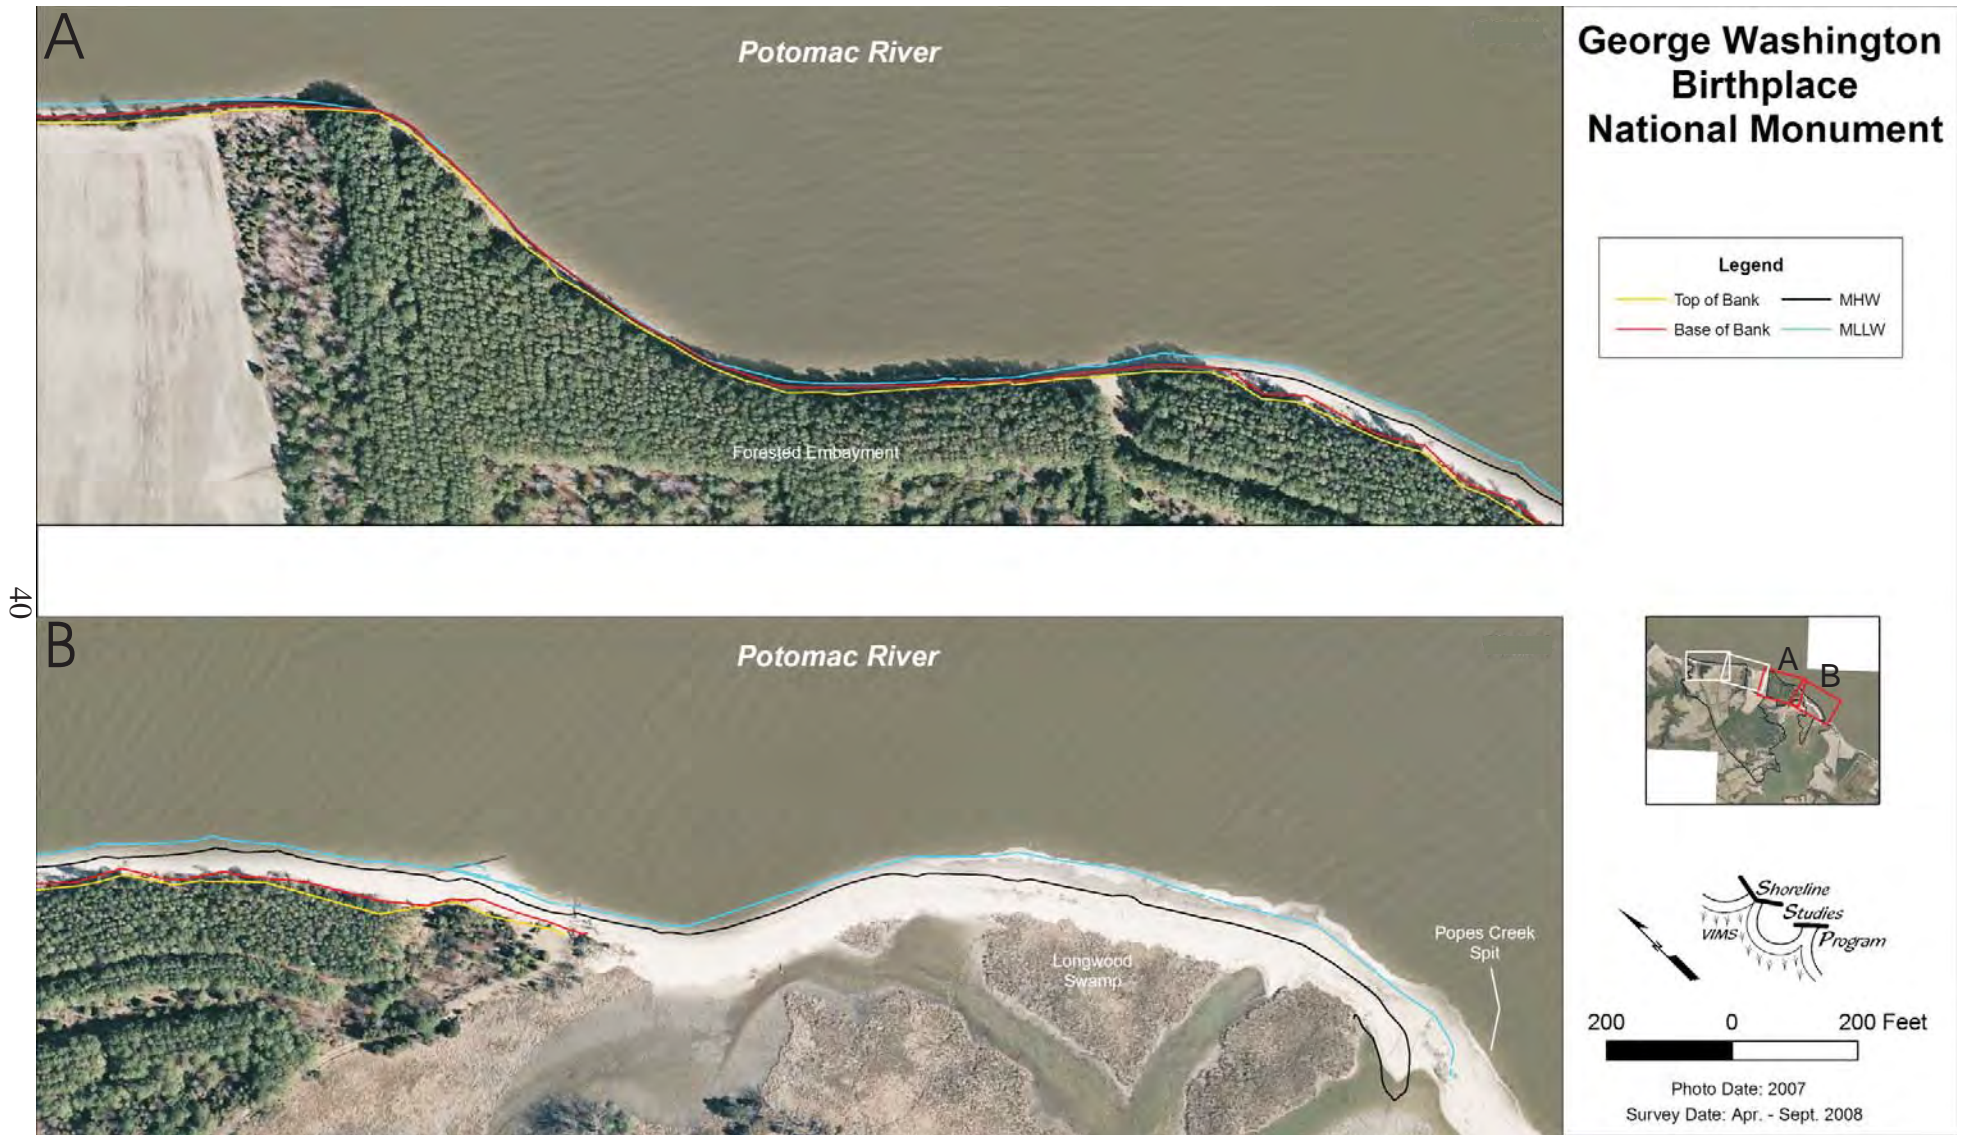
Figure 23. RTK-GPS survey results showing the top of bank, base of bank, mean high water, and mean lower low water along GEWA's eastern Potomac River shoreline.

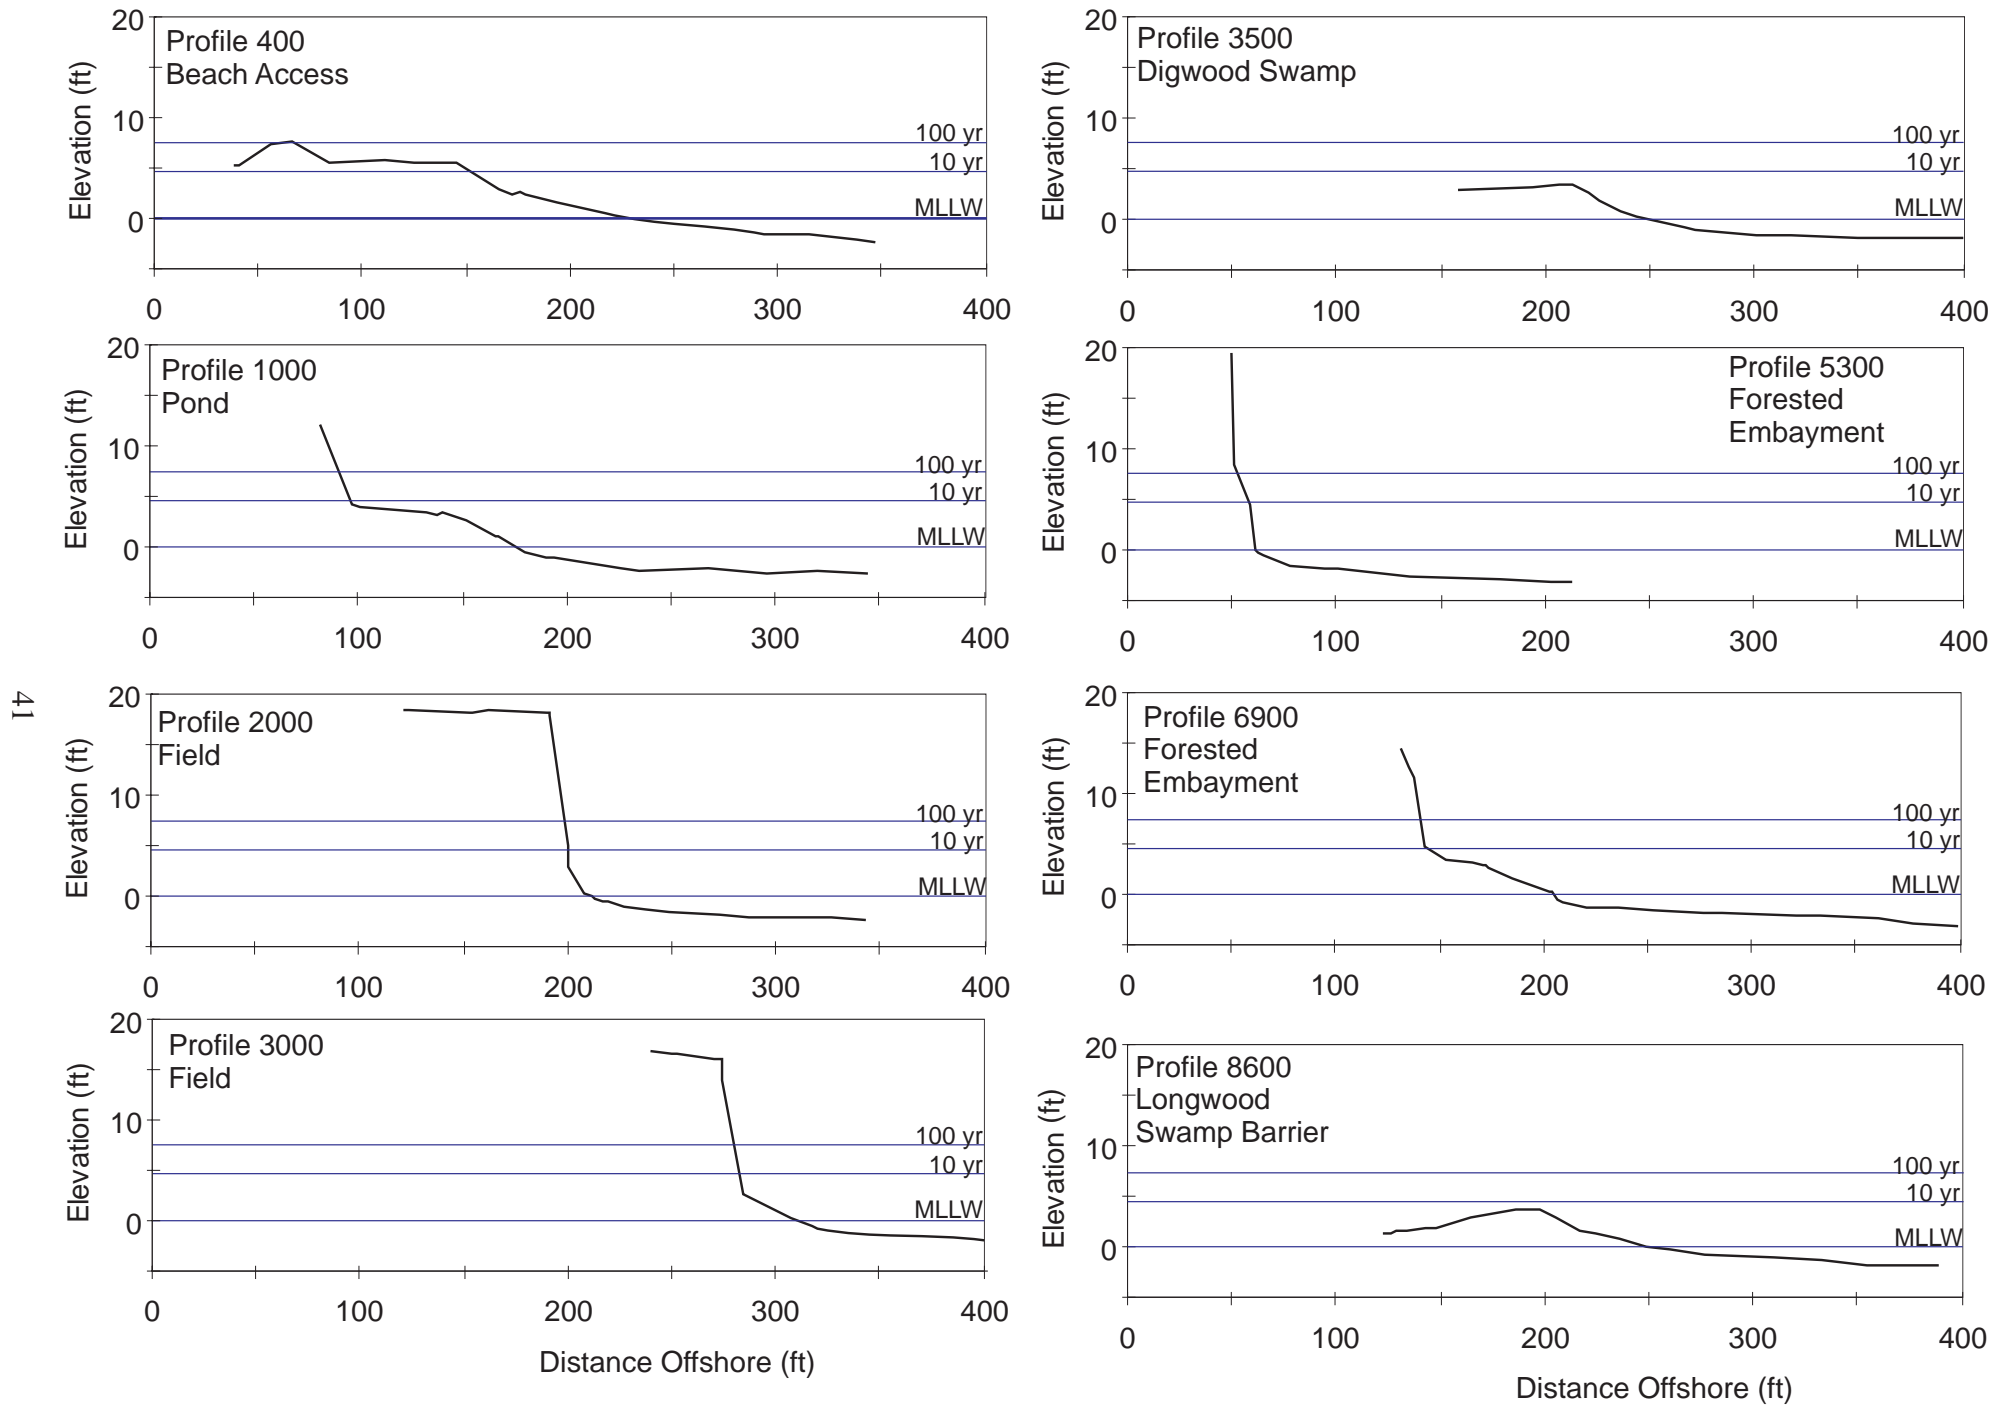
Figure 24. Typical profiles of different sections of GEWA's Potomac River Shoreline. Reference Figure 4 for profile locations.

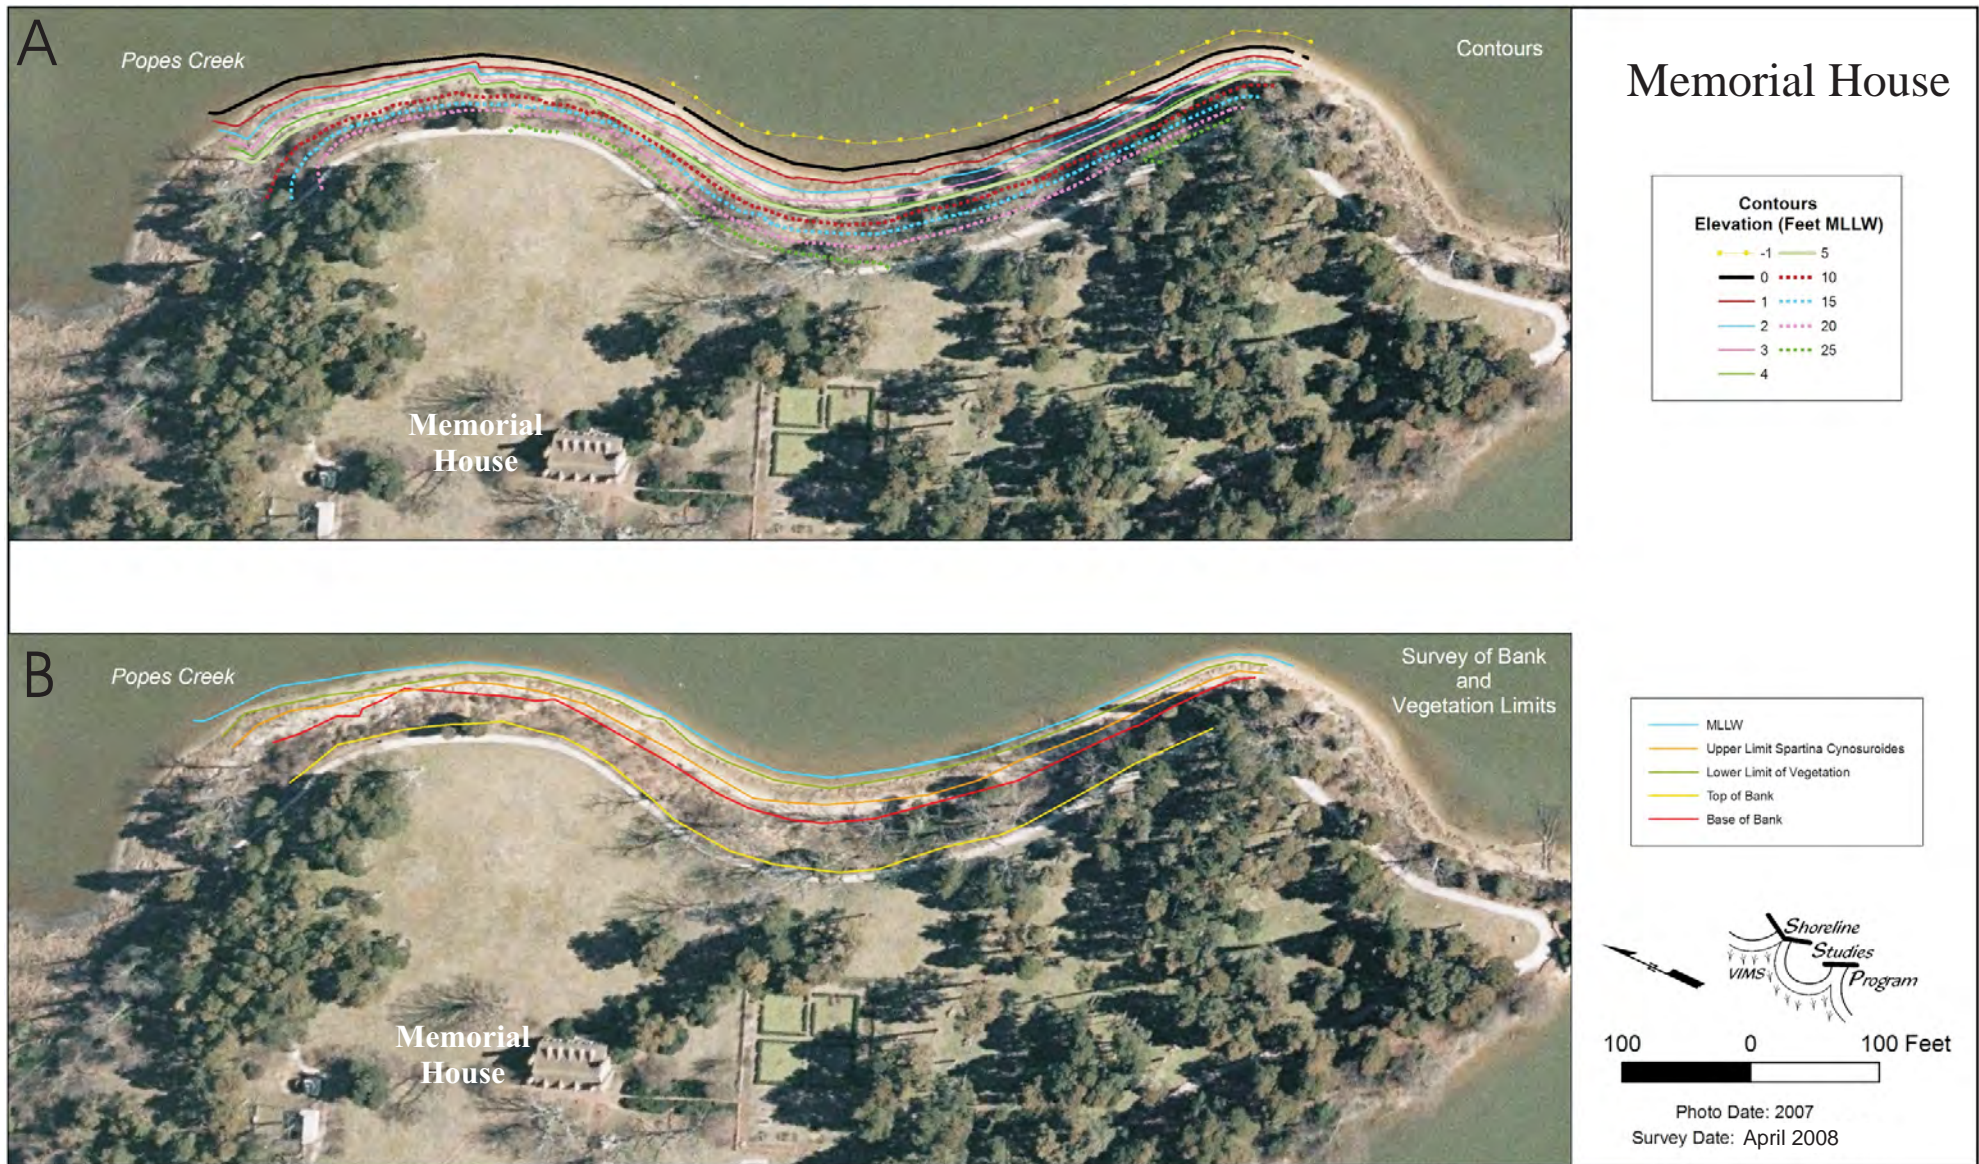
Figure 25. Survey results along GEWA's Popes Creek shoreline at the Memorial House showing A) elevation contours and B) topographic and vegetative features.

Figure 25A presents the surveyed elevations and Figure 25B the locations of the tops and base of the bank and tidal datums along Popes Creek in front of Memorial House. The shore along Popes Creek is not nearly as steep as along the Potomac and has a vegetative marsh fringe (Appendix A, photos 25-28). The elevations immediately inland are higher (maximum 27 ft (8.2 m) MLLW) than along the Potomac.

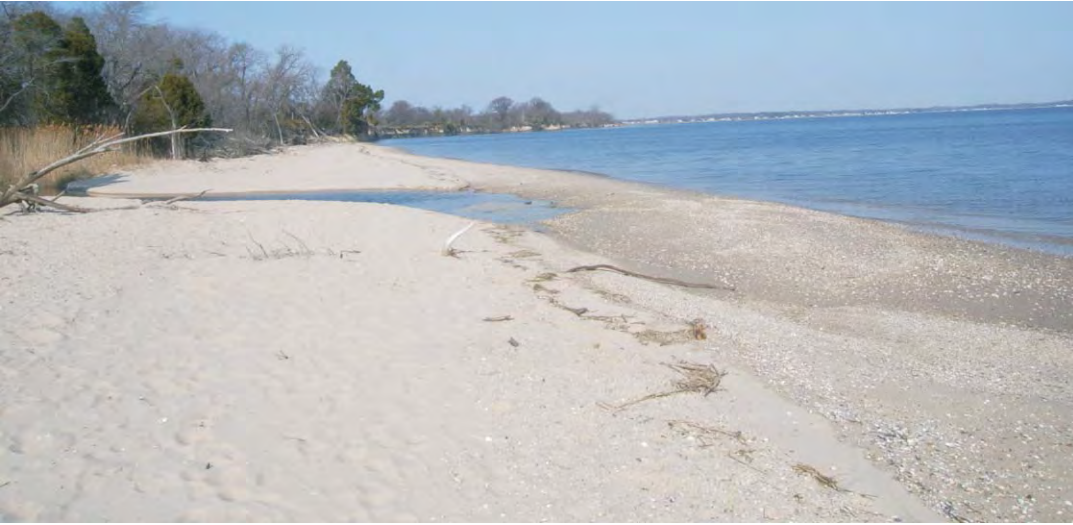
1. Entrance to Bridges Creek -Westernmost boundary of GEWA. Inlet is blocked at this time.

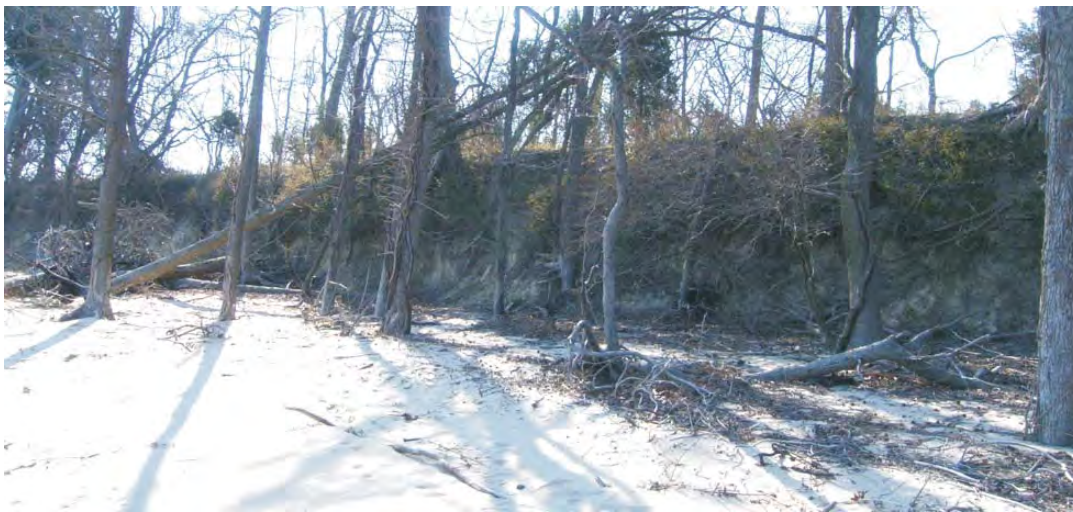
5. Bank erosion in front of the pond.

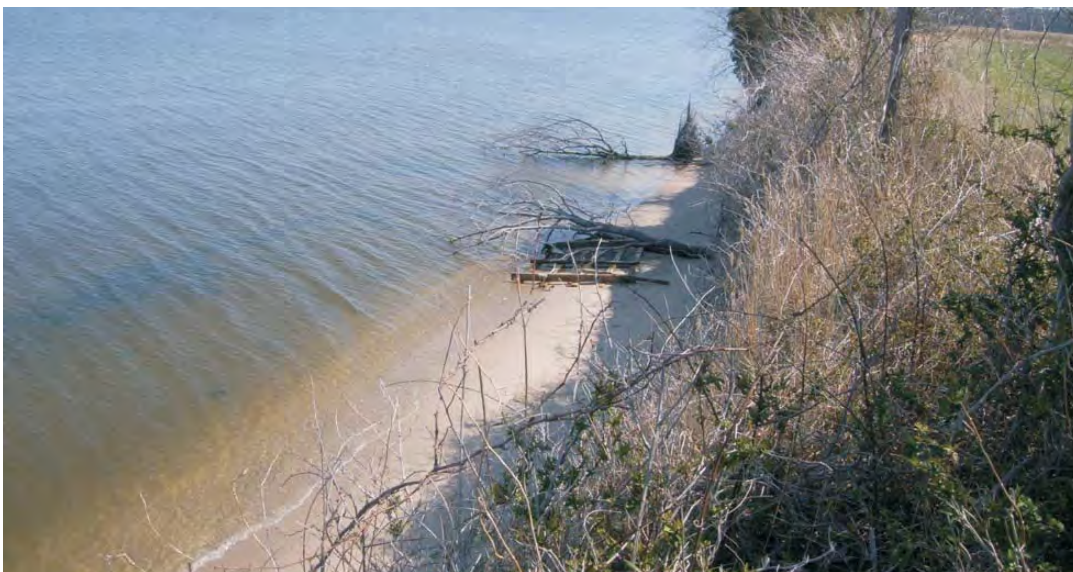
6. Eroding shoreline at the field .
