## Shore Status, Evolution, and Storm Vulnerability Assessments for George Washington Birthplace National Monument

## **Shore Status, Evolution, and Storm Vulnerability Assessments**

## Technical Report

May 2009

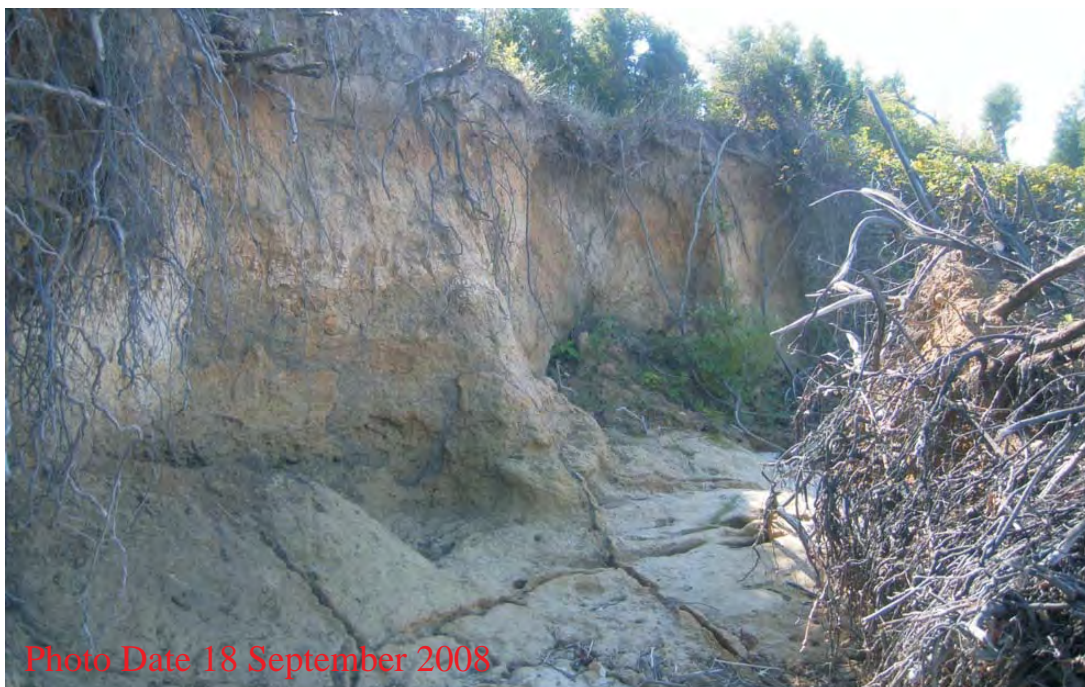
9. Erosional headland west of Digwood Swamp

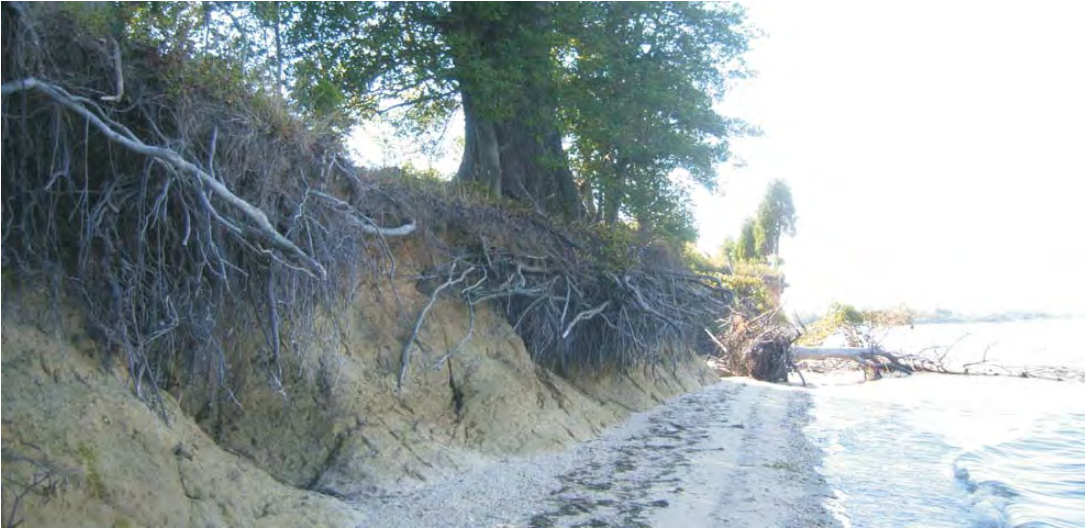
10. Erosional headland west of Digswood Swamp

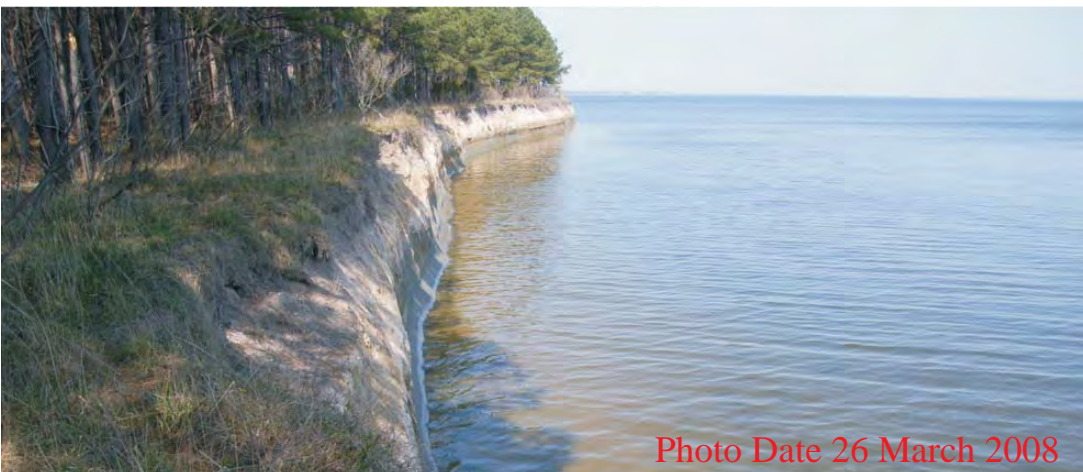
15. Vertical banks with no beach at high water along forested embayment - Top of bank elevation varies due to erosion at the top

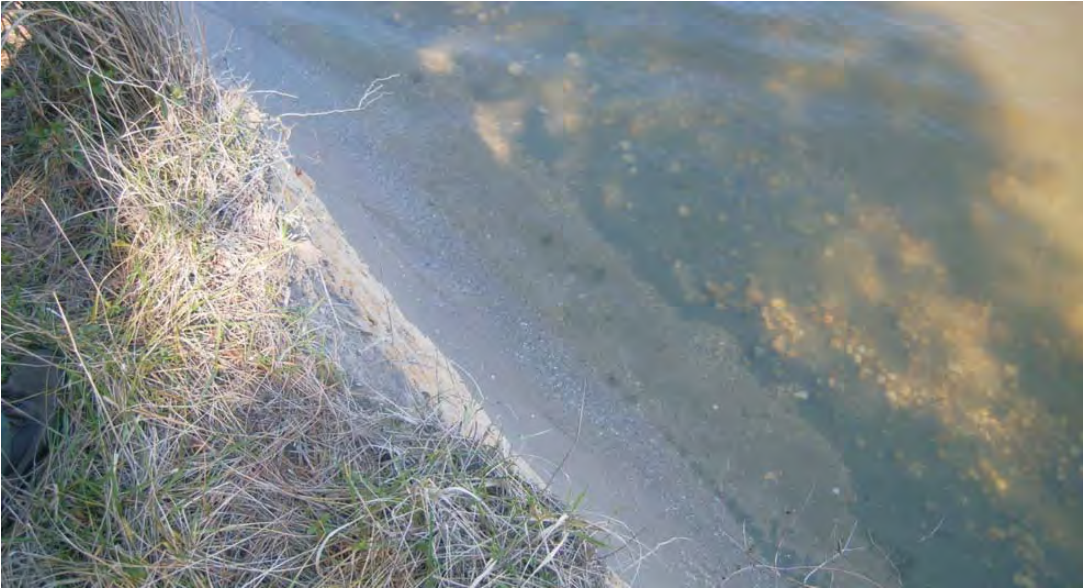
16. Vertical bank face.

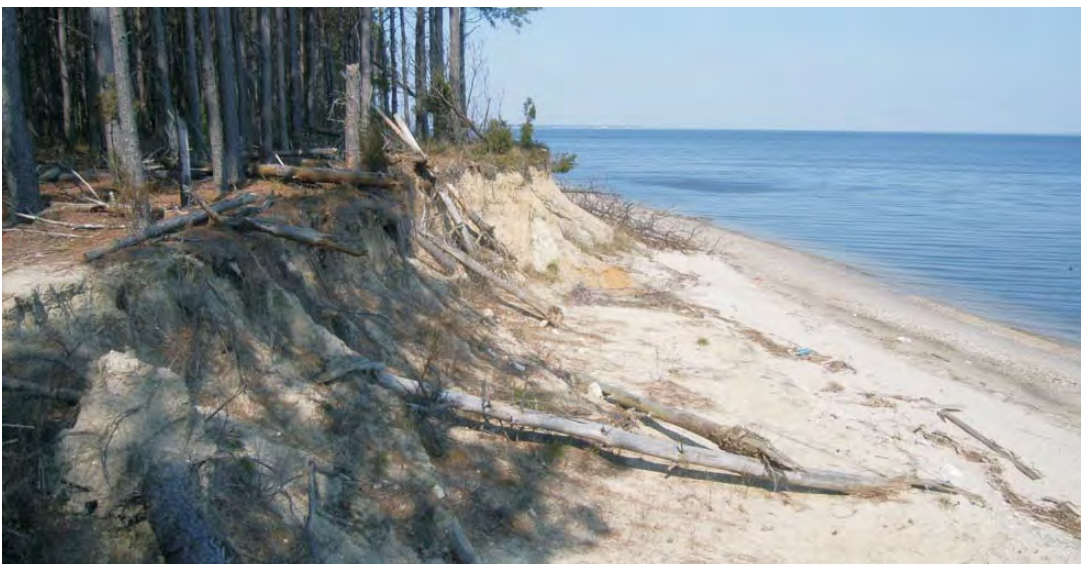
18. Eroding banks along the northeast facing shoreline.

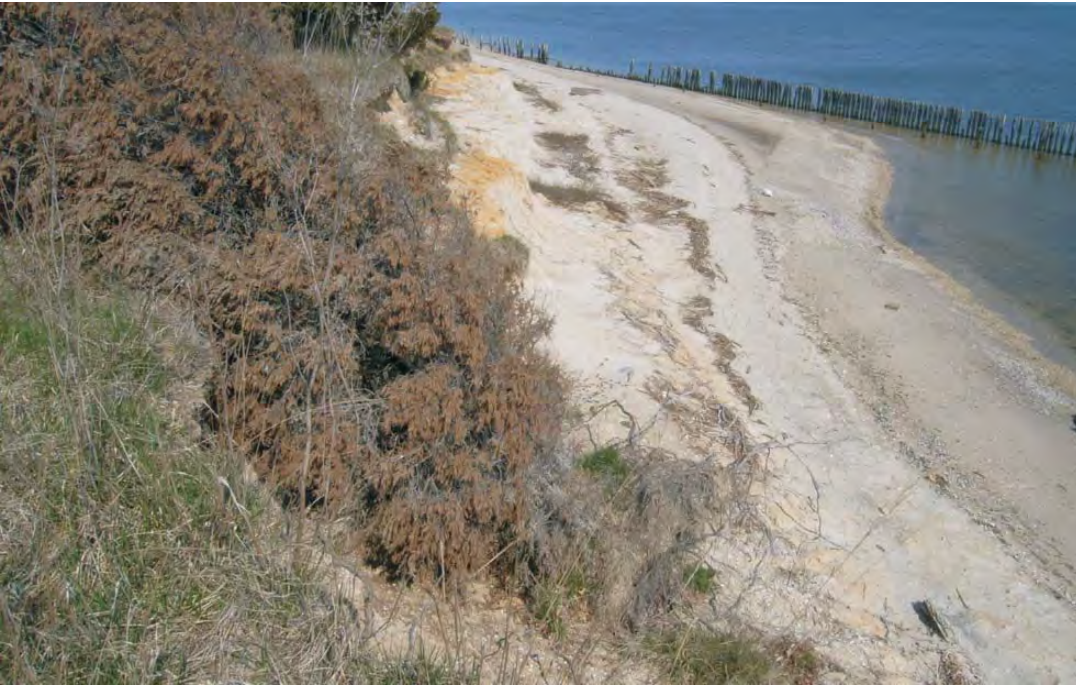
19. Along the northeast facing shoreline north of the sandy spit - Remnants of an old bulkhead are

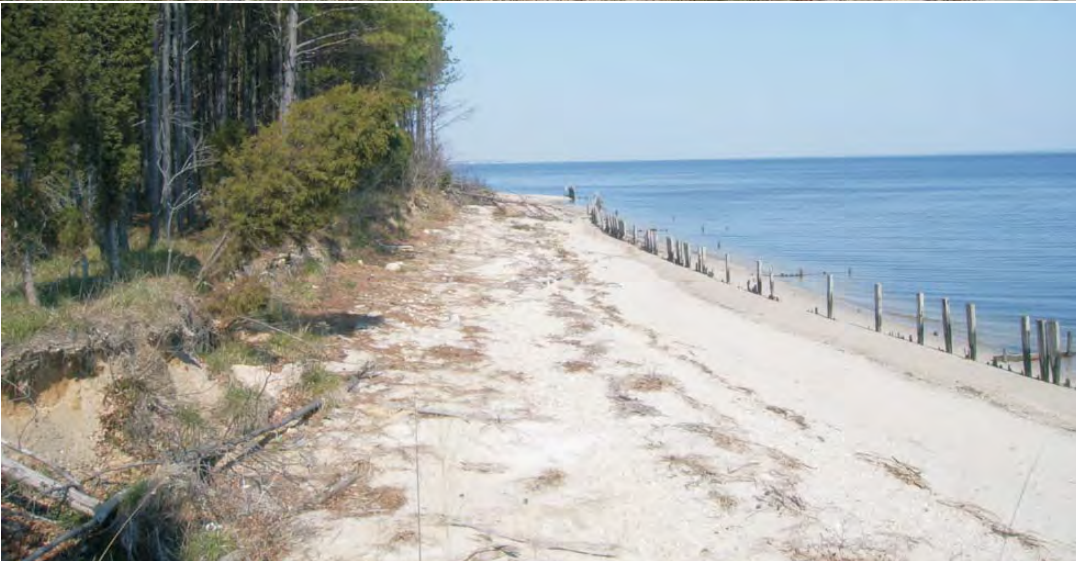
20. Shoreline where the sandy spit that fronts Longwood Swamp attaches to the upland - Remnants of an old bulkhead are evident.

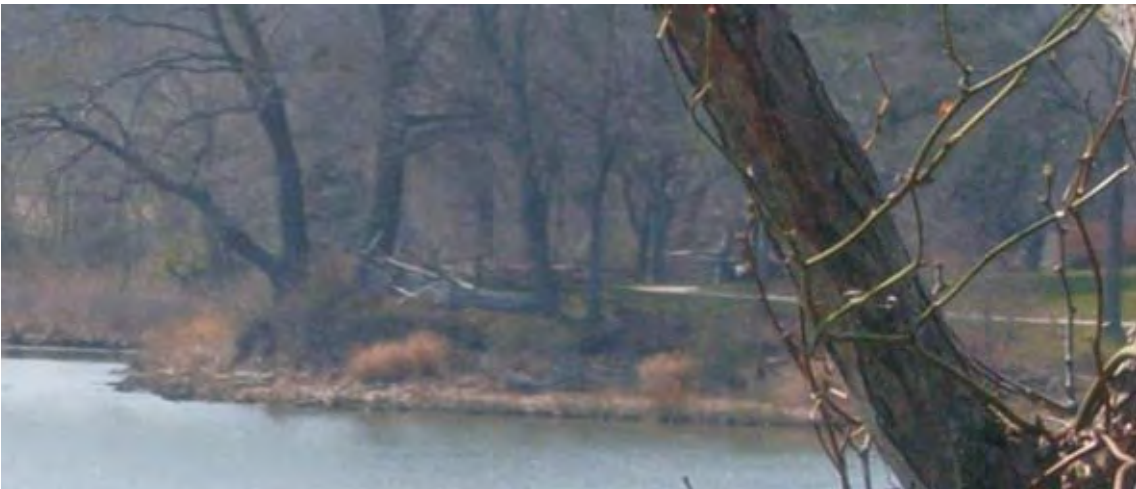
30. Eroding point of land near the Visitor's Center.

While not directly part of this study, shore erosion is occurring at the Visitor Center which is placed close to the shore. In addition, the height of the bank is lower in this region. For these reasons, it was considered vulnerable ([Figure 32](#)). Overall, about 3,800 ft (1,200 m) of shoreline was rated as "most vulnerable" and 1,000 ft (300 m) was rated as "vulnerable" along Potomac River and Popes Creek.

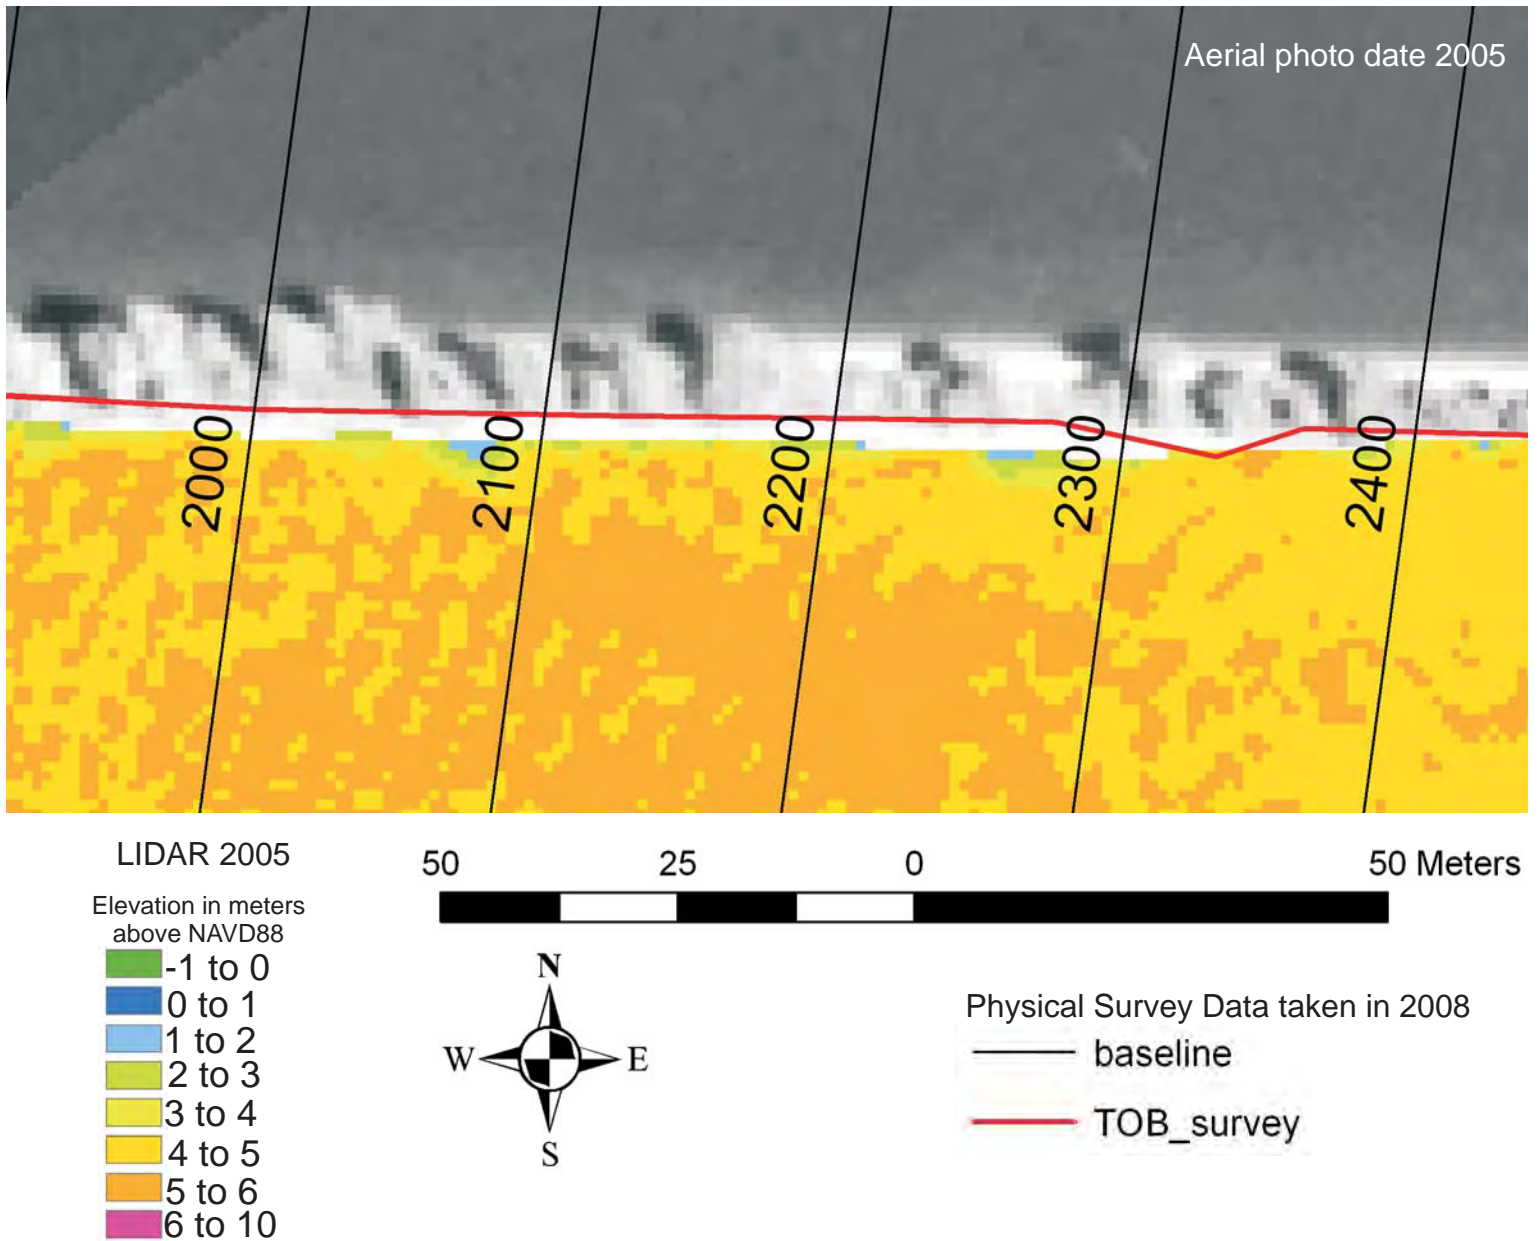
USGS’s gridded geotiff of LIDAR data taken in 2005 overlain on a rectified 2005 serial photo. Also shown is the profile cross-sections and the surveyed top of bank in 2008. The geotiff is cropped landward of the existing top of bank, and elevations indicate similar issues that were encountered with the 2008 data as described in the results and discussion sections of this report. In addition, the geotiff did not include the inholding’s shoreline on the Potomac River. Following methodology used to analyze the 2008 LIDAR data, this geotiff was used to generate the cross-sections that are compared to the 2008 physical survey on the following page. The selected cross-sections indicate that the data do not accurately represent the bank at GEWA.
