Fairfax County Shoreline Management Plan

***Prepared for
Fairfax County and
Virginia Coastal Zone Management Program***

Virginia Institute of Marine Science
College of William & Mary
Gloucester Point, Virginia

March 2015

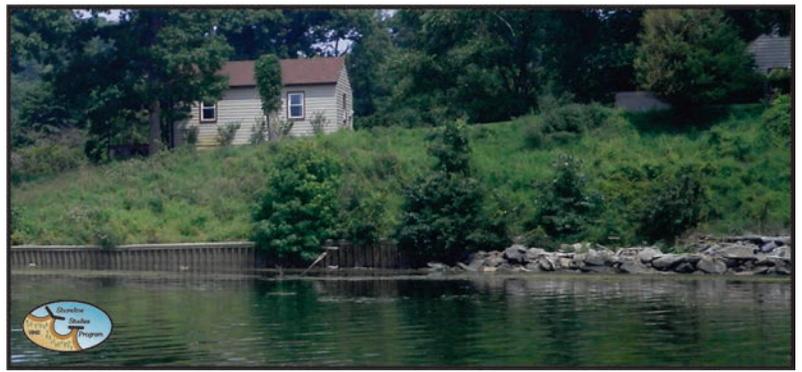
Figure 2-6. Shore protection along eroding banks of Belmont Bay.

shorelines (Figure 2-6) that transition to intermittently eroding upland banks along Belmont Bay to Kanes Creek (Figure 2-7). From Kanes Creek to Sandy Point the shoreline is alternating high eroding banks and low marsh coast with numerous trees along the bank and shore. This shore segment is part of Mason Neck State Park. There are three gabion structures just down river of the Park visitor's center (Figure 2-8) that are acting as breakwaters along the shoreline.

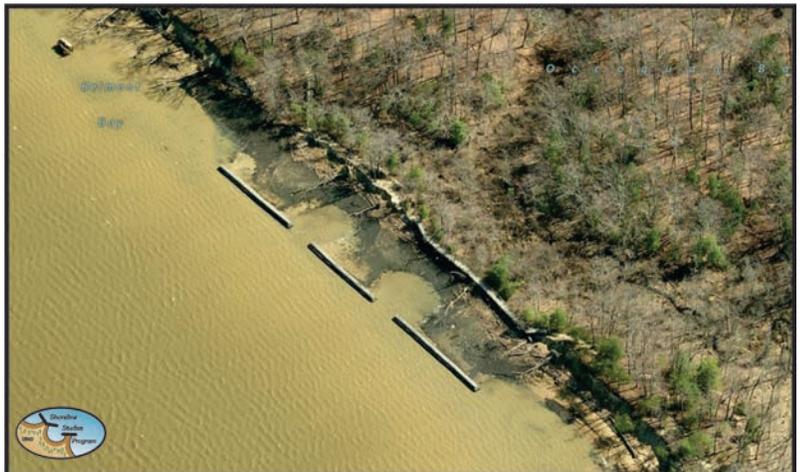
Figure 2-8. Gabion structures that are acting as breakwaters along Mason Neck State Park. From Bing Maps.

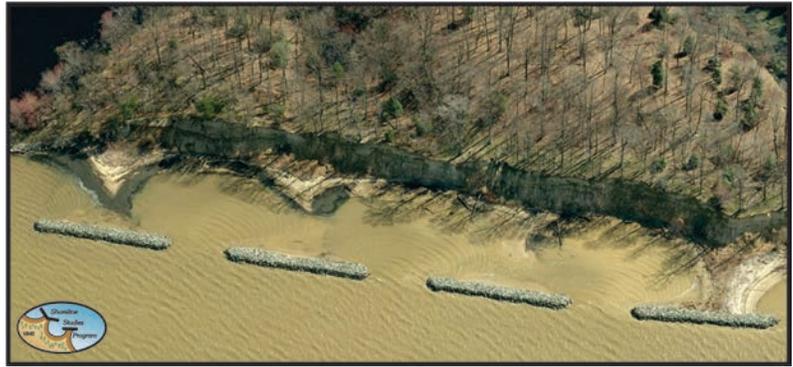
Figure 2-9. One attached and three detached breakwaters along Mason Neck north of High Point. As the sandy bank erodes, the breakwaters likely will become attached. From Bing Maps.

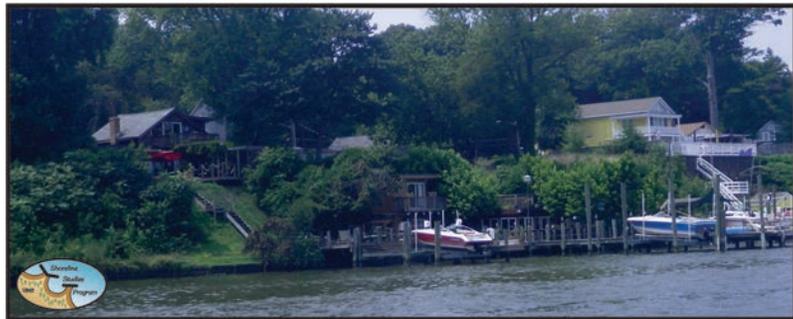
Figure 2-11. The shorelines along this section of shoreline in Reach 2 along the Potomac River has been graded and protected at the base.

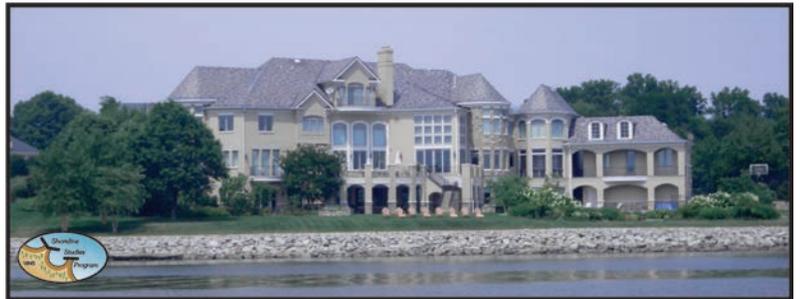
Figure 2-14. Ferry Point differs from other points in Fairfax in that it is developed and protected with a large revetment.

Beyond the entrance and continuing along the north shore of Dogue Creek, there are developed upland banks with gentle graded banks and hardened shoreline (Figure 2-13). The north coast of Dogue Creek continues to Ferry Point at the confluence with the Potomac River as a highly developed shoreline. Ferry Point is protected with rock (Figure 2-14).

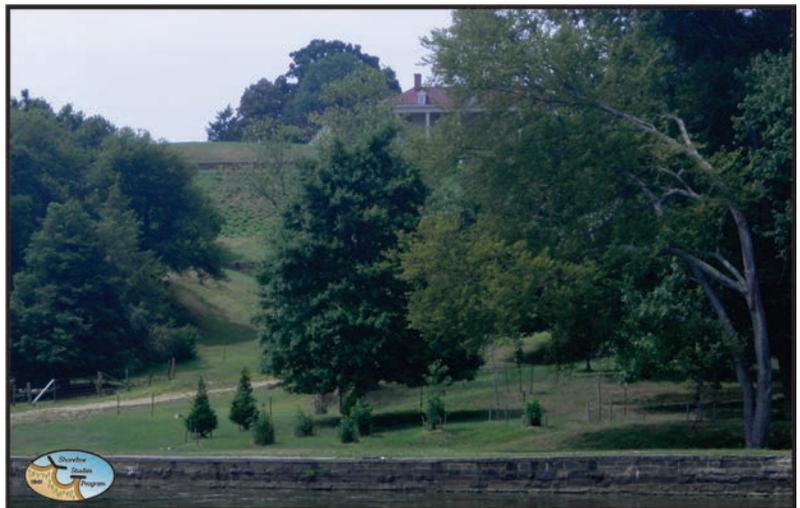
Figure 2-15. The high bank at Mount Vernon has been graded and the shoreline protected with a stone block seawall.

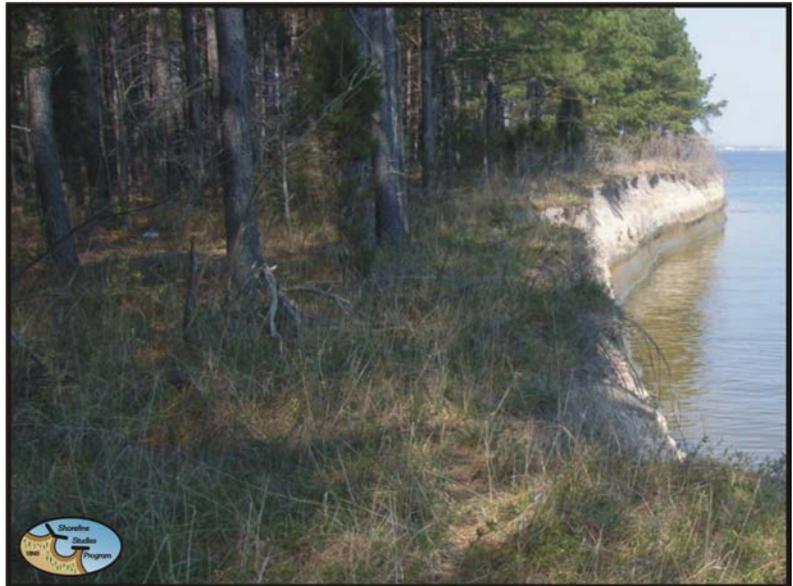
Figure 3-1. One example of forest management. The edge of the bank is kept free of tree and shrub growth to reduce bank loss from tree fall.

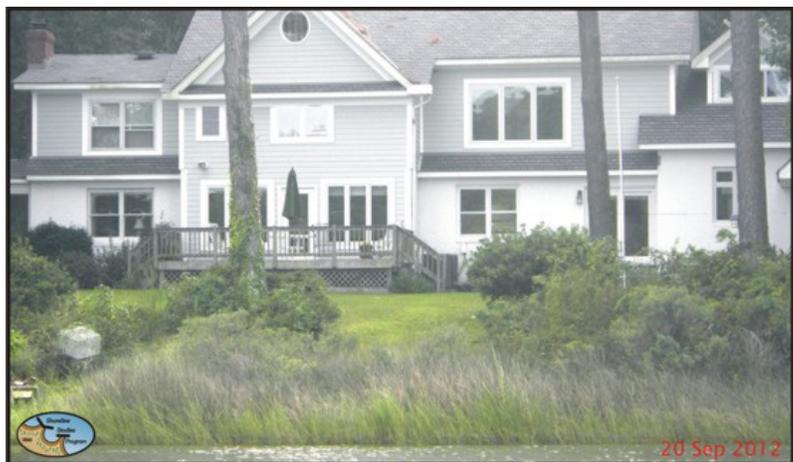
Figure 3-2. Maintaining and enhancing the riparian and marsh buffers can maintain a stable coastal slope.

Enhancement of both riparian and existing marsh buffers together can be an effective practice to stabilize the coastal slope (Figure 3-2) from the intertidal area to the upland by allowing plants to occupy suitable elevations in dynamic fashion to respond to seasonal fluctuations, shifts in precipitation or gradual storm recovery. At the upland end of the slope, forest buffer restoration and the planting of ornamental grasses, native shrubs and small trees is recommended. Enhancement of the marsh could include marsh plantings, the use of sand fill necessary to plant marsh vegetation, and/or the need for fiber logs to stabilize the bank toe and newly established marsh vegetation.

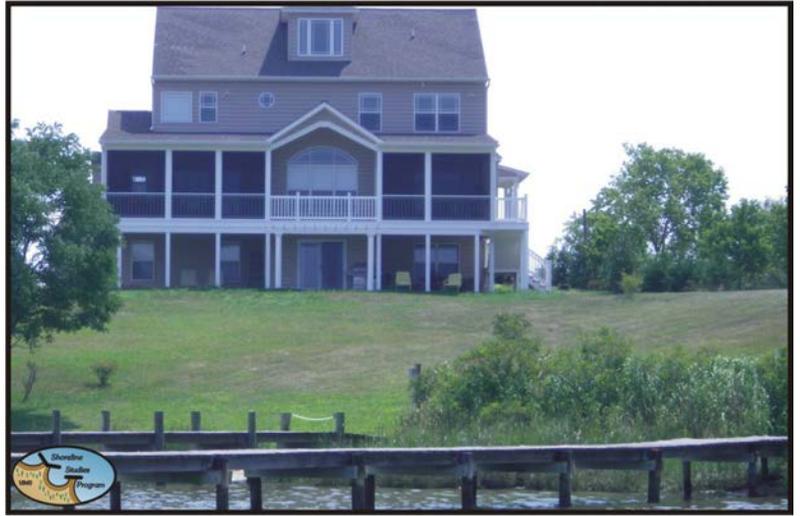
Figure 3-3. Bank grading reduces steepness and will improve growing conditions for vegetation stabilization.

In cases where the bank is unstable, medium or high in elevation, and very steep, bank grading may be necessary to reduce the steepness of bank slopes for wave run-up and to improve growing conditions for vegetation stabilization (Figure 3-3). The ability to grade a bank may be limited by upland structures, existing defense structures, adjacent property conditions, and/or dense vegetation providing desirable ecosystem services.

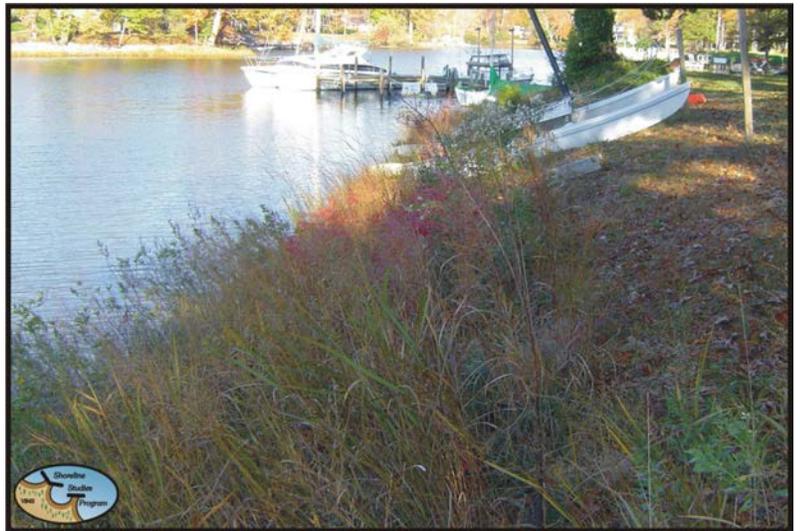
Figure 3-4. This low-energy site had minor bank grading, sand added, and *Spartina alterniflora* planted. This photo shows the site after 24 years.

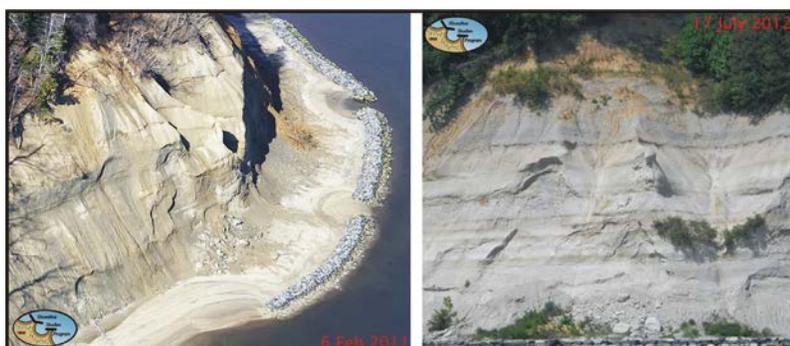
Figure 3-7. High sills built along the Potomac's high energy, high bank shoreline. The material that slumps from the bank will be caught behind the sills and stabilize the base of the bank by protecting it from wave attack. A more recent photo shows that the slump material is starting to become vegetated.

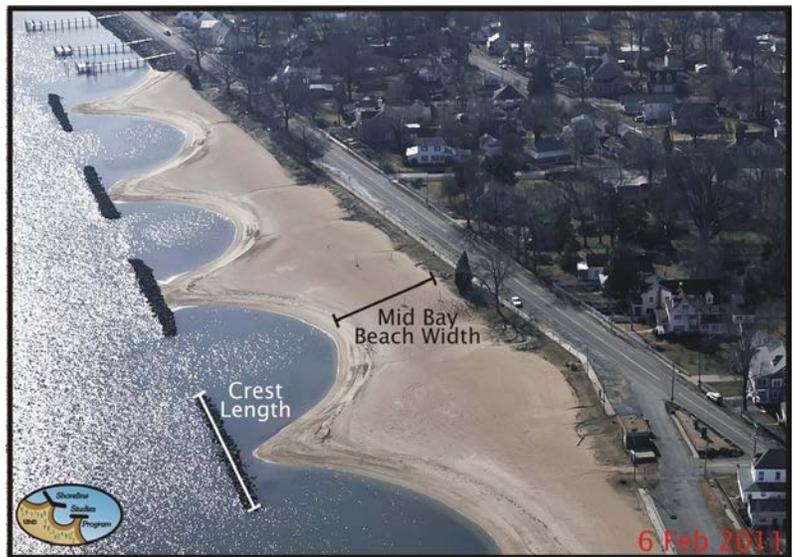
Figure 3-8. The breakwaters at Colonial Beach provide a wide recreational beach as well as storm erosion protection for the residential upland. These structures were installed in 1982.

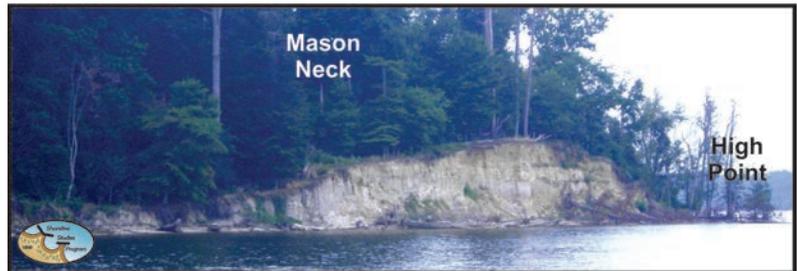
Figure 5-4. Existing conditions at High Point on Mason Neck.

The shoreline along Mason Neck at High Point is a high eroding bank (Figure 5-4). The bank is eroding at -2 to -5 ft/yr. In order to maintain High Point, a series of attached breakwaters are recommended (Figure 5-5). Detached breakwaters were built along a section of the coast in order to capture sand as the banks continued to erode (Figure 2-9). While these structures will eventually fill up with sand to create stable embayments, it is recommended that the breakwaters along High Point be attached in order to maintain the point. A typical cross-section is shown in Appendix 3, Figure 3-3.

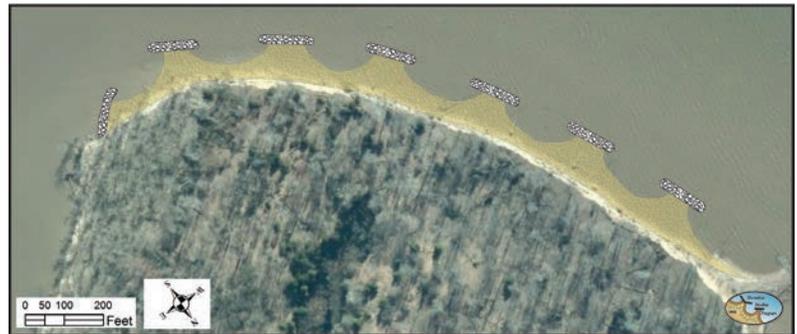
Figure 5-5. Proposed configuration of the breakwater shoreline BMP for High Point.

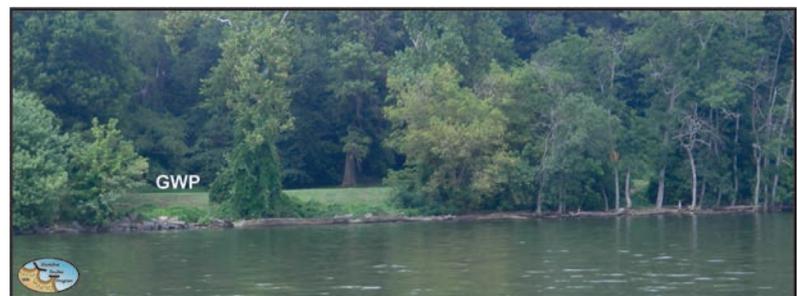
Figure 5-7. Existing conditions at the GWP turnout Area of Interest #2.

The second area of interest is a turnout along the GWP (Figure 5-6). This section of coast has a very low erosion rate (Figure 5-7), less than -1 ft/yr, but the Mount Vernon Trail, a paved multi-use trail that stretches from George Washington's Mount Vernon estate to Theodore Roosevelt Island, is relatively close to the shoreline (Figure 5-8). In addition to providing a buffer along the shore, a sill will create habitat and enhance the view along the turnout. A typical cross-section for a sill at this site is shown in Appendix 3, Figure 3-1.

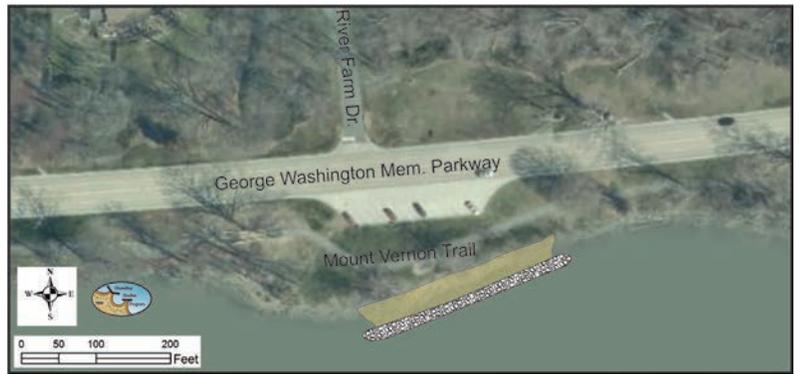
Figure 5-8. Proposed configuration of sill shoreline BMP for Area of Interest #2 along the GWP.

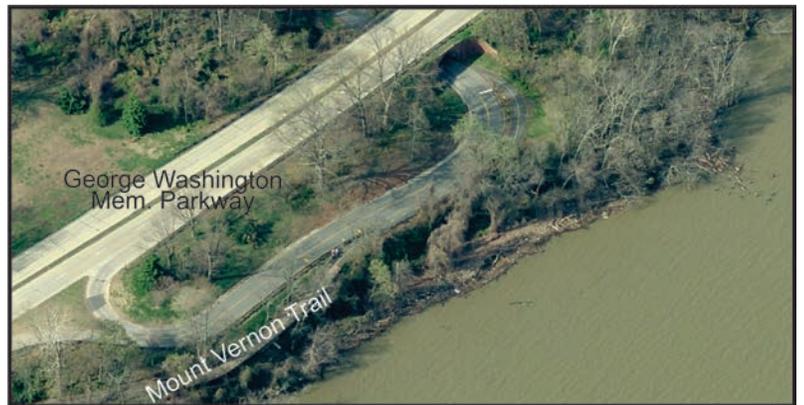
Figure 5-9. Existing conditions at the GWP turnout Area of Interest #3. From Bing Maps.

The third area of interest is also a turnout along the GWP (Figure 5-6). This section of coast has a higher erosion rate, -2 to -5 ft/yr, and the Mount Vernon Trail and turnout are very close to the eroding bank (Figure 5-9). A medium sill will protect the Trail and the shoreline from continued erosion (Figure 5-10). A typical cross-section for a sill at this site is shown in Appendix 3, Figure 3-2.

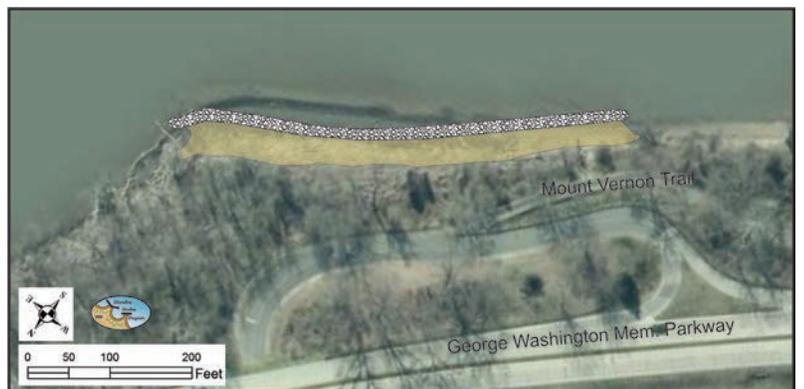
Figure 5-10. Proposed configuration of sill shoreline BMP for Area of Interest #3 along the GWP.
