King and Queen County Shoreline Situation Report

Special Report in Applied Marine Science and Ocean Engineering
SRAMSOE No.363

June, 2000

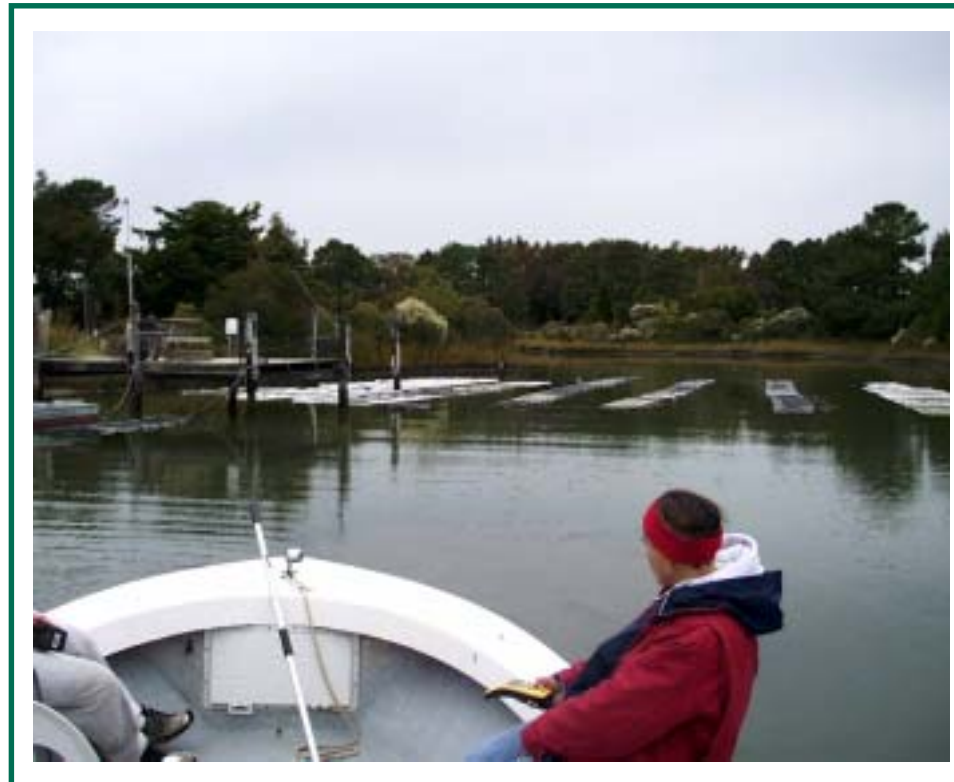
Collecting data with Trimble's Geo Explorer GPS unit

Data collection is performed in the field, from a small, shoal draft vessel, navigating at slow speeds parallel to the shoreline. To the extent possible, surveys take place on a rising tide, allowing the boat to be as close to shore as possible. The field crew consists of a boat operator, and two data surveyors. The boat operator navigates the boat to follow the shoreline geometry. One surveyor collects information pertinent to land use and bank condition. The second surveyor logs information relevant to shoreline structures.

The GPS units are preprogrammed with the complete suite of shoreline features described in section 2.2. These features are stored in a "data dictionary" prepared specifically for this project. As features are observed in the field, the GPS unit tags each geographic coordinate pair with the attribute's code. The survey, therefore, is a complete set of geographically referenced shoreline features.
