## Arlington County, Virginia - Shoreline Inventory Report: Methods and Guidelines

# Arlington County, Virginia Shoreline Inventory Report Methods and Guidelines

**Prepared By:**  
**Comprehensive Coastal Inventory Program**  
**Center for Coastal Resources Management**  
**Virginia Institute of Marine Science, College of William and Mary**  
**Gloucester Point, Virginia**  
**December 2018**

Special report in Applied Marine Science and Ocean Engineering No. 473 of the Virginia Institute of Marine Science

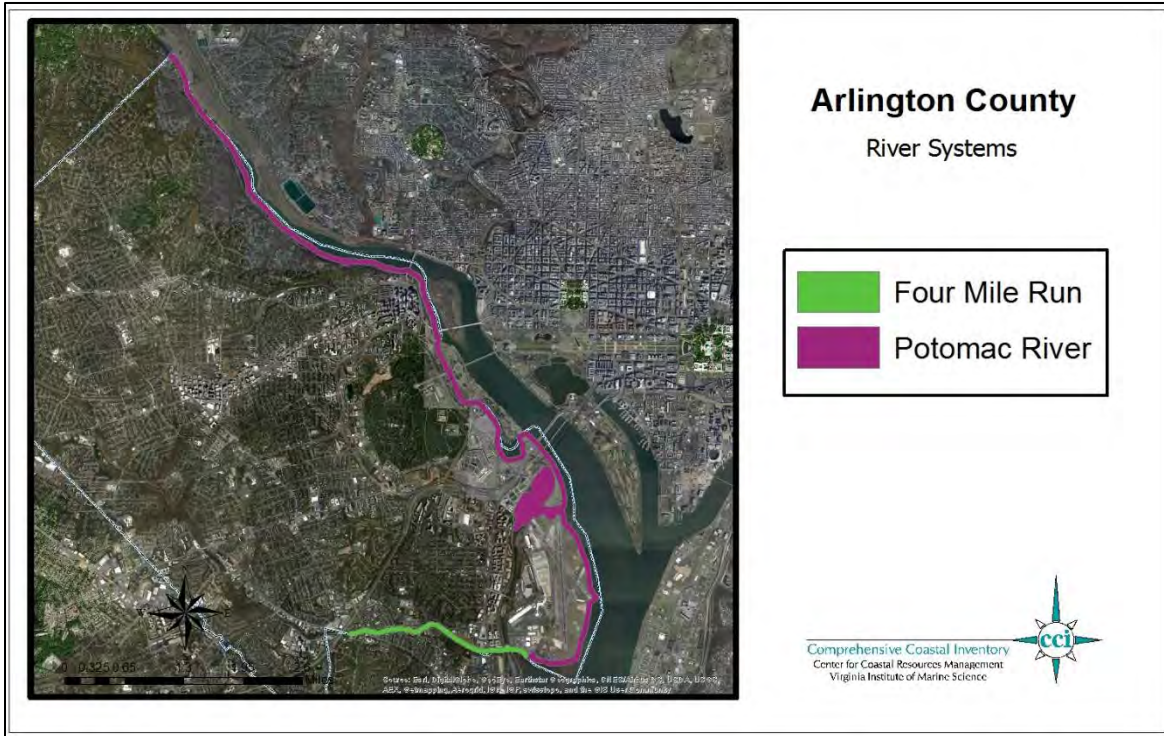
Figure 2. River Systems in Arlington County

Summary tables (Tables 4-7) quantify conditions observed on the basis of river systems (Figure 2). Refer to Figure 2 for the location of these rivers systems. Note, river systems do not

correspond to watershed boundaries. They were developed for convenience in reporting data.

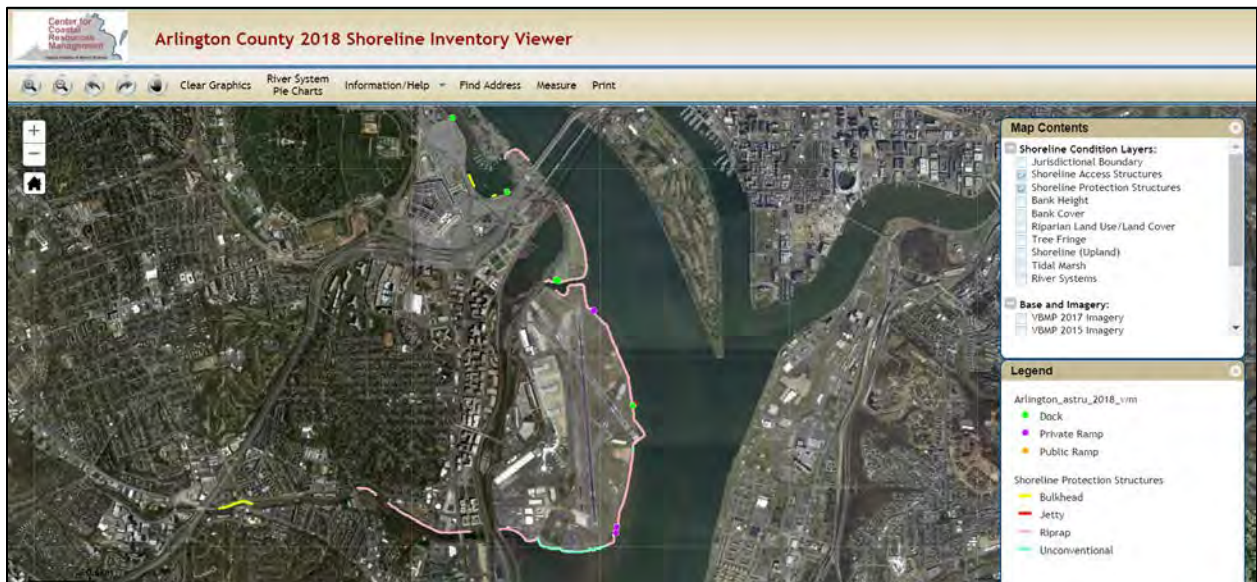
Figure 4. Map Viewer illustrates Shoreline Access and Protection Structures for a section of Arlington County.

In Figure 4 Shoreline Access Structures, and Shoreline Protection structures are selected.

Shoreline Access structures are point features that includes piers and boat ramps. The actual footprint of these structures is not measured; only their location. Shoreline Protection Structures are line features and are mapped and illustrated in the viewer to show where they occur along the shoreline. Figure 5 illustrates riparian land use in the riparian zone for the same section of the County.

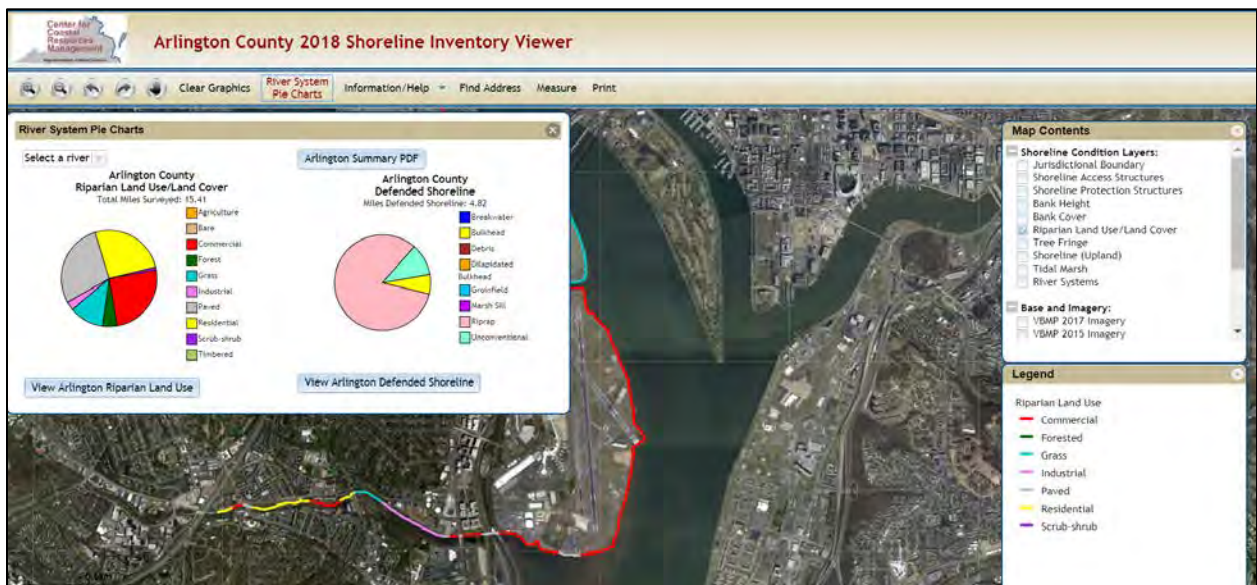
Figure 7. Pie charts display land use and shoreline hardening statistics for each tributary.

The top toolbar also includes tabs to access some important status information for the locality. By clicking on the “River System Pie Charts” button, users can obtain a statistical summary distribution of the riparian land use and amount of hardened shoreline for a specific water body selected from the drop down menu in the upper left (Figure 7). More detailed results in table format can be found by clicking the Arlington County Summary PDF button also in the window. The summary statistics are reported by river systems (Figure 2).

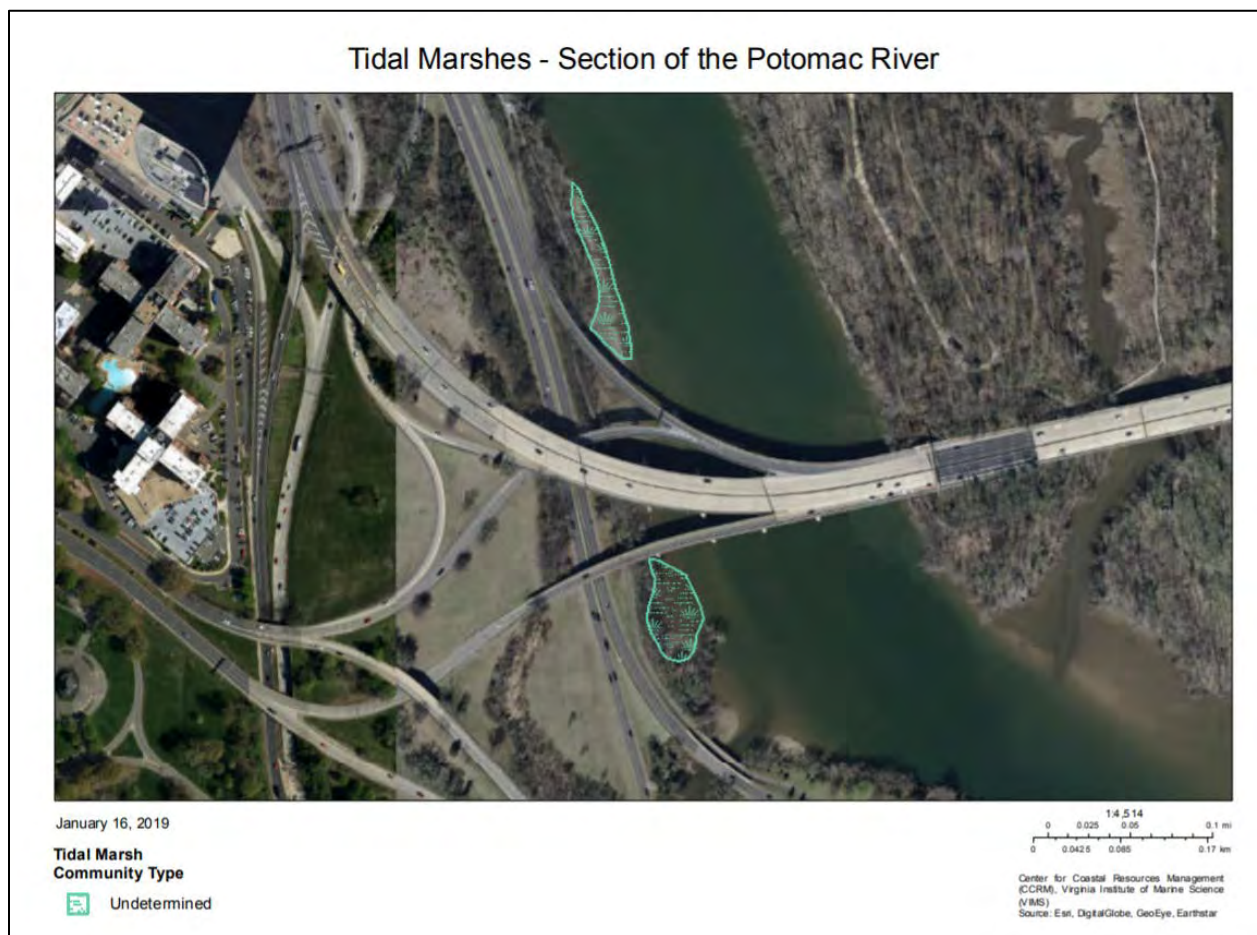
Figure 8. Customized print window for a section of Potomac River

button. The page can be set up for printing to 8.5 x 11 portrait or landscape style. Figure 8 is an example of a customized map generated for a section of the Potomac River. Here the tidal marsh communities are displayed, and the community type is reported in the legend beside the illustration.
