Preliminary assessment of benthic macrofauna community within intertidal mudflats, Lake Rudee, Virginia Beach, Virginia

PRELIMINARY ASSESSMENT OF BENTHIC MACROFAUNA COMMUNITY WITHIN INTERTIDAL MUDFLATS

Lake Rudee, Virginia Beach, Virginia

A report to:
Waterway Surveys and Engineering Ltd.
and Emery Chickey

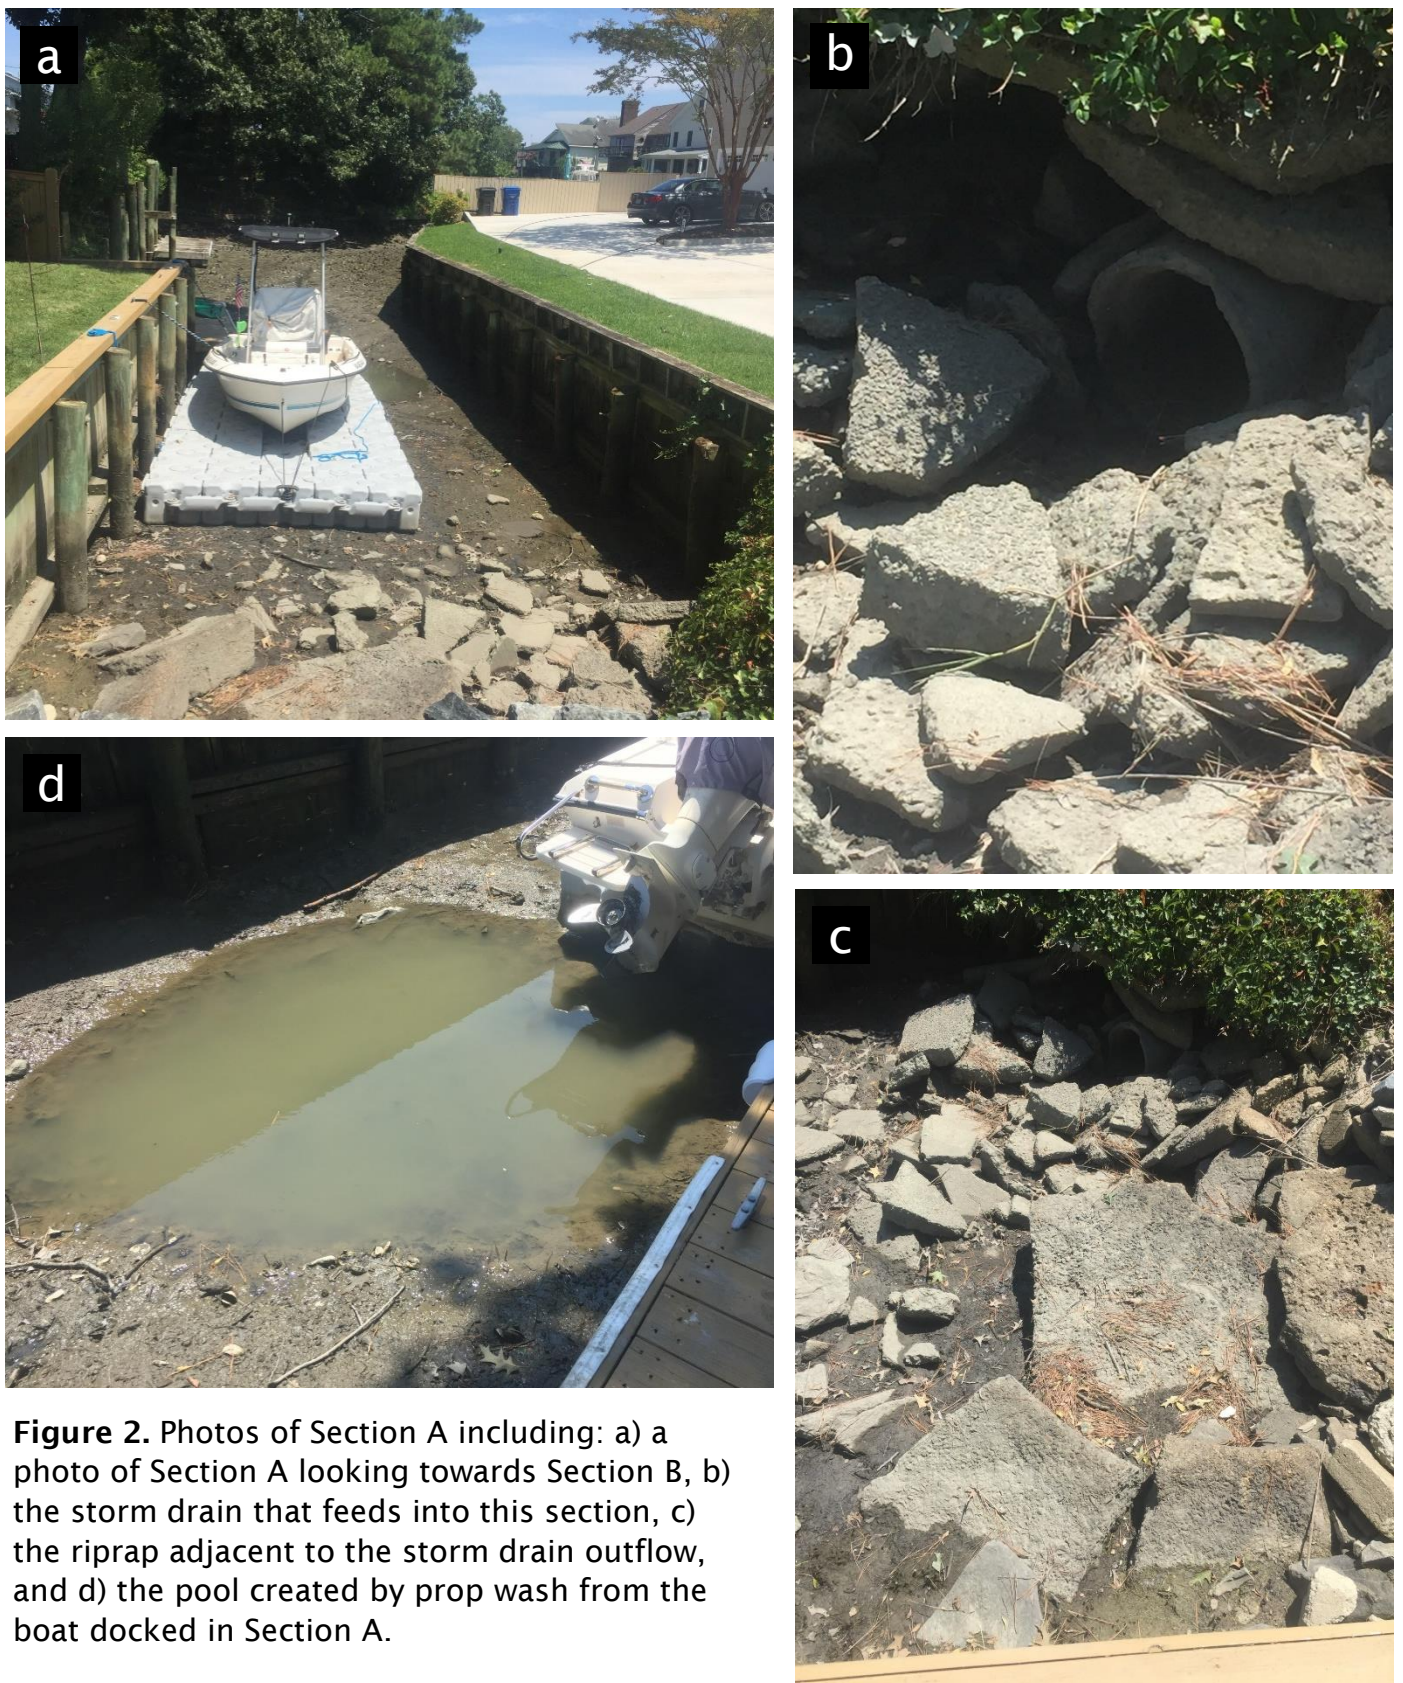
Section A (Fig. 2) is the farthest from the mouth of the canal and is the location of a storm drain that drains into the canal. There is a small amount of riprap adjacent to the outlet of the storm drain. The other edges of the canal in this area do not have riprap. This section of the canal is characterized by firmer, sandier sediments than other sections of the canal presumably as a result of the storm drain. There are two floating docks within this section of the site. This section is entirely intertidal but contains a manmade pool at low tide created by prop wash from the boat docked in the canal. Observations in this section were made by walking in the canal.

Figure 2. Photos of Section A including: a) a photo of Section A looking towards Section B, b) the storm drain that feeds into this section, c) the riprap adjacent to the storm drain outflow, and d) the pool created by prop wash from the boat docked in Section A.

Observations suggest that the proposed dredge area is commonly used by highly mobile invertebrates and vertebrates including blue crabs and several species of fish. The small pool created by the boat prop wash in Section A (Fig. 2d), contained a number of organisms including at least: one blue crab, >50 small (~3-5cm in total length) schooling fish of unknown species, ~10 slightly larger schooling fish of unknown species, and two non-schooling juvenile fish (<3cm) that were black in color and were very different in shape from other species observed. Observations were also made from the seawall at the northwestern corner of Section D as the tide began to come in. During this time, animals observed feeding at the edges of the mudflat as the tide rose included at least three blue crabs and nine schools (~20 fish in each) of small fish. Depressions in the soft sediments, especially in Section D, suggest that organisms such as larger benthic-feeding fish and/or rays may feed in the area when it is covered by water.

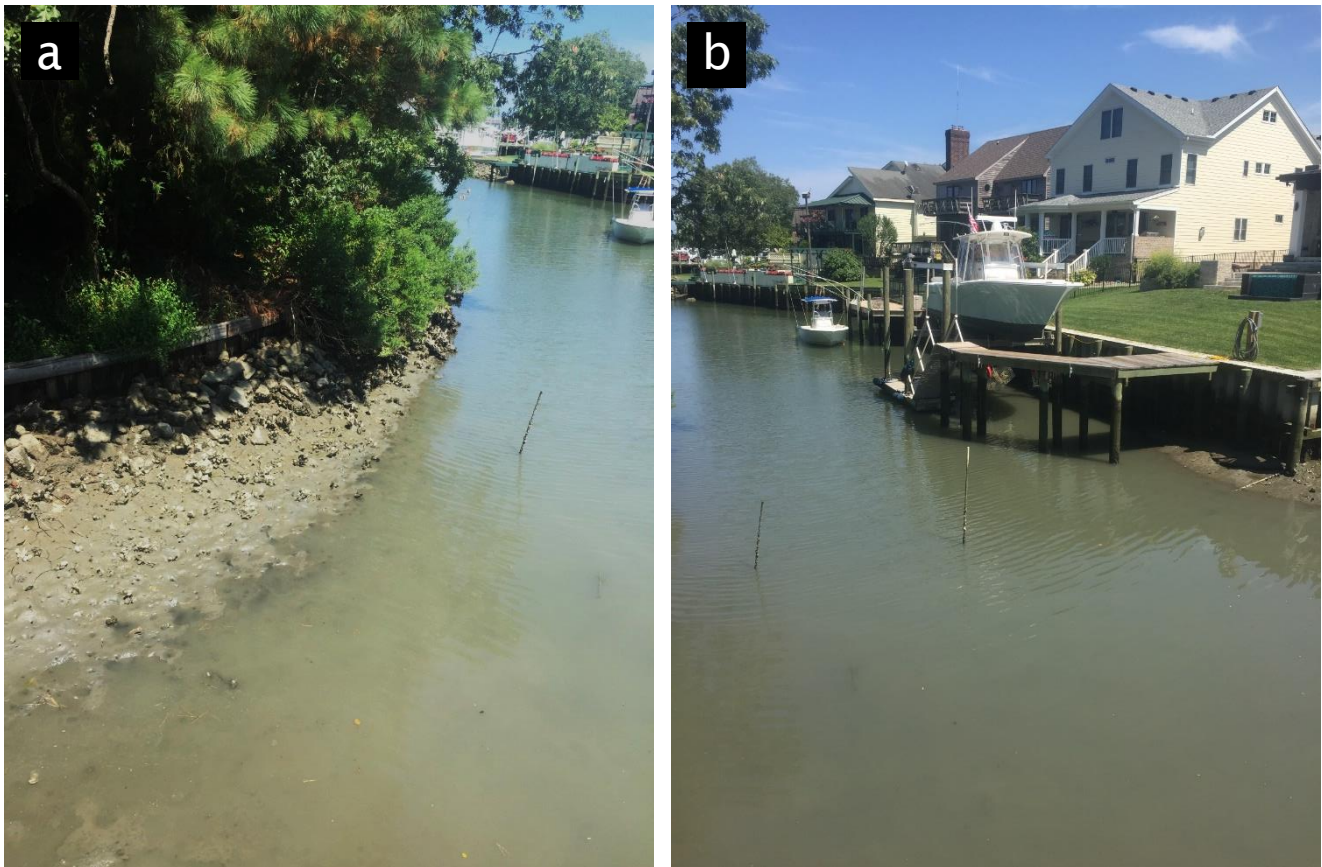
Section C (Fig 4) lies downstream of Section B. The north side of this section is composed of riprap in front of a seawall. On the north side the intertidal zone is dominated by riprap but some areas have a strip of intertidal mudflat in front of the riprap. On the south side some sections of the seawall have a narrow intertidal mudflat area but others have no intertidal area. This section has a relatively small proportion of intertidal area. All observations in this section were made from shore.

Figure 4. Photos of Section C showing: a) the seawall fronted by riprap that makes up most of the northern side and b) the seawall without riprap on the southern side.

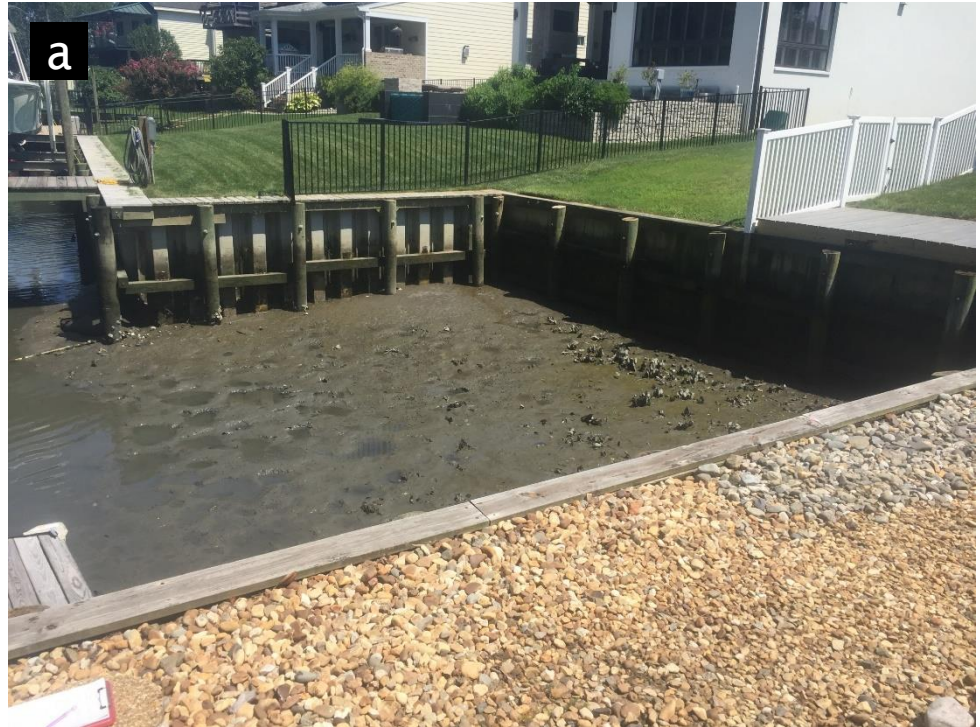
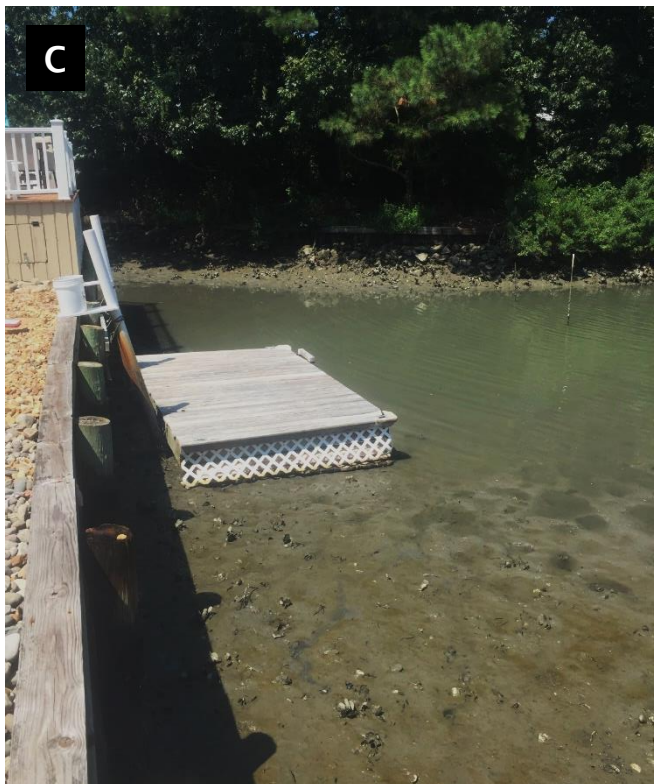
Section D (Fig. 5) lies to the south of Section C. It has one floating dock and is dominated by an intertidal mudflat. All observations in this section were made from shore.

Figure 5. Photos of Section D showing: a) the majority of the intertidal mudflat area, b) the area adjacent to the southernmost section of the seawall that has the highest density of oysters, and c) a view from Section D into Section C showing the floating dock.

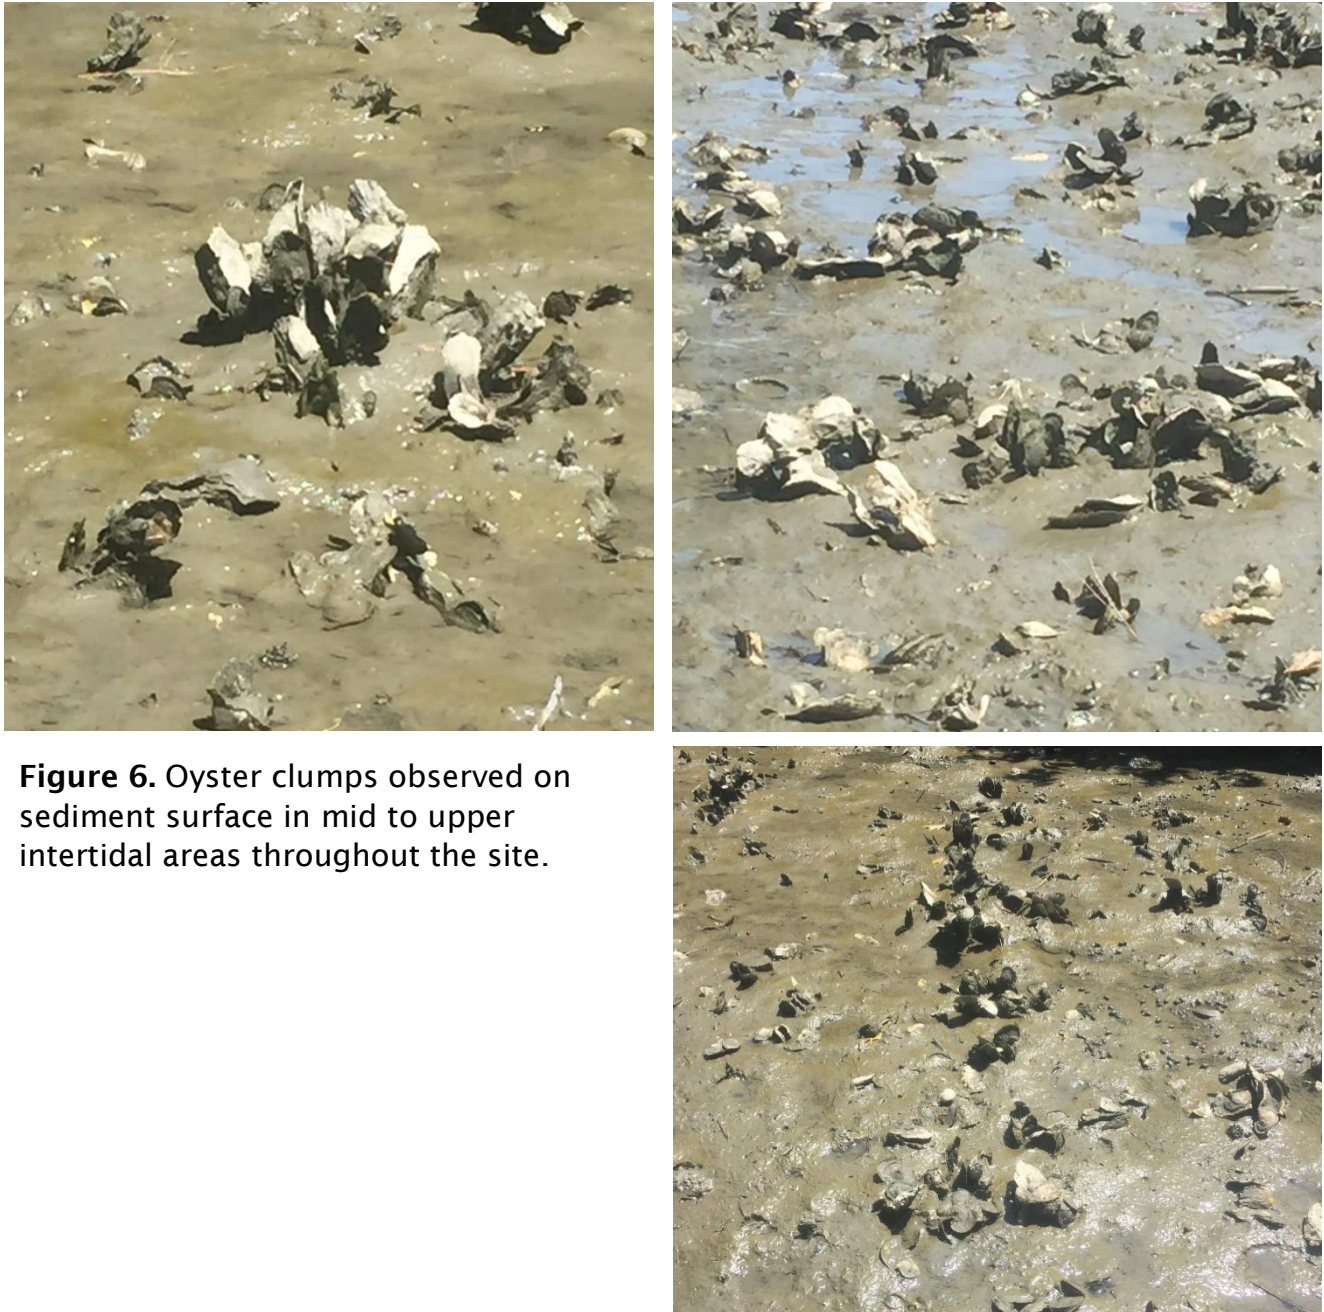
Significant numbers of the eastern oyster *Crassostrea virginica* were observed in all four sections (Fig. 6). Oyster clumps on the sediment surface were most common in Section B. Oyster clumps attached to riprap were most common in Section C. Most oysters were live and showed signs of recent growth.

Figure 6. Oyster clumps observed on sediment surface in mid to upper intertidal areas throughout the site.

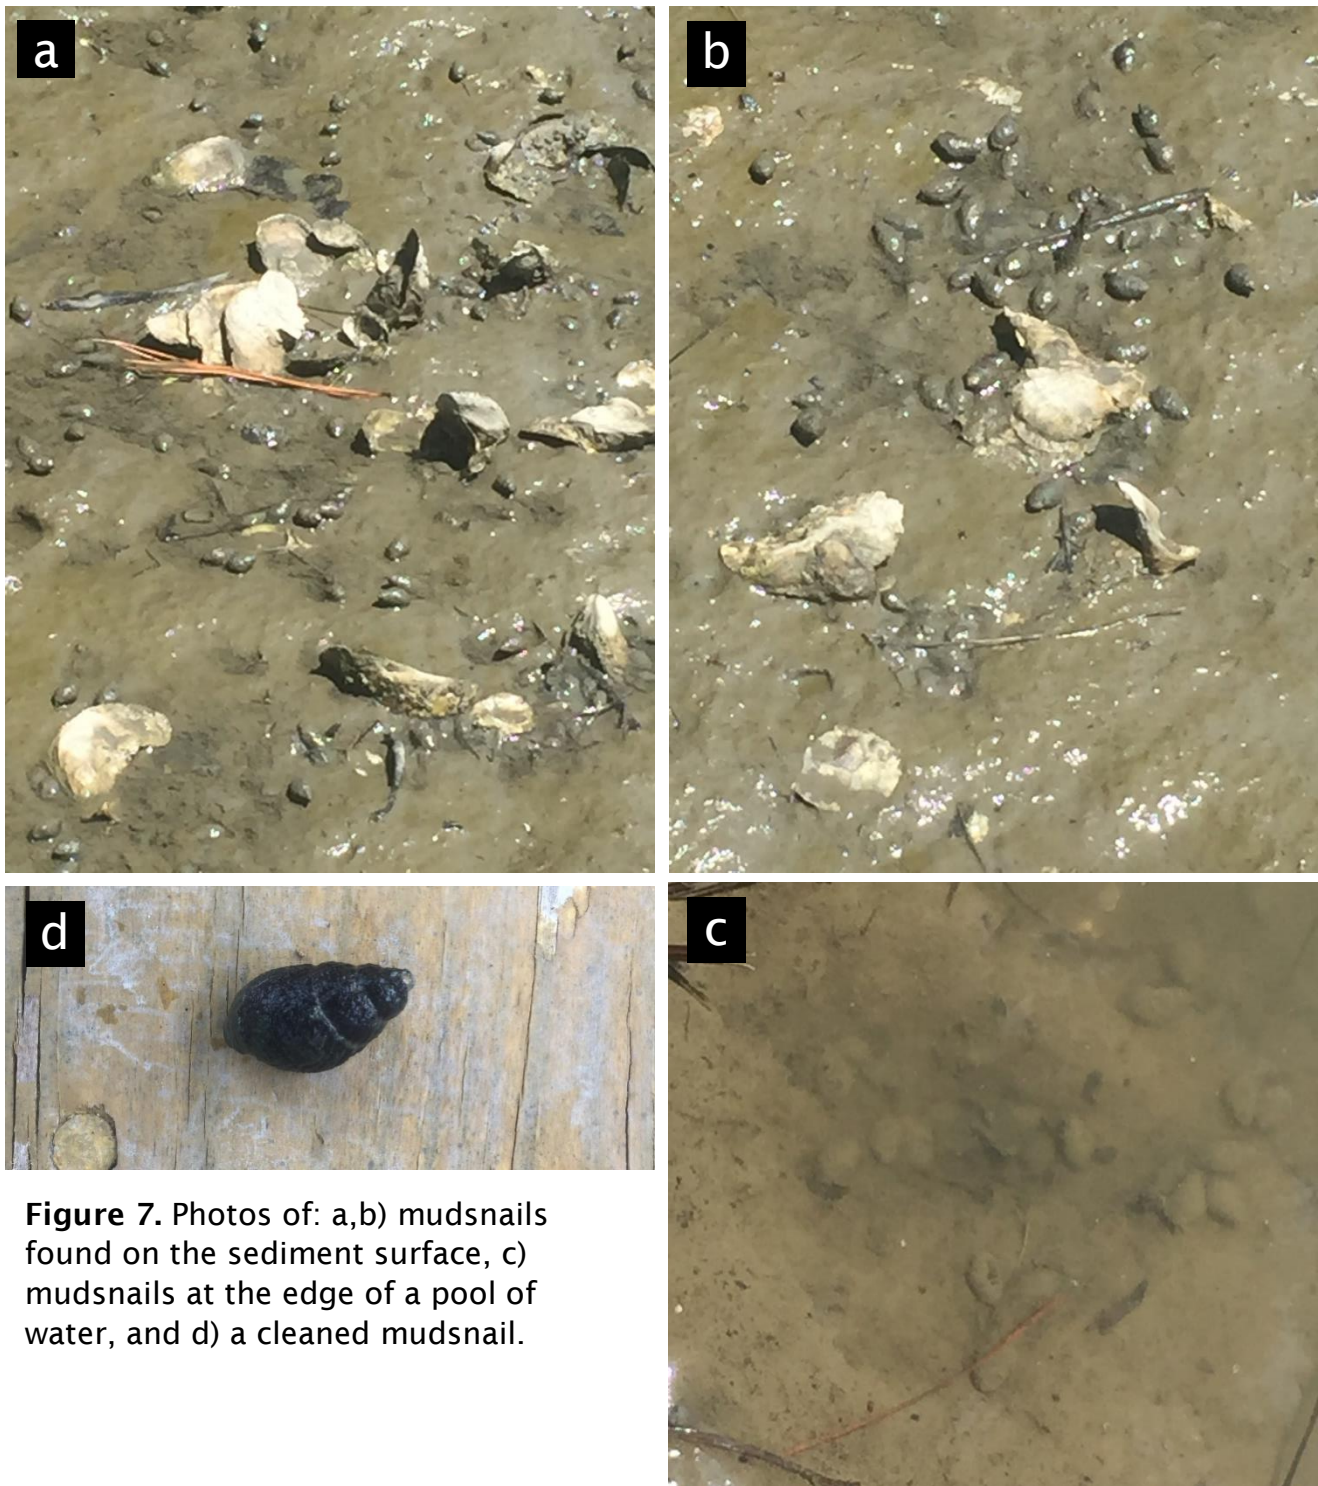
Mudsnails were abundant and observed in all sections (Fig. 7). Mudsnails were common both on the sediment surface and at the edges of small and larger pools within the intertidal zone.

Figure 7. Photos of: a,b) mudsnails found on the sediment surface, c) mudsnails at the edge of a pool of water, and d) a cleaned mudsnail.

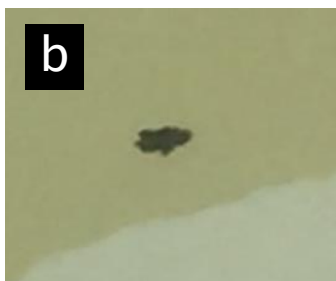
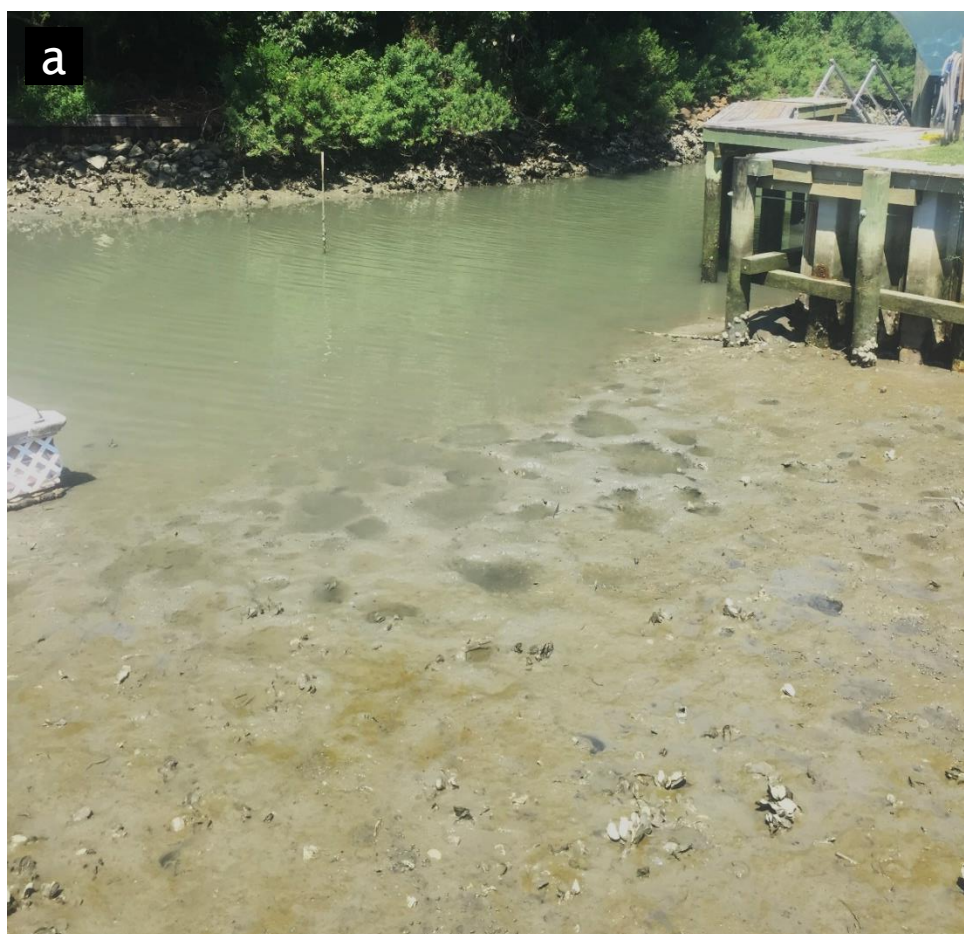
Figure 8. Photos of: a) area where multiple crabs and schools of small fish were observed feeding as the tide rose and b) one of two juvenile fish observed in pool in Section A. Note depressions in sediment surface (a) are likely due to feeding of larger fish and/or rays.
