City of Newport News, Virginia Shoreline Inventory Report Methods and Guidelines

November, 2009

Special report in Applied Marine Science and Ocean Engineering No. 414 of the Virginia Institute of Marine Science

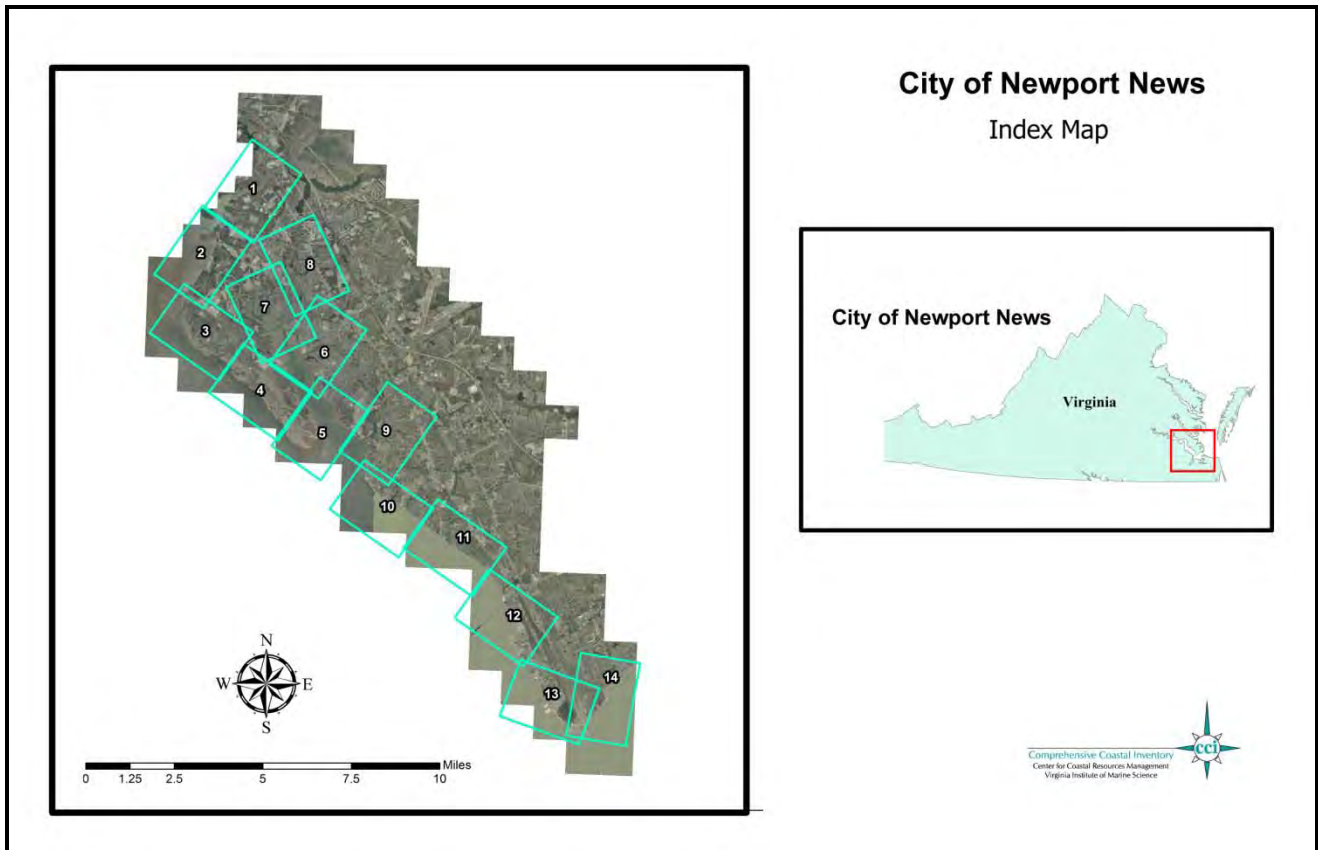
Figure 2. Map index for the City of Newport News

For publication purposes the city is divided into a series of maps. Maps are scaled at 1:12,000 for publication at 11x17. Scale will vary if printed at a different size. There are 14 maps for the City of Newport News determined by the city's geographic size and shape. For each map there are four plates (plate 1a, 1b, 1c, 1d, etc.), for a total of 56 map compositions. On the website (Figure 1), an index is provided to help users locate the area of interest and view the orientation of the maps to each other (Figure 2). Each plate can be individually selected and viewed from the plate list along the left hand column of the index page.

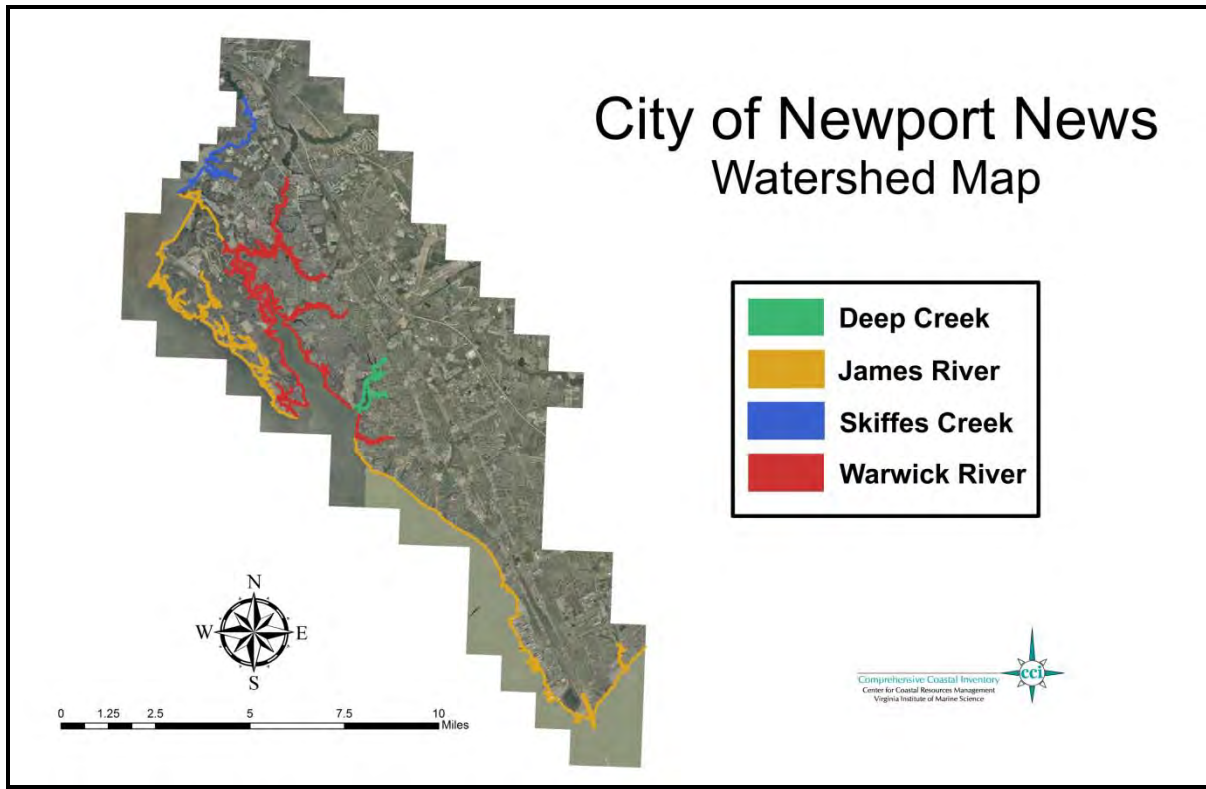
Figure 3. Delineation of City watersheds used for data reporting

Tables 4, 5, and 6 quantify features and conditions mapped along the rivers using frequency analysis techniques in ArcInfo. The values quantify features by river system (Figure 3). For linear features, values are reported in actual miles surveyed. Point features are enumerated. The total miles of shoreline surveyed for each tributary is reported. For the city, a total of 91.93 miles were surveyed in the field. Approximately 64.92 miles of shoreline were surveyed using remote sensing techniques. Figure 4 illustrates where field surveys were conducted and where remote sensing techniques were applied. The majority of these miles were places where navigation was restricted. Table 6 reports the survey dates, miles surveyed, and miles surveyed remotely.

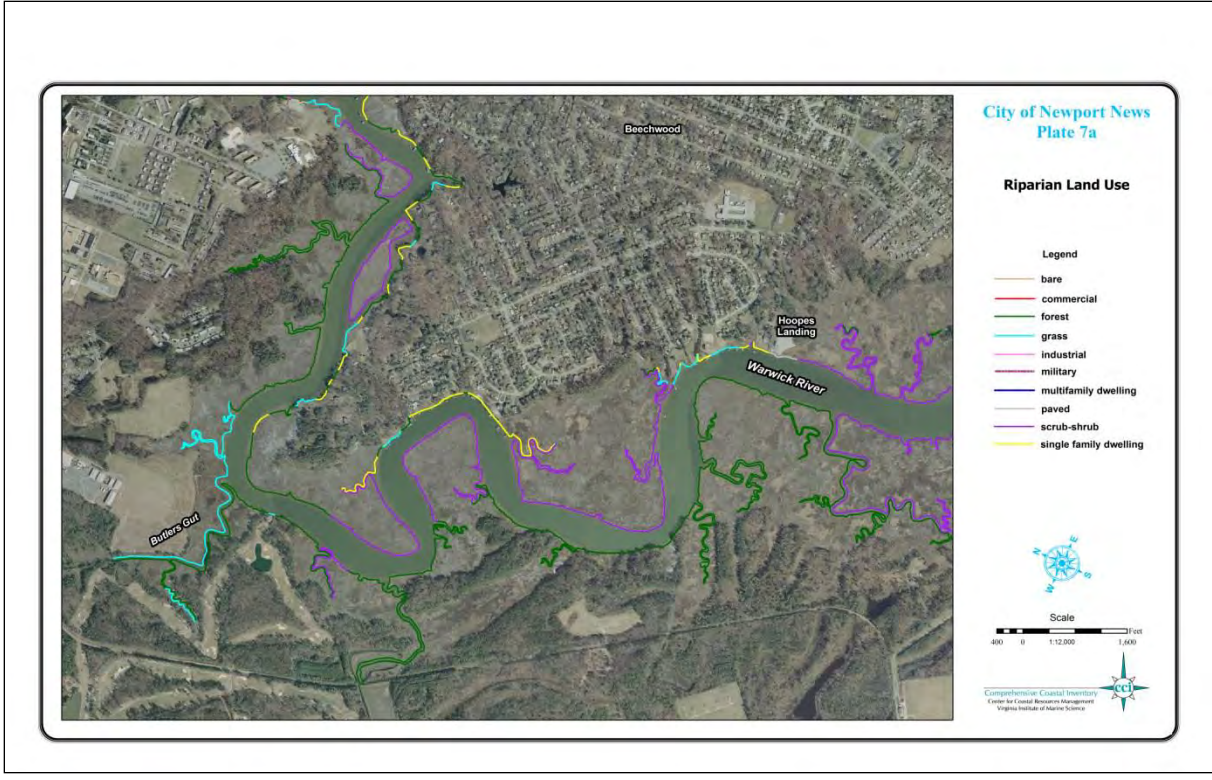
Figure 6. Sample riparian land use map for the City of Newport News

2.2a) Riparian Land Use: Land use adjacent to the bank is classified into one of thirteen classes (Table 1). The classification provides a simple assessment of land use, which provides insight to land management practices that may be anticipated. GPS is used to measure the linear extent along shore where the practice is observed. The width of this zone is not measured. Riparian forest is considered the primary land use if the buffer width equals or exceeds 30 feet. This

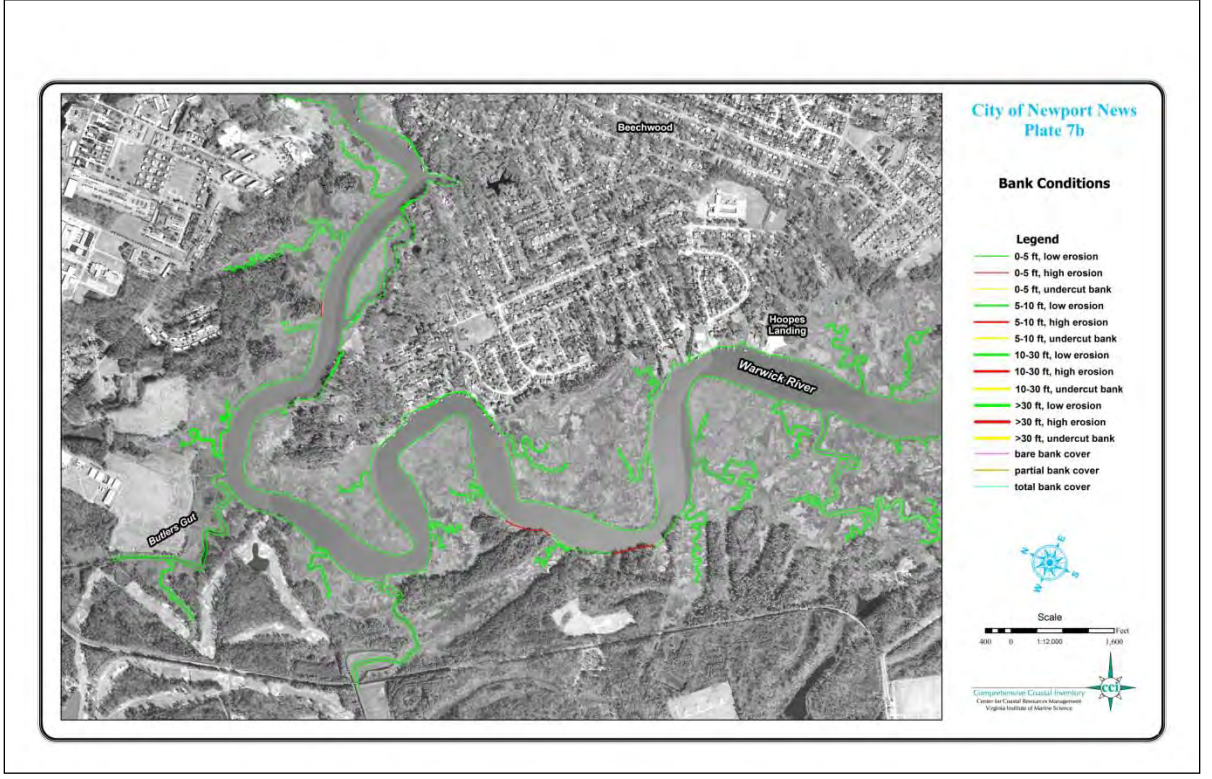
Figure 7. Map illustrating bank conditions for plate 7 in the City of Newport News

Plate B depicts the condition of the bank; specifically bank stability, bank cover, and bank height. The colors light green, red and yellow are used to report if the bank presents low erosion, high erosion, or undercut, respectively. The thickness of the line reflects the bank height; where the thickest lines designate the highest banks (> 30 feet). The bank cover is

Once you determine which plate you want, the scroll down menu on the left has links to the four part series for each plate (Figure 5). At the top of the scroll bar Riparian Land Use (plate a) is first. You can scroll down to see links to maps illustrating Bank Conditions (plate b), Shoreline Features (plate c), and Natural Buffers (plate d). The content and details of the four part plate series was described in detail in Chapter 2. The actual map will come up when you click on the plate number. For example, Figure 6 is the riparian land use map for plate 7. Figure 7 is the map illustrating bank conditions for plate 7. Figure 8 shows all the shoreline features for that same area, and Figure 9 the natural buffers associated with that section.

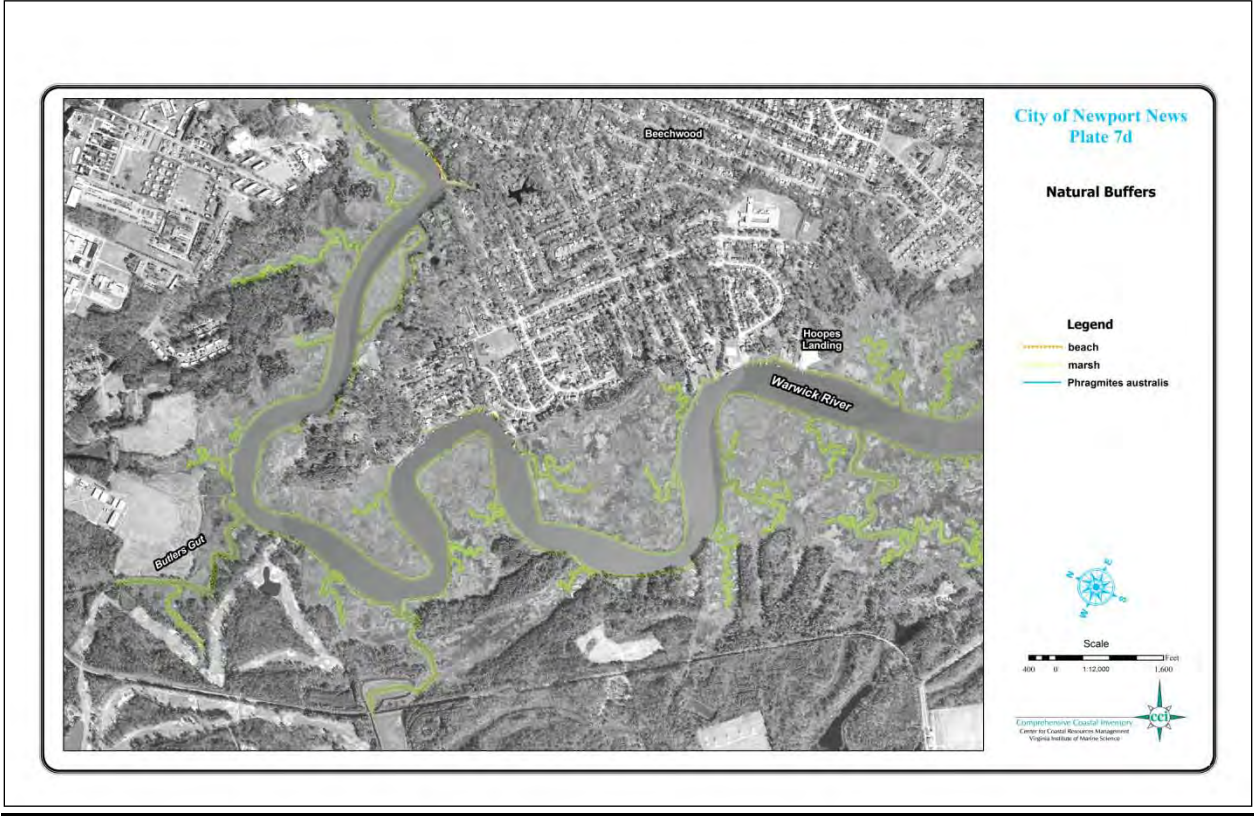
Figure 9. Map illustrating natural buffers for plate 7 in the City of Newport News

On Plate D, a pattern of small colored circles along the shoreline describes any natural buffers present. These are limited to marshes and beaches. Orange solid circles represent the presence of beaches and green open circles represent marshes. The presence of the invasive species *Phragmites australis* is designated with a blue line shown behind the shoreline.
