## Occohannock on the Bay Living Shoreline Project

# Occohannock on the Bay Living Shoreline Project

*Shoreline Studies Program  
Virginia Institute of Marine Science  
William & Mary*

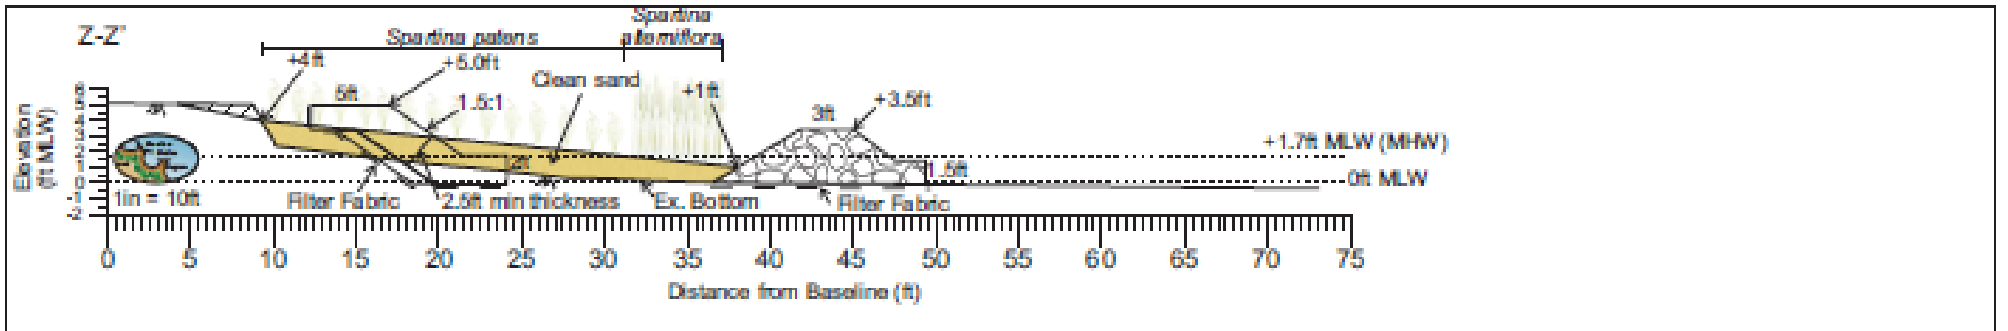
Reach 1  
Sill 1

# Typical Cross-Sections

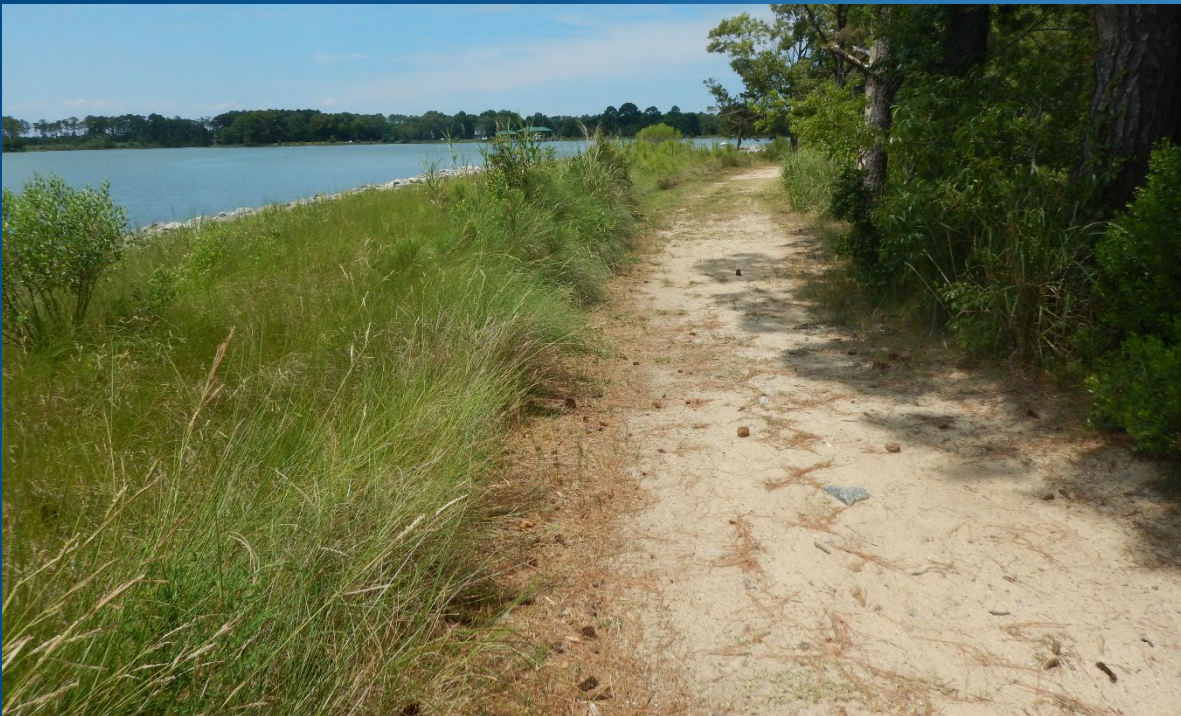
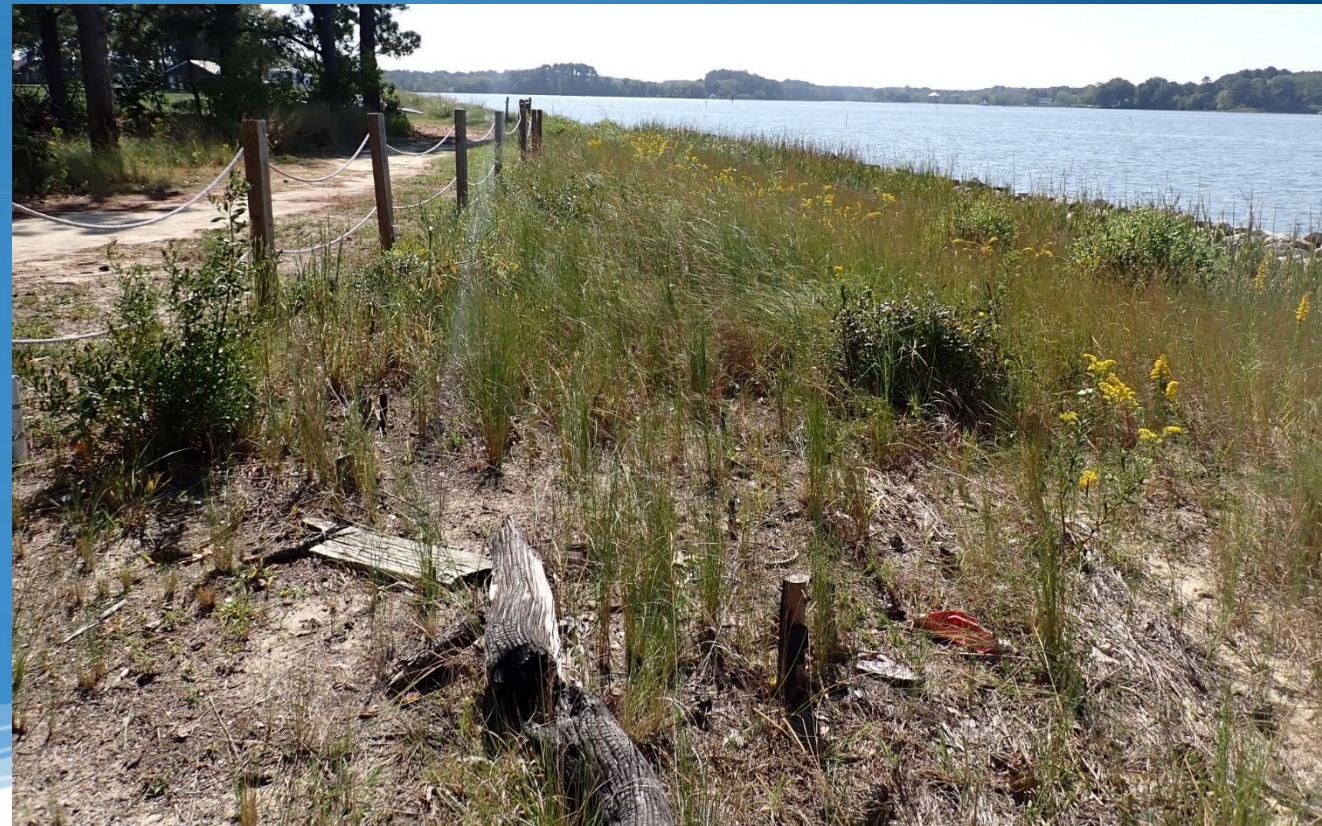
Maintenance: Salt bush and small pines were growing along backshore and low bank when we visited for a monitoring survey of the site. We reminded the property owners of needed maintenance to ensure that the marsh continues to thrive. After 10 years, the property has been maintained by removing small trees (<1 inch diameter.)

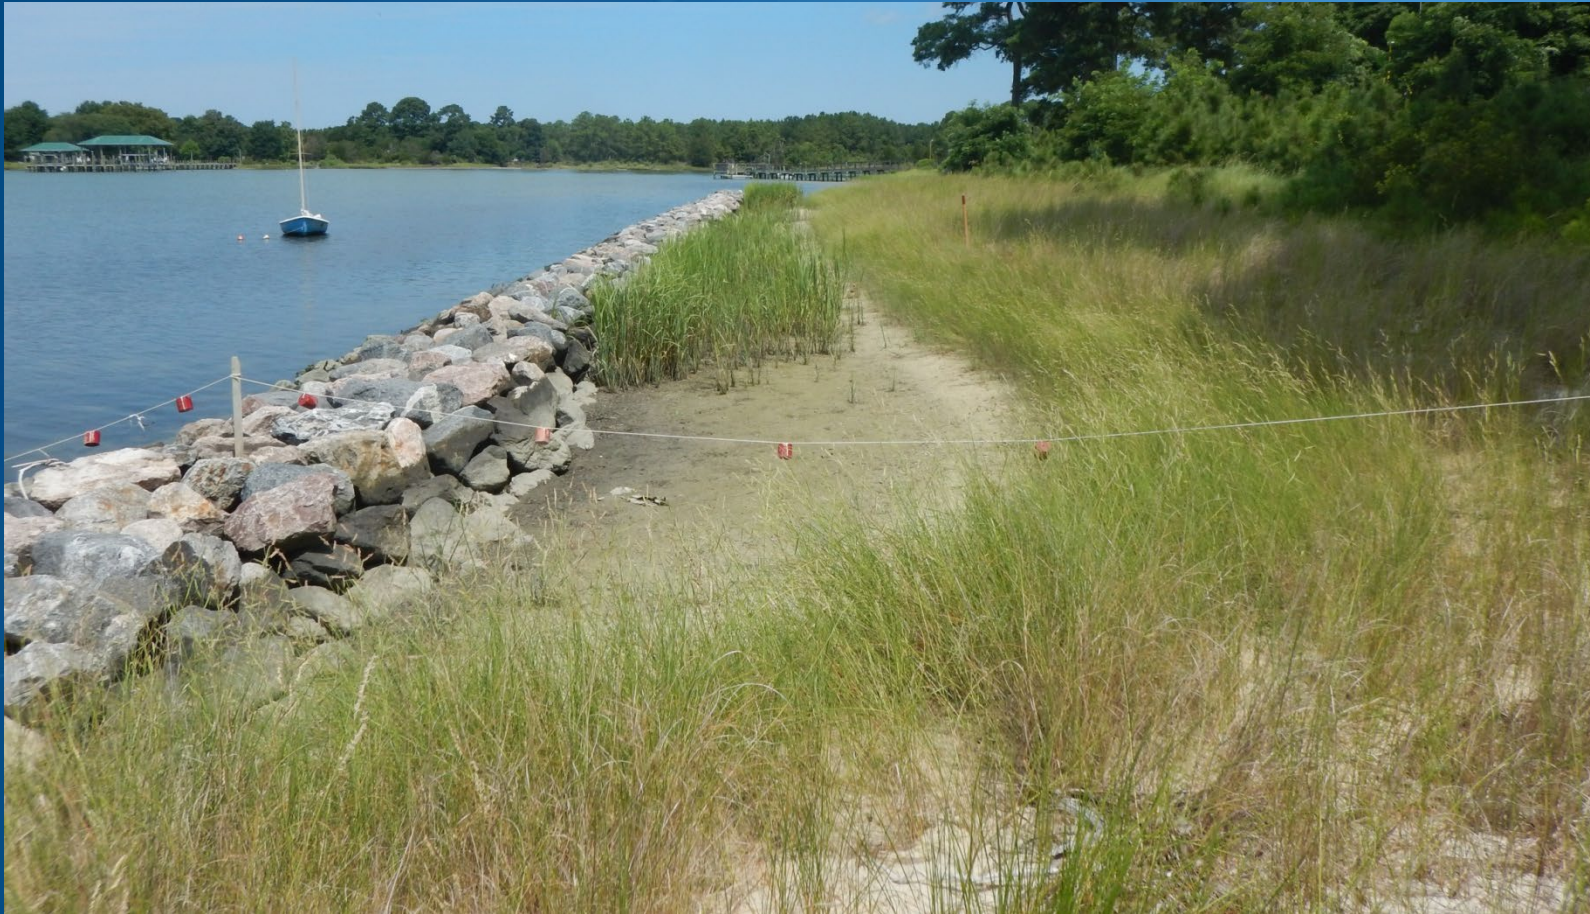
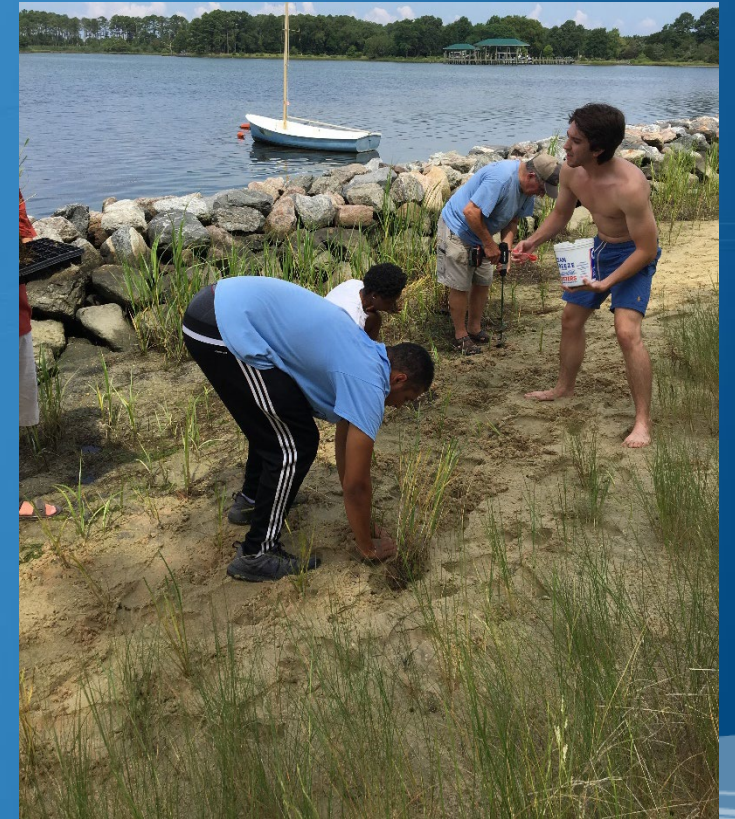
*During a site visit, a bare spot was noted. It was replanted by volunteers later that summer and has filled in very well in the last 6 years.*

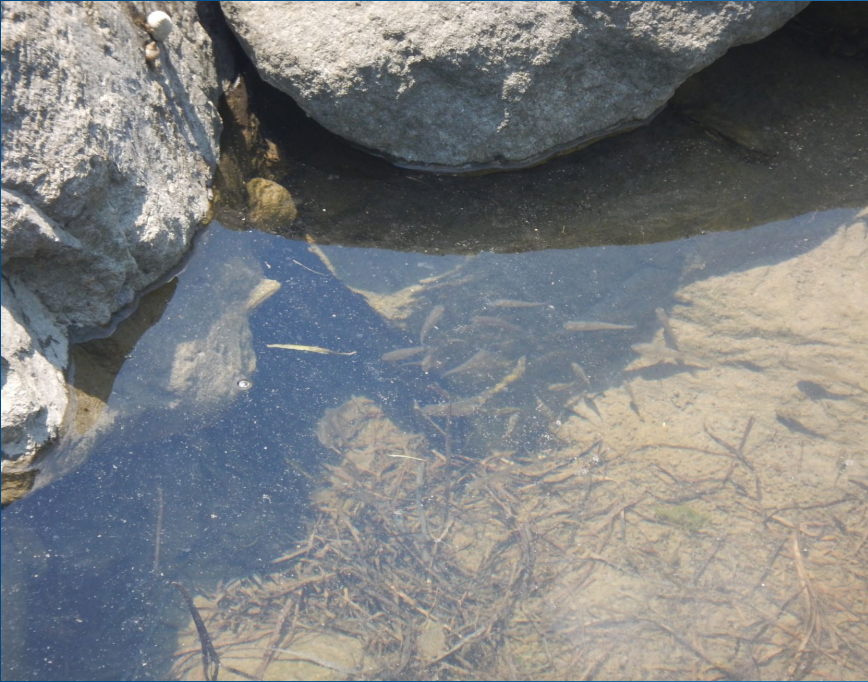
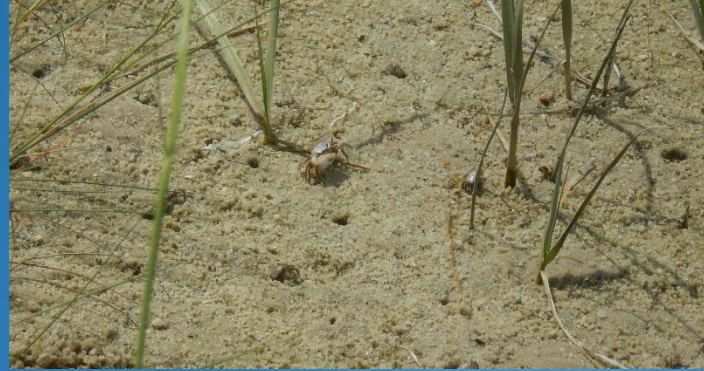
Shellfish growth on the rock sills; faunal usage of the marsh; and small fish utilization along sill structures at high water.

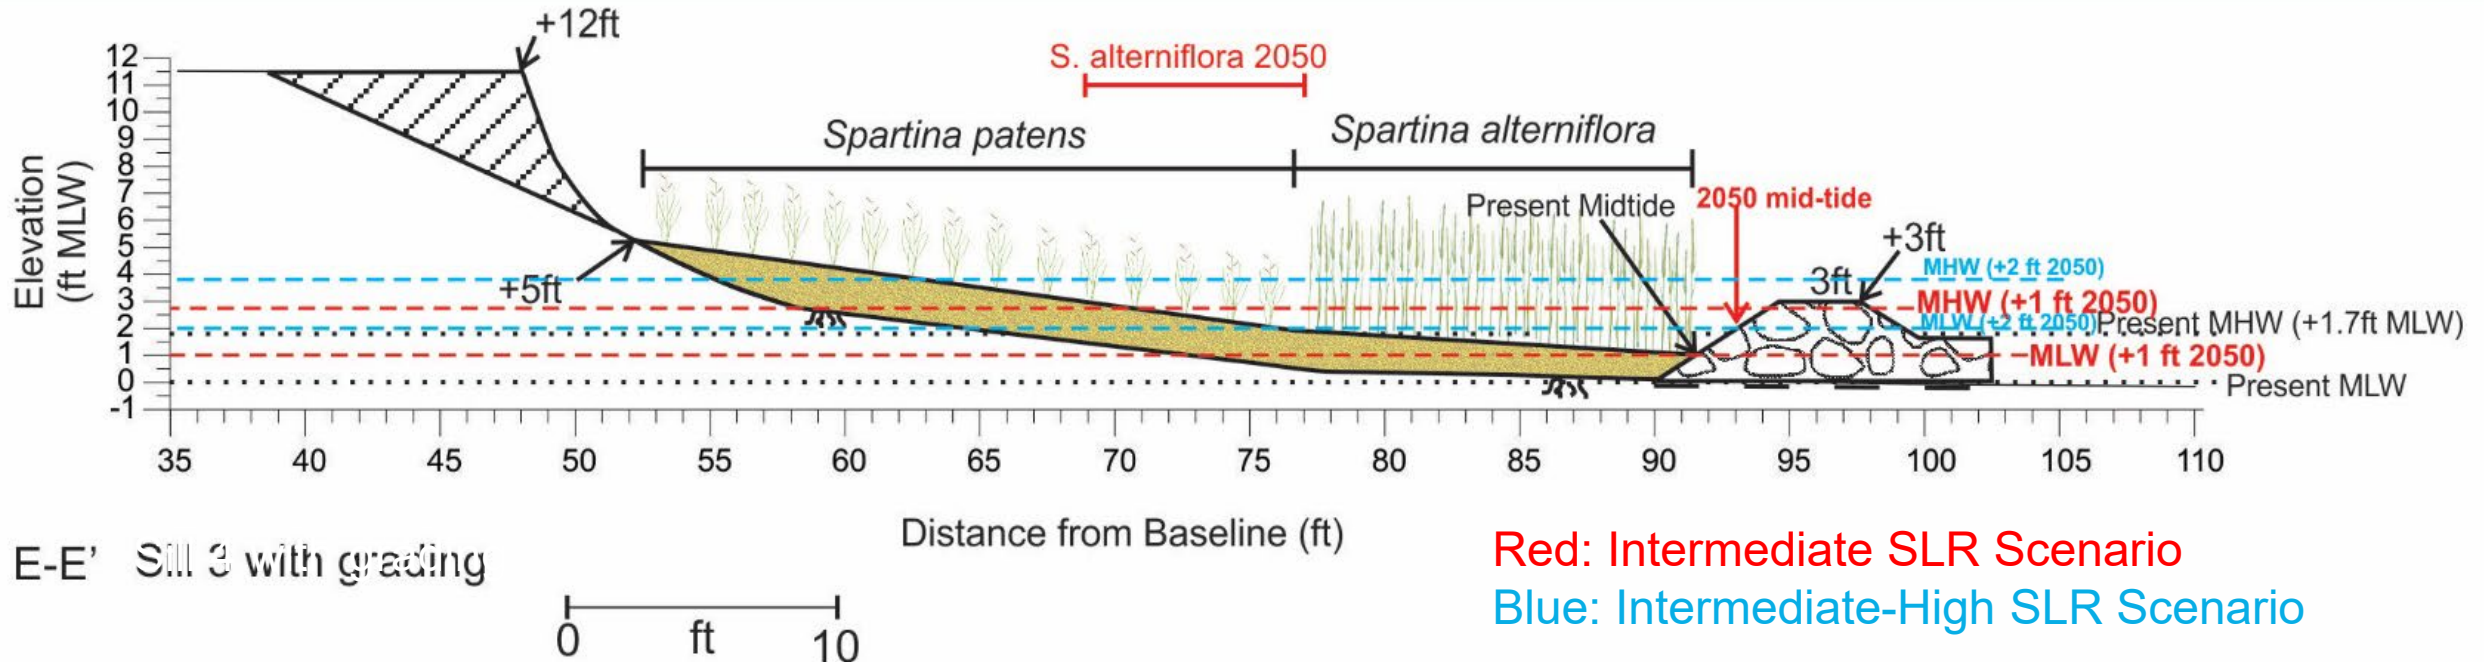
By overlaying SLR parameters onto the existing shore conditions, we can show how SLR will impact the site.

- A non-vegetated wetland will develop immediately landward of the sill where the existing low marsh is.
- Low marsh will migrate into the existing high marsh.
- High marsh will be able to migrate up the graded slope.
