Mattanock Town Restoration Plan

A capstone project in partial fulfillment of the requirements for the degree of Master of Arts in Marine Science at the Virginia Institute of Marine Science, William & Mary

Using Mattanock Town's historical land use to understand the property's current conditions to implement a holistic approach to restoration.

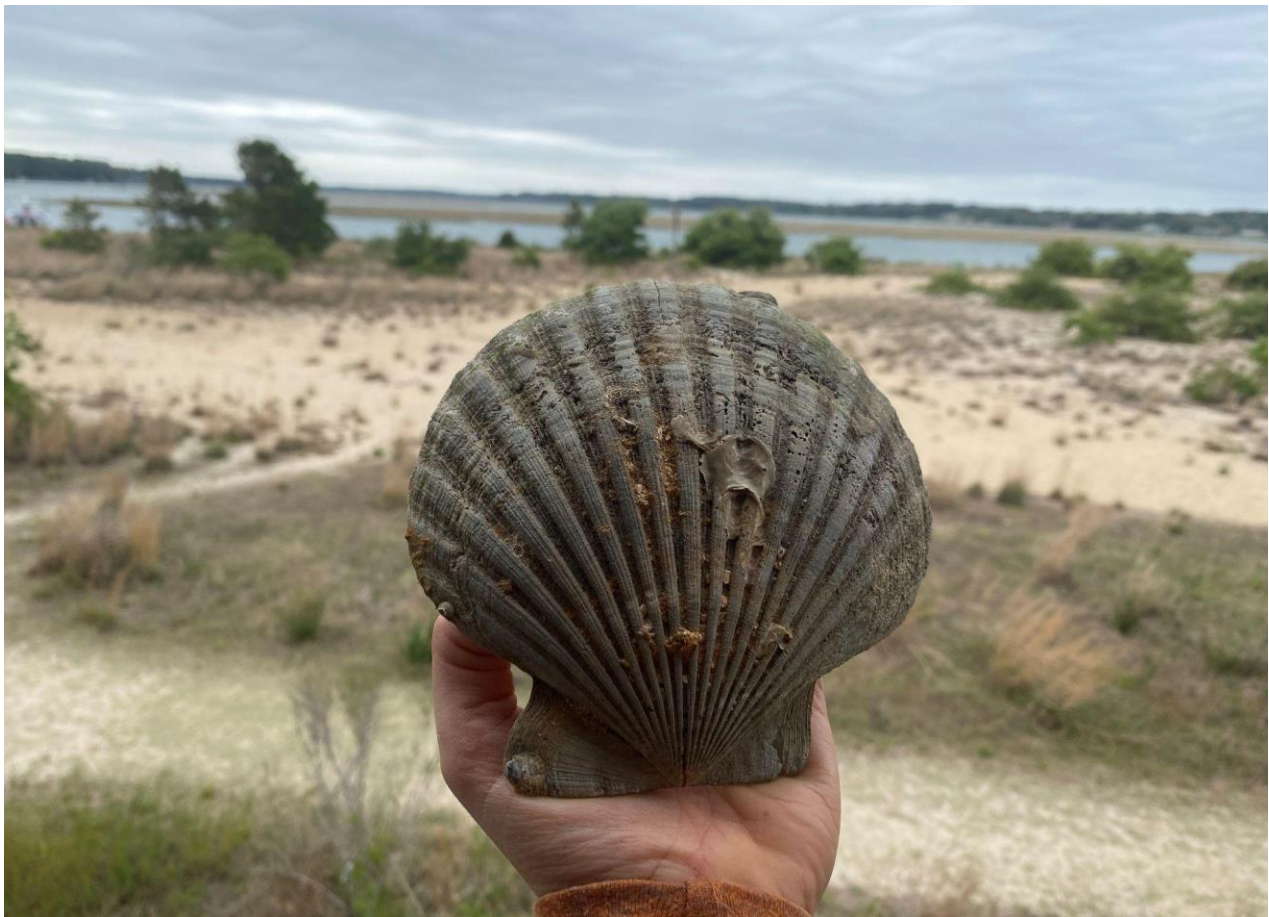
Figure 2: *Chesapecten jeffersonius* found along the shoreline at Mattanock Town. K. Grigsby, 2021

Chesapecten jeffersonius, a scallop species, dominated the Churchland Flats during the Miocene into the Pliocene period (23.03 to 2.58 million years ago) (Donohue, 2016). *Chesapecten jeffersonius* fossils are found along the shoreline at Mattanock Town and are so common in the tributaries of the Chesapeake Bay watershed that they are now Virginia's state fossils (Donohue, 2016) (Figure 2).

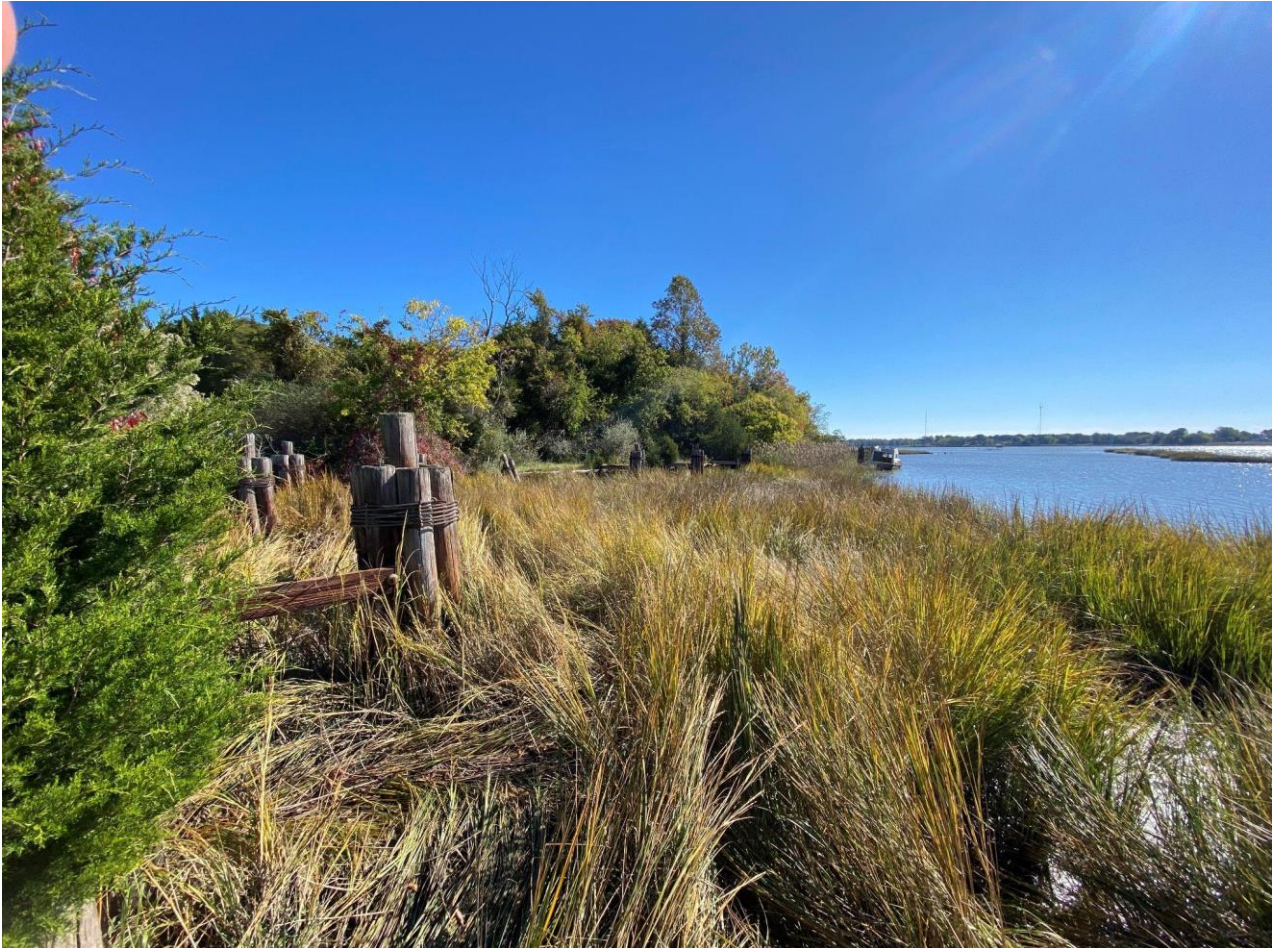
Figure 4: The remaining harbor and pilings from the Lone Star Cement Corporation. K. Grigsby, 2022

In 1971, the EPA shut down the mine operation due to its unregulated and dangerous practices (Drex, n.d.). Once Lone Star shut down, the City of Suffolk took possession of the property and turned a portion of it into a public park. However, the city did little mitigation to remedy the impacts on the land and the surrounding waterway. Because of this, evidence of the historical land use (both positive and negative) can still be seen upland and along the shoreline (Figure 4).

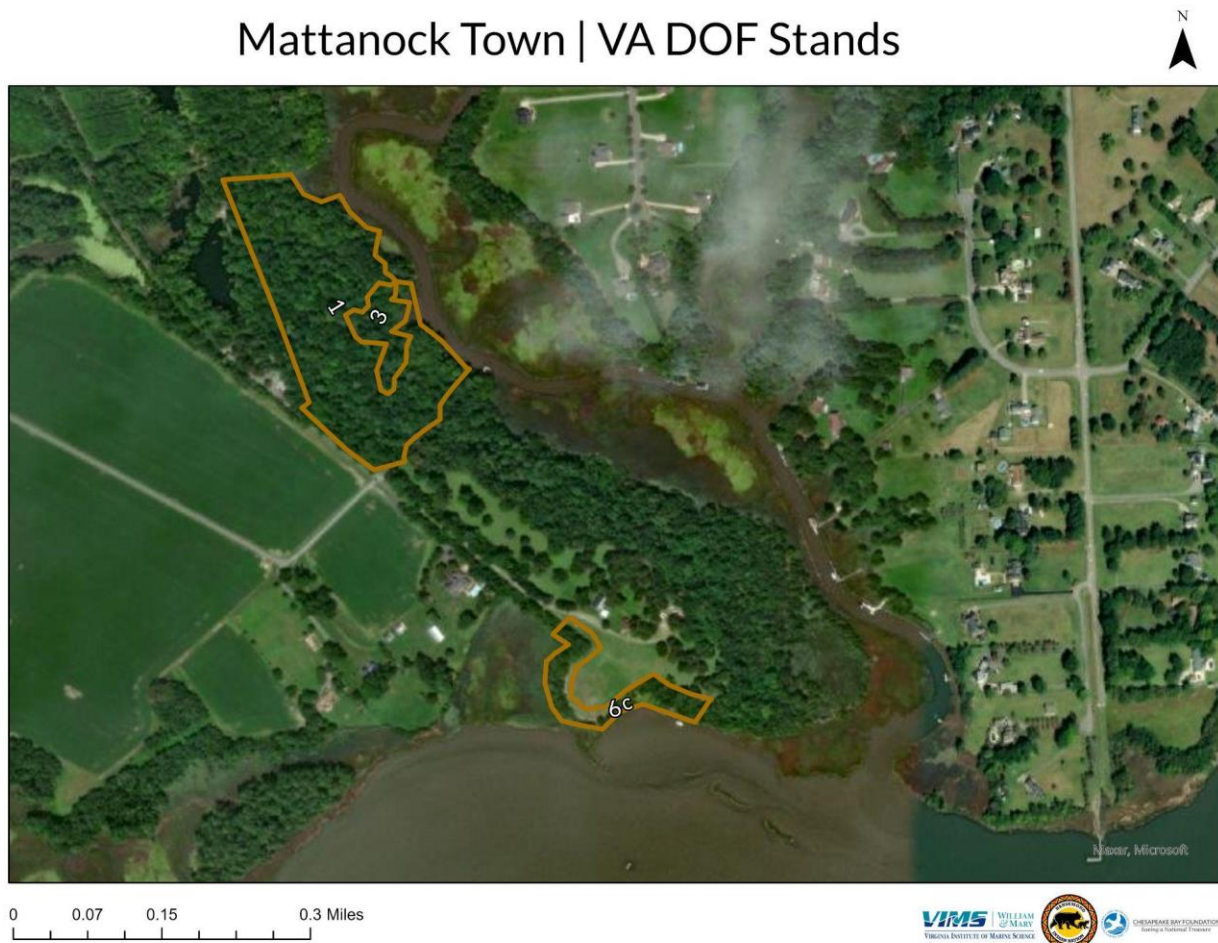
Mattanock Town | VA DOF Stands

Figure 6: Overview map of Stands 1, 3, and 6c that Mattanock Town's Restoration Plan focuses on (Grigsby, 2021, VA DOF Stands).

It is considered the first line of defense in protecting local water bodies from agricultural and industrialized areas' stormwater runoff (USDA National Agroforestry Center, 2012). Knowing that the mine operation impacted this critical habitat at Mattanock Town, the NIN worked with the Department of Forestry to develop an *Urban Forest Management Plan* for the site (Topping, 2021). This plan focused on analyzing the forest's health by taking an inventory of the native and invasive plant population, the age of the trees, and the tree size. In addition, it identified any potential fire hazards and future issues that could occur if not adequately addressed. Once an inventory of the site was complete, borders were drawn using ArcGIS around similar vegetative types. These zones are called stands, and the *Urban Forest Management Plan* uses them to organize the recommended approach for restoration. This data analysis will focus primarily on Stands 1, 3, and 6c due to their vulnerability to sea level rise, the high invasive plant population and the most opportunity for cultural engagement (Grigsby, 2021, VA DOF Stands) (Figure 6).

Stand 1 is 15.4 acres and consists of native trees such as *Liriodendron tulipifera*, *Platanus occidentalis*, *Acer floridadum*, and *Ulmus americana* (Topping, 2021). *A. floridadum* and *U. americana* are rare in our region (Topping, 2021). In addition, a *Quercus rubra*, with a “diameter of 57” at breast height,” is the largest observed tree on the entire property (Topping, 2021). Although the canopy is relatively healthy

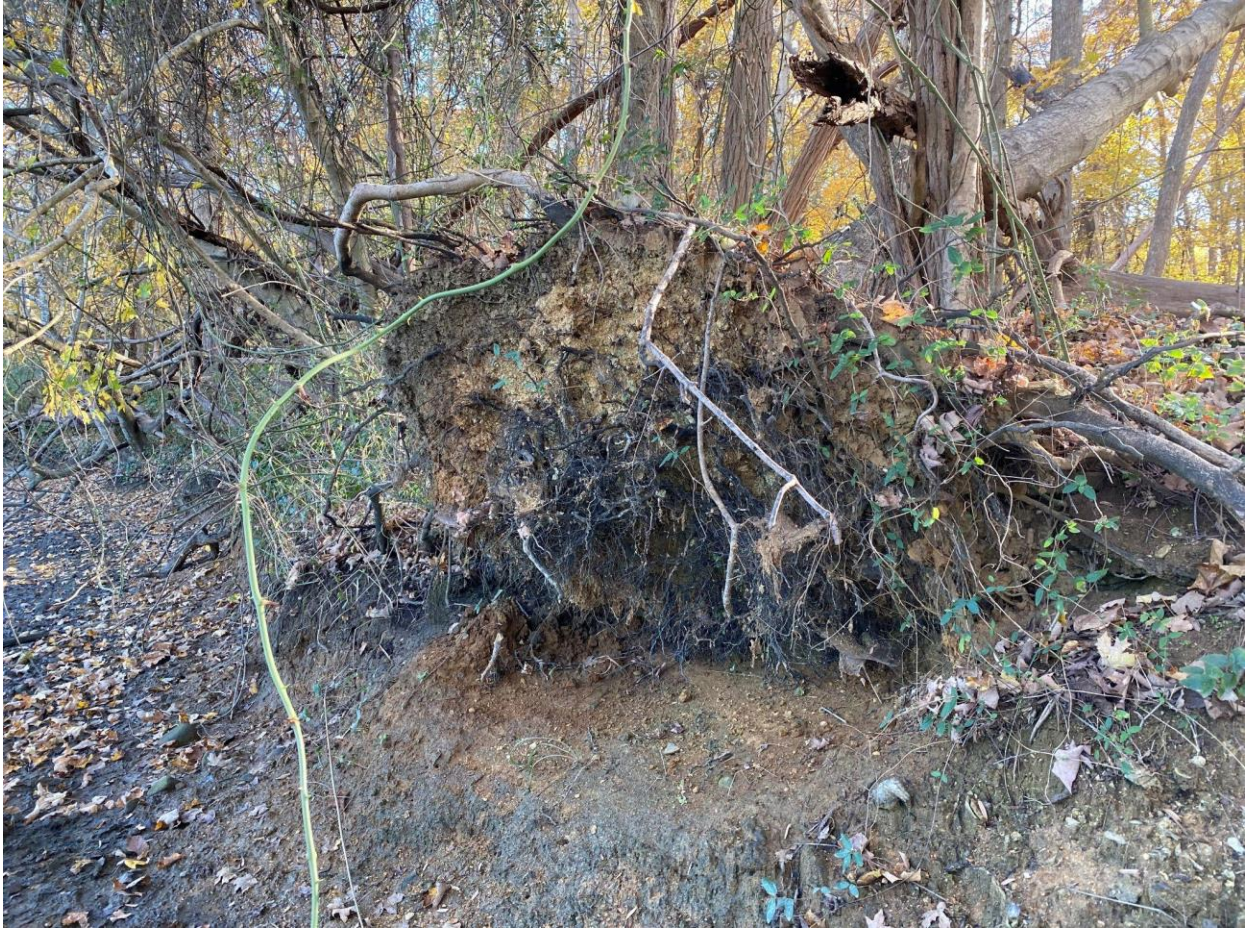
Figure 12: Fallen tree along the eroding mine berm at Site 1. K. Grigsby, 2021.

Due to *C. jeffersonius* layered within the berm's sediment and secondary successional growth on top of the berm's ridge, Lone Star Mining Company likely dug out the pit and left the edge to create a natural barrier. Historical maps show that tidal wetlands present at Site 1 were relatively narrow even before Lone Star (Marshau et al., 1919). The increased activity and potential dredging of Cedar Creek by the mine operation likely eradicated the wetland vegetation along this stretch of shoreline. The lack of fringe marsh made the berm more susceptible to erosion and compromised the stability of the tree roots, which increased their likelihood of falling during storm events. As the trees fall, the root ball dislodges a large chunk of the bank, causing erosion along the berm (Figure 12).

In addition to the increased erosion rate, the fallen trees also shade out this section of shoreline and cause a steep grade to form along the berm (US Geological Survey, 2022). Most native and non-native plants within tidal wetlands require full sun exposure and a gradual slope to prosper. *Spartina alterniflora*, the most common salt marsh plant species in the low marsh zone, has a growing range determined by tidal inundation and by the slope of the shoreline. The growing range is typically from above MLW to Mean High Water (MHW) (Smith et al., 2015), and the target grade is 3:1 or flatter (Hardaway et al., 2017). Site 1's suitable growing range for *S. alterniflora* is 0.5 meters to 2.99 meters above MLW (US Geological Survey, 2022; VIMS, 2021). However, the area is completely shaded (Angstadt, 2022, Spring Drone Orthoimagery).

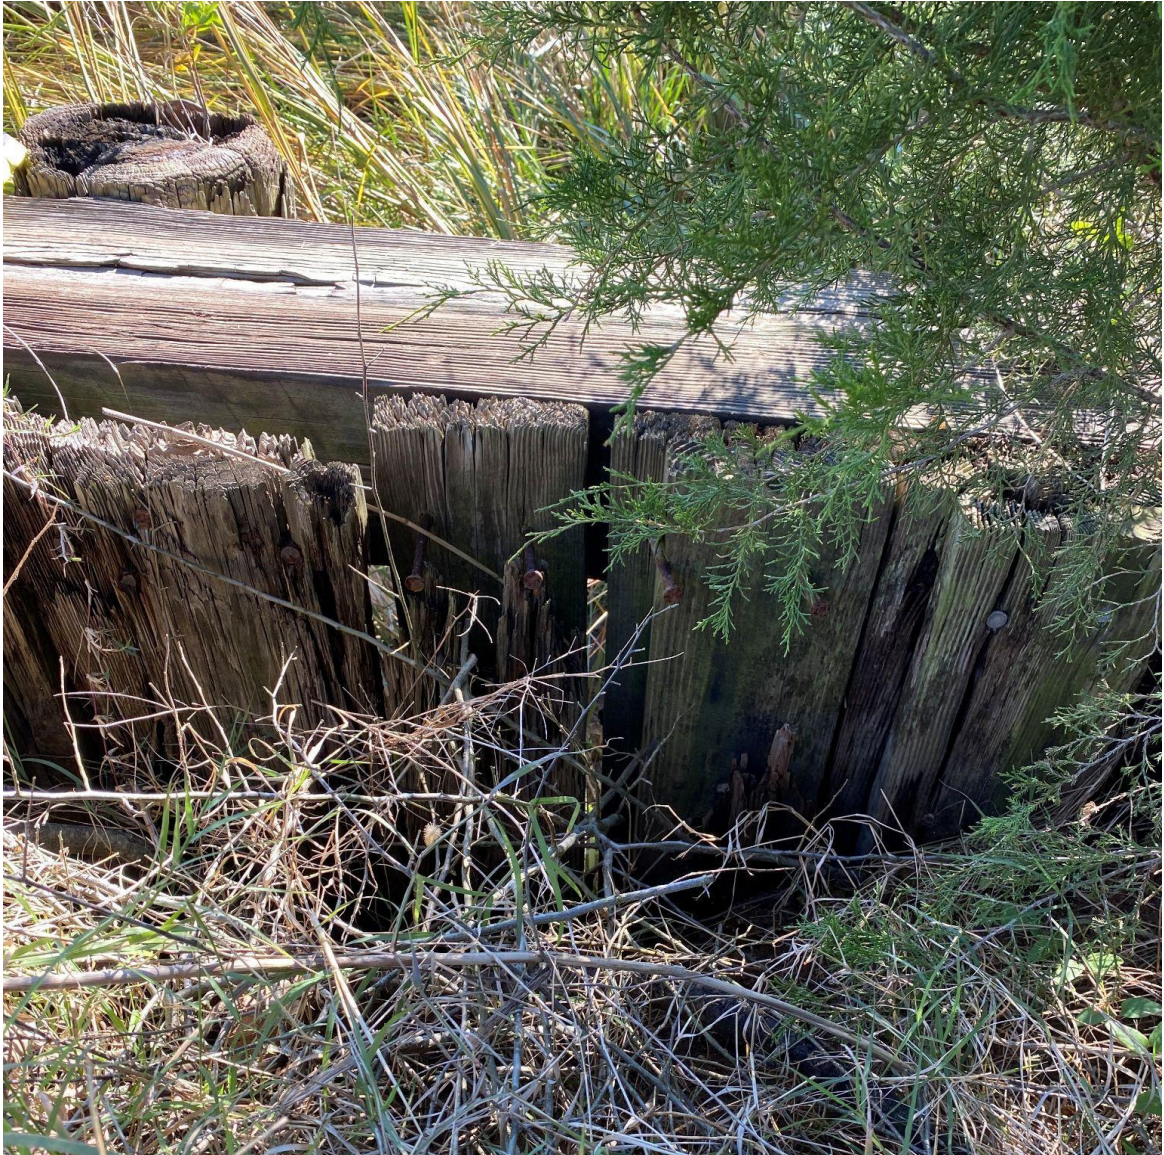
Figure 13: Pit that formed behind the dilapidated bulkhead at Site 2. K. Grigsby, 2022.

At Site 2, a dilapidated bulkhead still exists, and although it is currently stabilizing the bank, it has gone without routine maintenance since the closing of Lone Star in 1971. Without regular maintenance, bulkheads develop pits on the landward side of the structure. These pits result from the bulkhead deflecting the wave energy, causing undercutting at the base, which leads to holes at the bottom of the structure. As these holes become more prominent, water erodes the land behind the bulkhead, causing pits to form (Figure 13). These pits will become more prominent with an increase in sea-level rise, and Site 2 will start to see impacts to the shoreline with just a meter increase (HRPDC, 2018).

However, a *Spartina cynosuroides* dominated marsh has formed channelward, stabilizing the shoreline and is likely slowing down the bulkhead's degradation (Grigsby, 2022, Mattanock Town Tidal Marsh

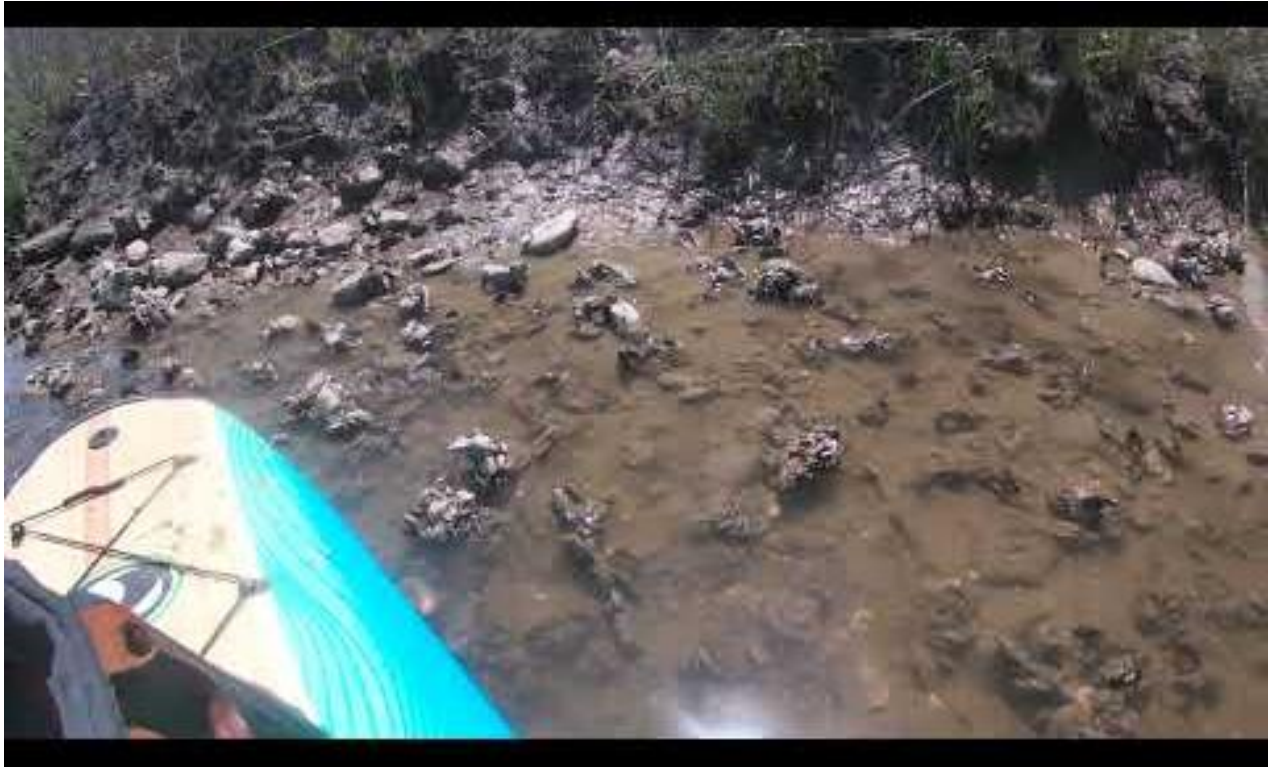
Figure 14: Benthic biomass present along Cedar Creek at Mattanock Town. K. Grigsby, 2022

Suitable site conditions for an oyster sill structure (constructed of bagged oyster shell or concrete reef structures) include salinity above eight PPT, a firm bottom, adequate inundation, and low to moderate energy settings (Chesapeake Bay Foundation, 2020). However, the presence of an existing oyster population is the best determinant of oyster viability (Chesapeake Bay Foundation, 2020). A small wild oyster population is present within Cedar Creek adjacent to the floating dock, where large stones are present along the shoreline (Figure 14). While there is little evidence of an oyster population directly along the shoreline at Site 1, the lack of substrate for oysters to settle on could be a limiting factor since they are present directly downstream.

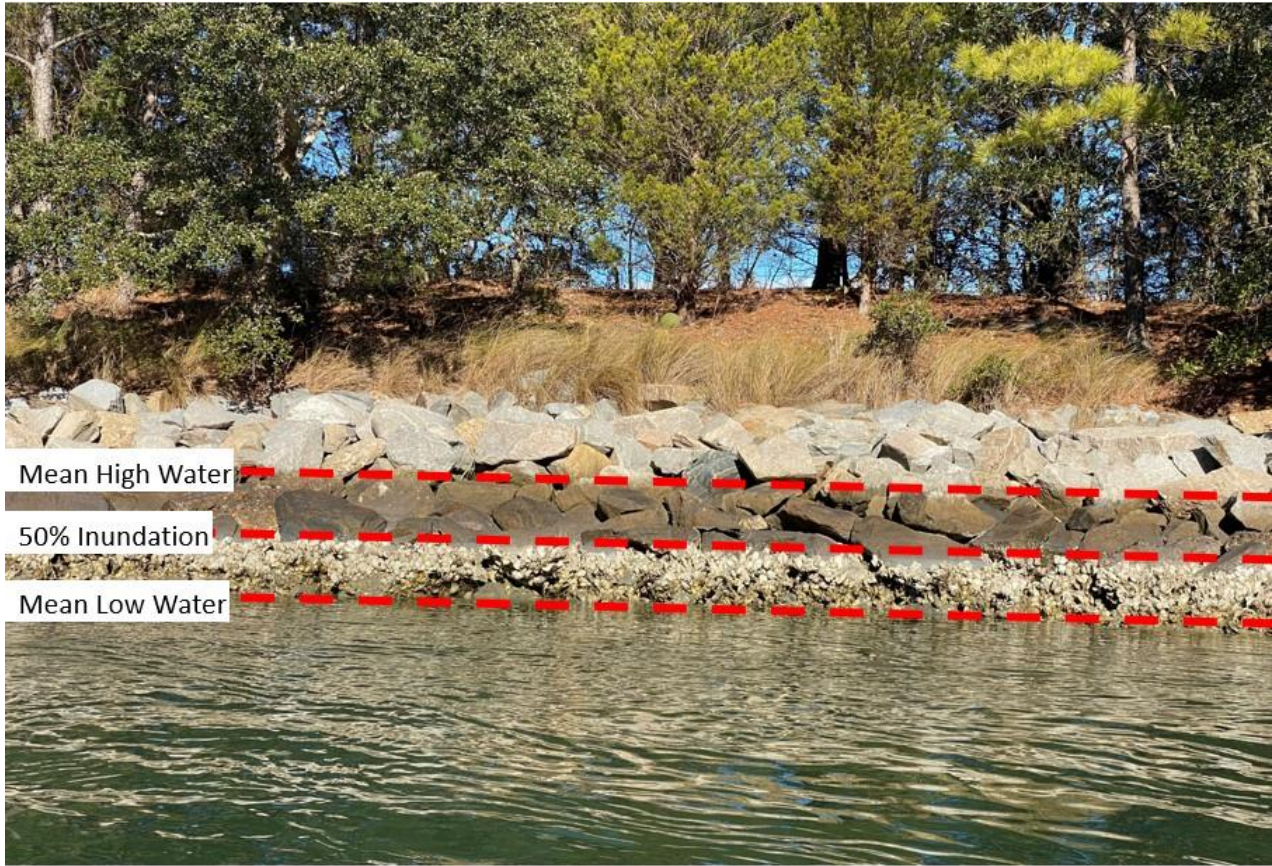
Figure 15: Showing the threshold of oysters growing range between MLW and MHW. This image was taken on the Lynnhaven River. K. Grigsby, 2023.

A critical threshold for intertidal oyster reef establishment is 50% inundation duration (Morris et al., 2021) (Figure 15). Studies show that as freeboard decreases, wave attenuation decreases (Morris et al., 2021). In this case, compensating crest height with crest width may provide the requisite wave attenuation goals (Morris et al., 2019). Additional research is needed to determine the ratio between the wave crest height and the width of the sill structure. The marsh islands adjacent to Site 2 may be suitable for gathering this information. However, the nearshore depth and sediment composition are still needed to determine if this is an appropriate test site.

In low-energy environments, such as Site 1, achieving the target inundation is attainable since the goal of the sill structure is to mimic the natural environment rather than attenuate the wave energy. *Spartina alterniflora*'s lowest elevation in the adjacent marsh or along the existing shoreline determines the crest height of sill structures in low-energy environments. The mean tide range is slightly over a meter above MLW (VIMS, 2021). To achieve target inundation, the sill height at Site 1 should not exceed 0.5 meters, and *S. alterniflora*'s lowest average growing elevation is 0.5 meters above MLW (US Geological Survey, 2022; VIMS, 2021). Based on these calculations, the shoreline at Site 1 can reach target inundation while simultaneously stabilizing the shoreline.

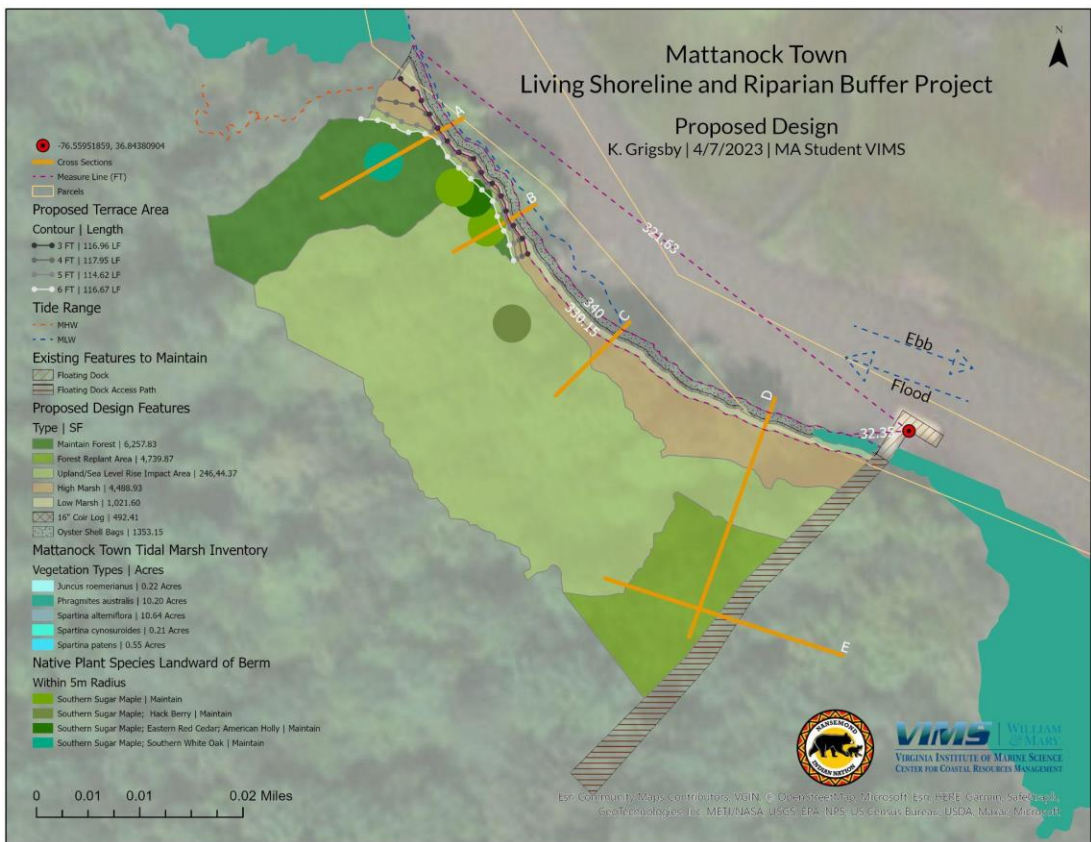
Figure 23: Map created to illustrate the proposed project design. K. Grigsby, 2023.

Topping, 2021). However, rare native trees are landward of the berm and within the project footprint (Grigsby, 2022, Upland Plants Species Along Berm; Topping, 2021). The proximity to the proposed project area and grading could negatively impact the health of these tree species (Figure 17). Permitting agencies will require contractors to implement practices to ensure minor damage. That said, most species marked “Impacted” will be damaged or removed during grading (Figure 17). In that case, mitigation measures will be required by the Suffolk Wetlands Board. Since this is a likely scenario if a living project occurs, a replanting area is proposed in the final conceptual design (Figure 23).

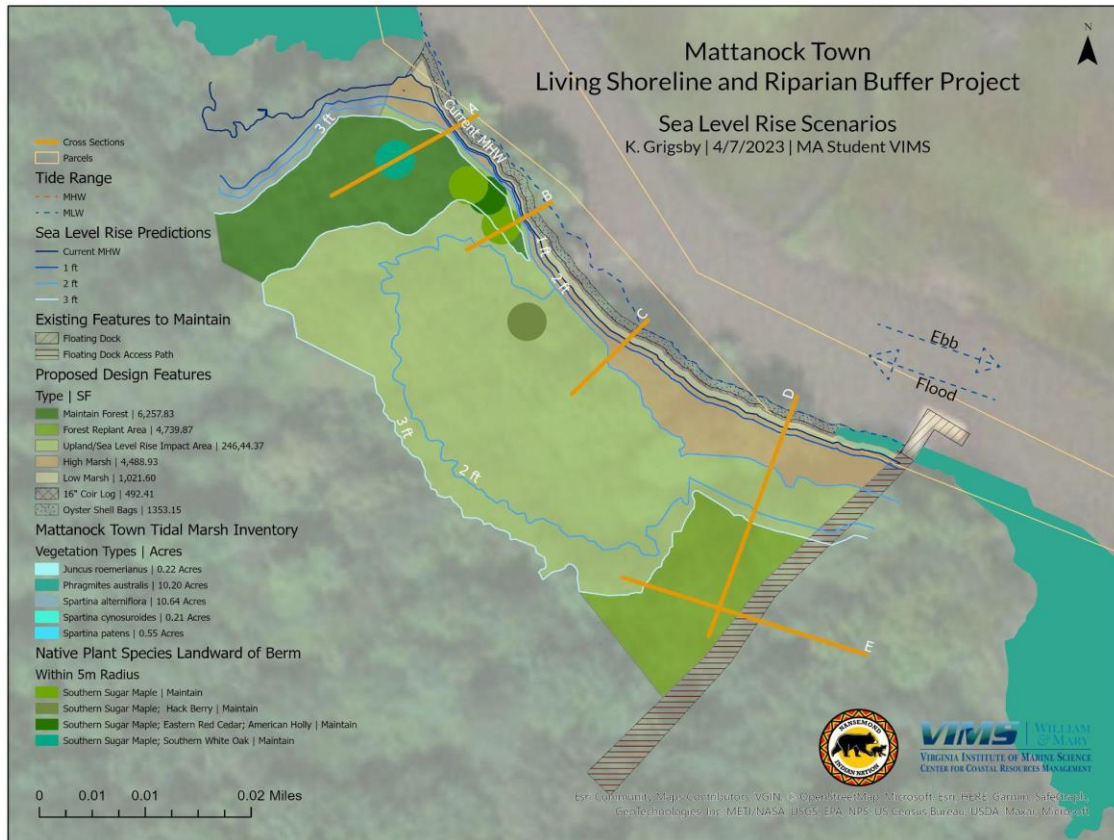
Figure 24: Map created to illustrate the proposed project design and how sea level rise will impact the upland with the proposed elevations. K. Grigsby, 2023.
