City of Suffolk, Virginia Shoreline Inventory Report Methods and Guidelines

**Comprehensive Coastal Inventory Program
Center for Coastal Resources Management
Virginia Institute of Marine Science, College of William and Mary
Gloucester Point, Virginia
October, 2013**

Special report in Applied Marine Science and Ocean Engineering No. 437 of the Virginia Institute of Marine Science

City of Suffolk - Shoreline Inventory Report

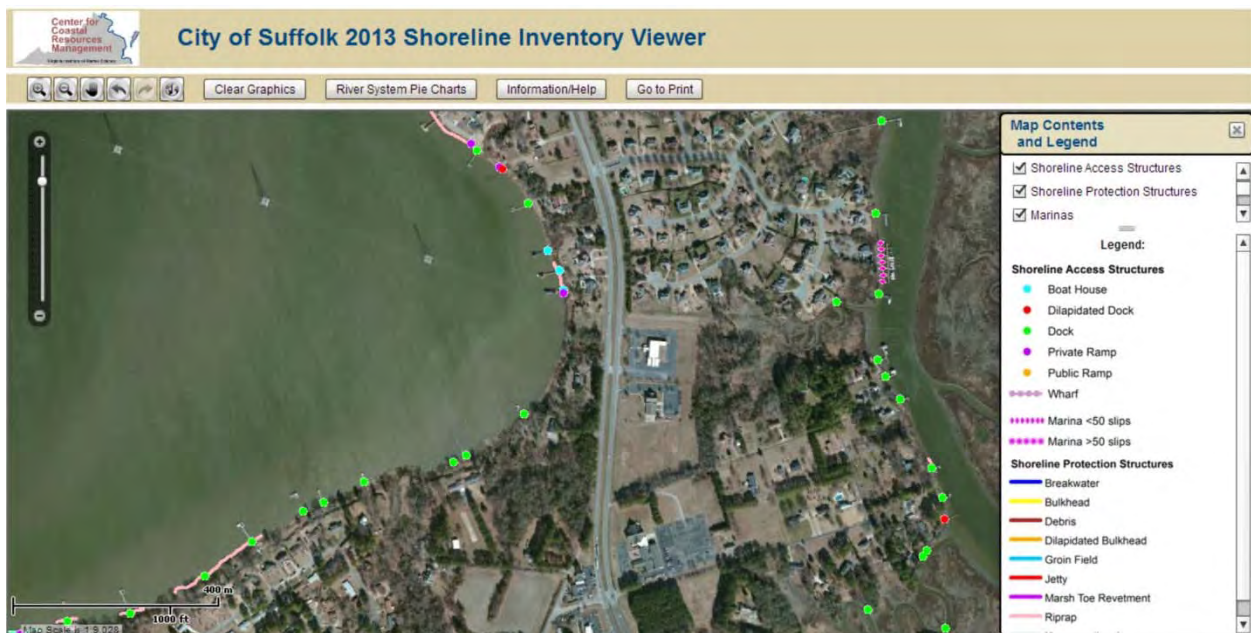
Figure 5. Map Viewer illustrates Shoreline Access and Protection Structures.

In Figure 5 Shoreline Access Structures, and Shoreline Protection structures have been selected along with the boundary. Shoreline Access structures are point features that includes piers and boat ramps. The actual footprint of these structures is not measured; only their location. Shoreline Protection Structures are line features and are mapped and illustrated in the viewer to show where they occur along the shoreline. Figure 6 illustrates riparian land use.

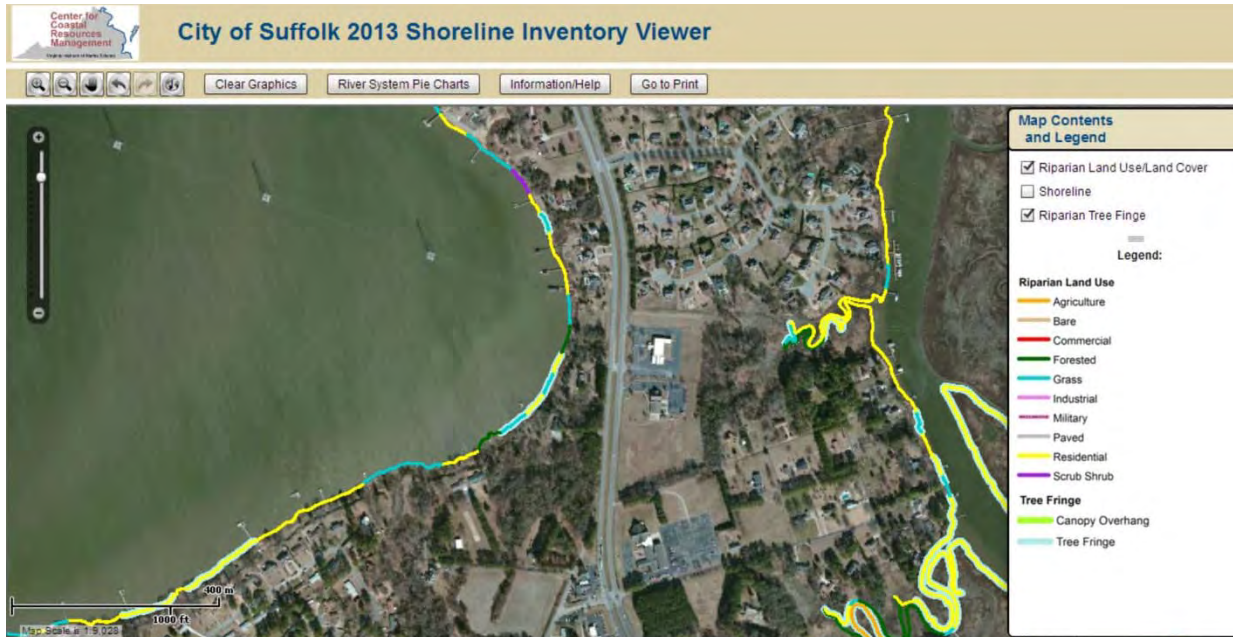
Figure 6. Distribution of land use in the riparian zone is displayed for this region of the City.

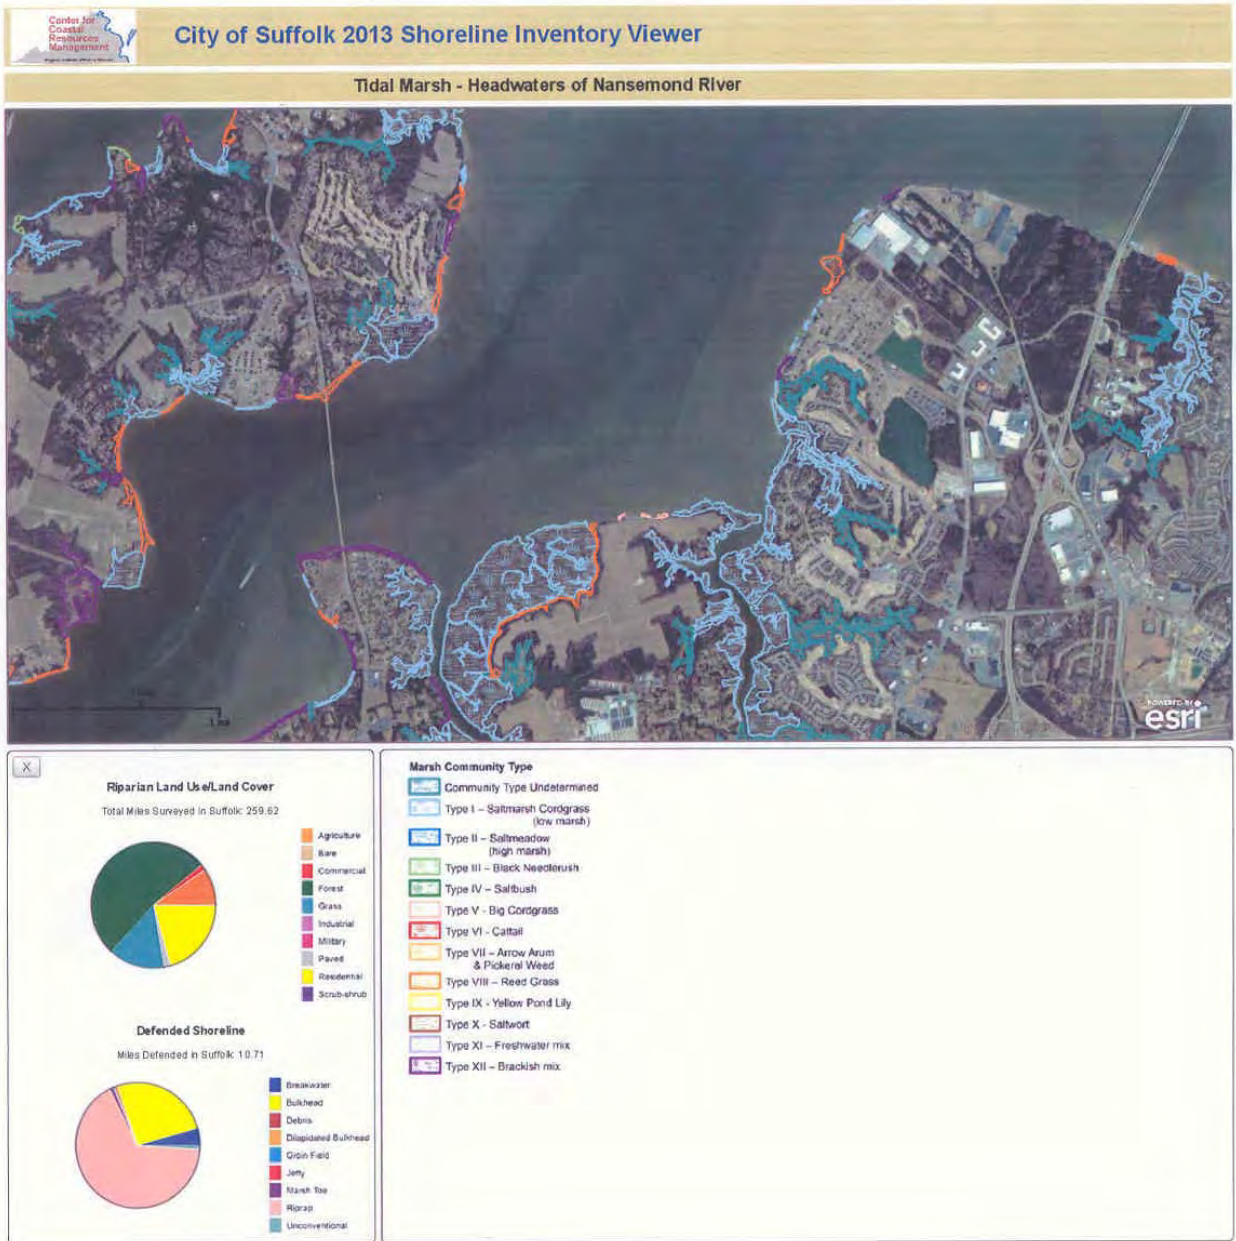
Figure 9. Customized print window for the mouth of Nansemond River.

Finally, users have the option to personalize their own maps (i.e. map extent, data displayed, map title, etc) and print them by clicking “Go to Print” button. The map legend and the charts display below the map. The page is set up for printing to 8.5 x 11 portrait style. Figure 9 is an example of a customized map generated for the mouth of Nansemond River. Here the tidal marsh communities are displayed, and the community type is reported in the legend below the illustration. Also illustrated are the summary pie charts showing land use and shoreline hardening along the entire tributary.
