Gloucester County, Virginia Shoreline Inventory Report Methods and Guidelines

**Comprehensive Coastal Inventory Program
Center for Coastal Resources Management
Virginia Institute of Marine Science, College of William and Mary
Gloucester Point, Virginia
January 2015**

Special report in Applied Marine Science and Ocean Engineering No. 441 of the Virginia Institute of Marine Science

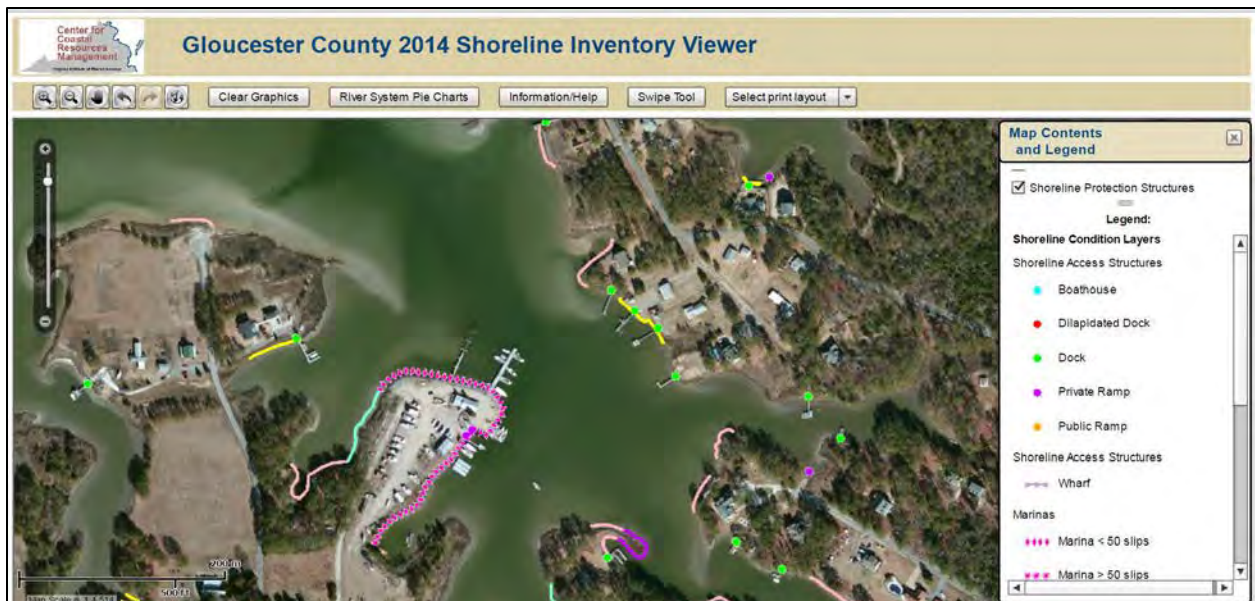
Figure 4. Map Viewer illustrates Shoreline Access and Protection Structures for a section of the County.

In Figure 4 Shoreline Access Structures, and Shoreline Protection structures are selected. Shoreline Access structures are point features that includes piers and boat ramps. The actual footprint of these structures is not measured; only their location. Shoreline Protection Structures are line features and are mapped and illustrated in the viewer to show where they occur along the shoreline. Figure 5 illustrates riparian land use in the riparian zone for the same section of the County.

From the “Map Contents and Legend” the user may check various attribute layers on or off. The user must use the scroll bar on the far right to see the complete list of attributes available. When layers are turned on, the corresponding legend appears in the lower half of the panel, and the data are displayed in the “Map Window” (Figure 4).

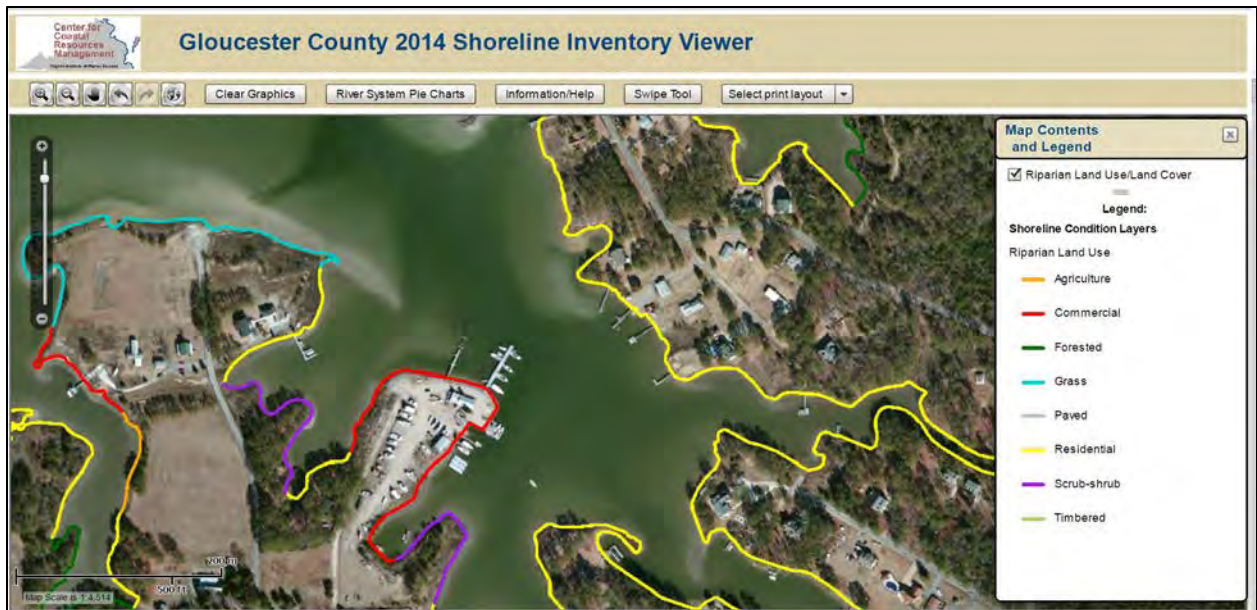
Figure 5. Distribution of land use in the riparian zone is displayed for this region of the County.
