Chesterfield County and the Cities of Colonial Heights, Petersburg, and Richmond, Virginia Shoreline Inventory Report: Methods and Guidelines

Comprehensive Coastal Inventory Program
Center for Coastal Resources Management
Virginia Institute of Marine Science, College of William and Mary
Gloucester Point, Virginia
December 2017

Special report in Applied Marine Science and Ocean Engineering No. 464 of the Virginia
Institute of Marine Science

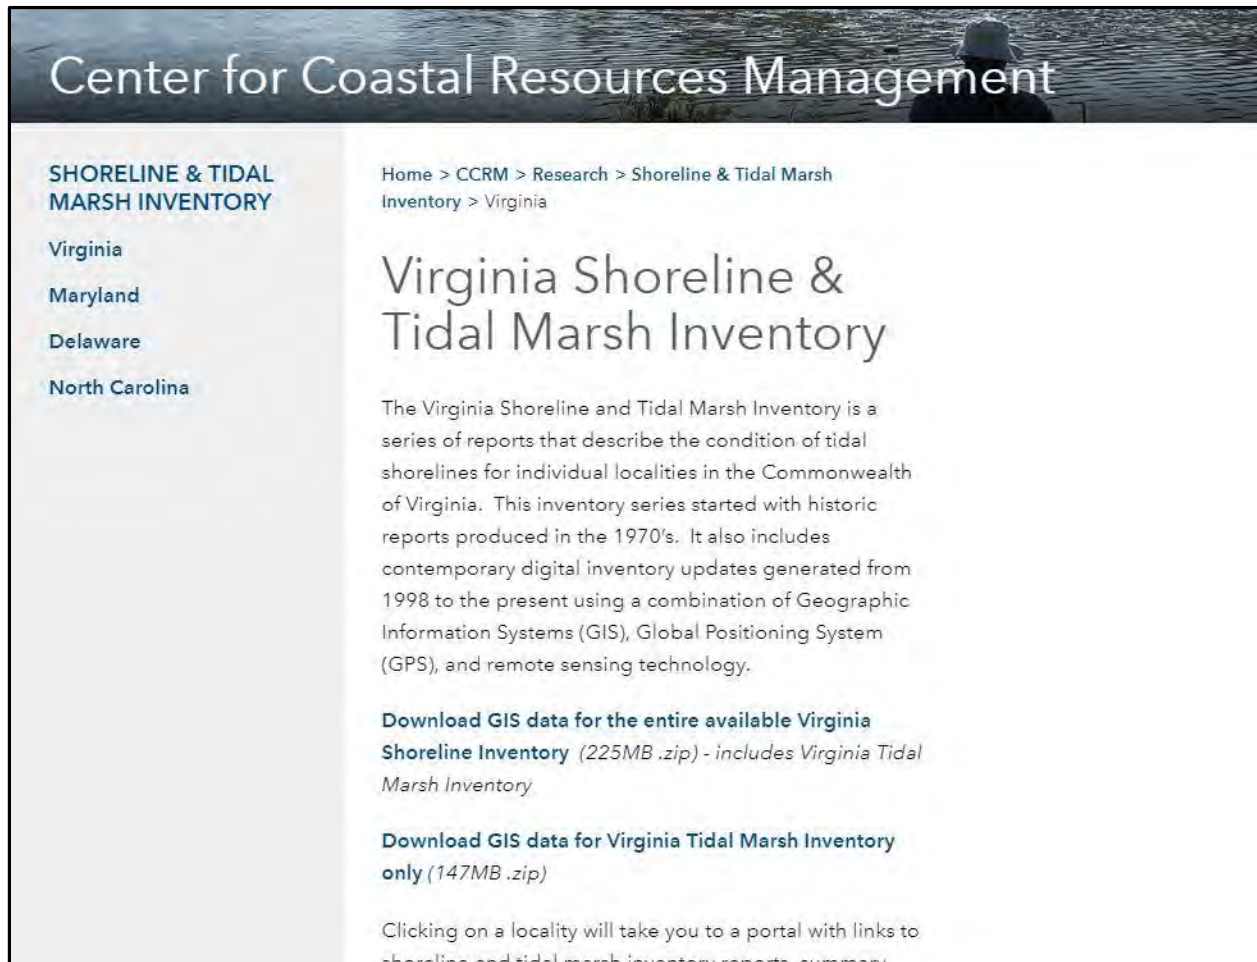
2.4c.) Map Viewer and Summary Tables: The Chesterfield County Shoreline Inventory is delivered to the end user through a website; <http://www.vims.edu/ccrm/research/inventory/virginia/index.php> (Figure 1.), by clicking on Chesterfield County, the City of Colonial Heights, the City of Petersburg, or the City of Richmond in the list of localities. The new format for Shoreline Inventories includes a map viewing tool rather than maps in pdf format. The map viewer allows users to interact with the datasets within a familiar “google” type map service that was developed with Javascript. Here they can view data of their choice and customize map products for printing themselves. Access to the GIS data, summary tables and methods report is also available through this website.

Figure 1. Shoreline Inventory Website

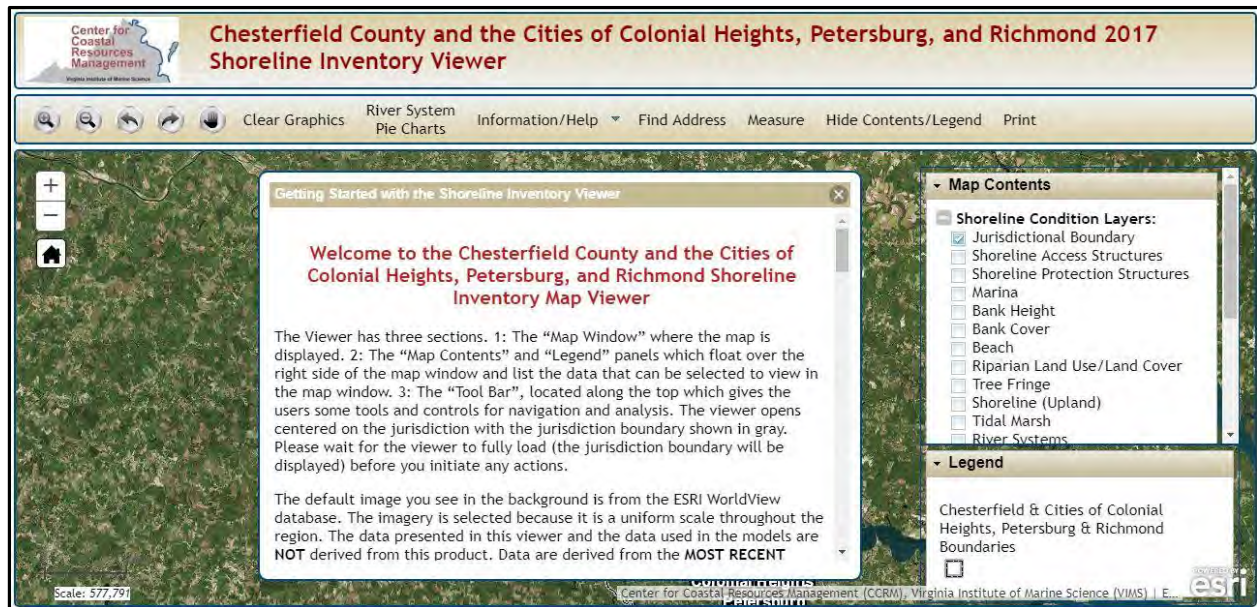
The Viewer has two panels: “Map Window”, where the map is displayed and “Map Contents and Legend”, where data that can be selected and viewed in the map window are listed. A tool bar is located along the top of the “Map Window” which gives users some controls for navigation and analysis (Figure 3.).

Figure 3. Opening page for Chesterfield County and the Cities of Colonial Heights, Petersburg, and Richmond Shoreline Inventory Viewer

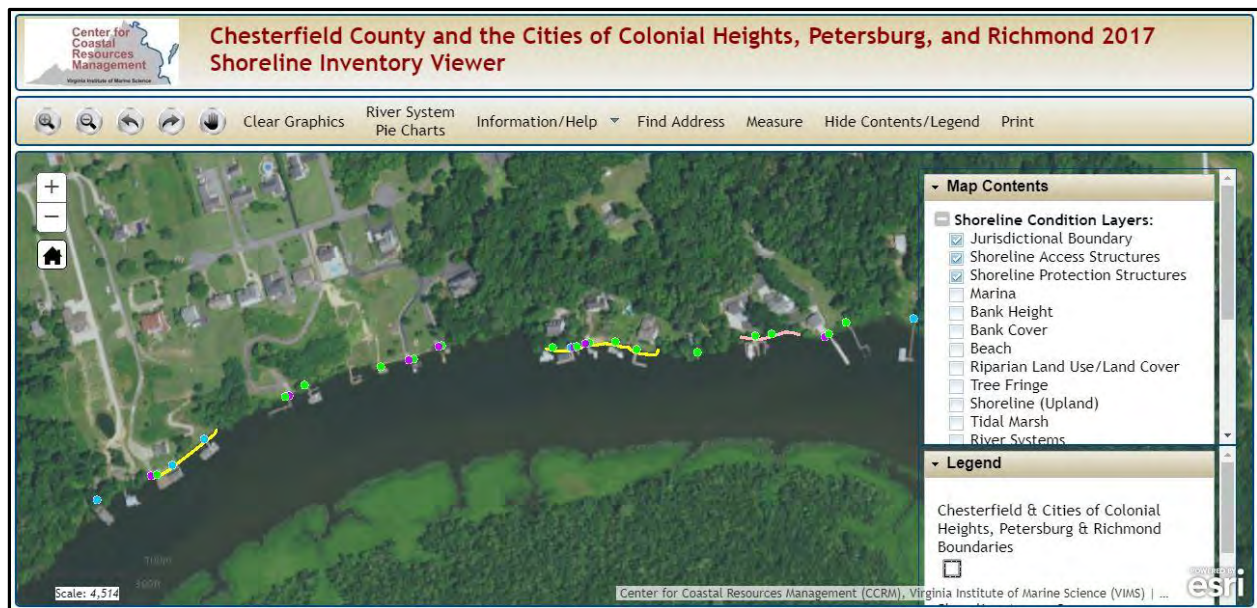
Figure 4. Map Viewer illustrates Shoreline Access and Protection Structures for a section of Chesterfield County.

In Figure 4 Shoreline Access Structures, and Shoreline Protection structures are selected. Shoreline Access structures are point features that includes piers and boat ramps. The actual footprint of these structures is not measured; only their location. Shoreline Protection Structures are line features and are mapped and illustrated in the viewer to show where they occur along the shoreline. Figure 5 illustrates riparian land use in the riparian zone for the same section of the County.

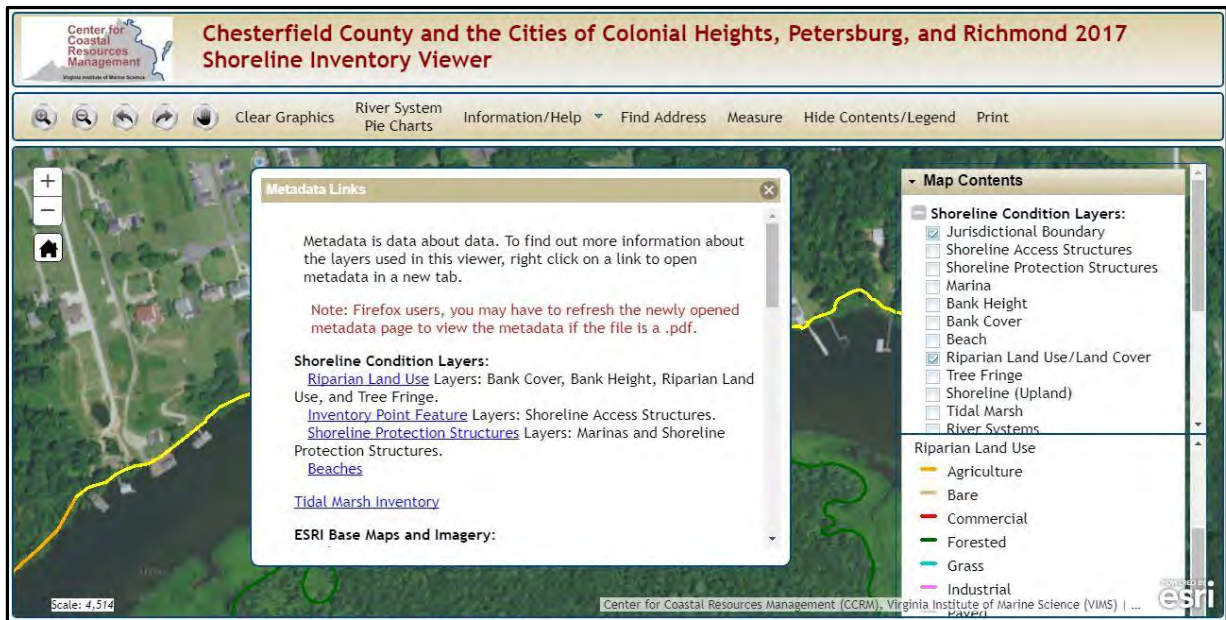
The user can use the zoom and pan tools from the top toolbar or the slide bar on the left side of the map window to change their map extent. If the map resolution is exceeded the window will become illegible. Detailed information can be obtained about the data by selecting the “Information/Help” tab at the top of the map viewer. From here the inventory glossary and metadata records can be easily accessed. In Figure 6 the selection for metadata has been made and 5 possible records can be retrieved.

Figure 6. Link to Metadata records has been selected from the top Information tab in the toolbar.

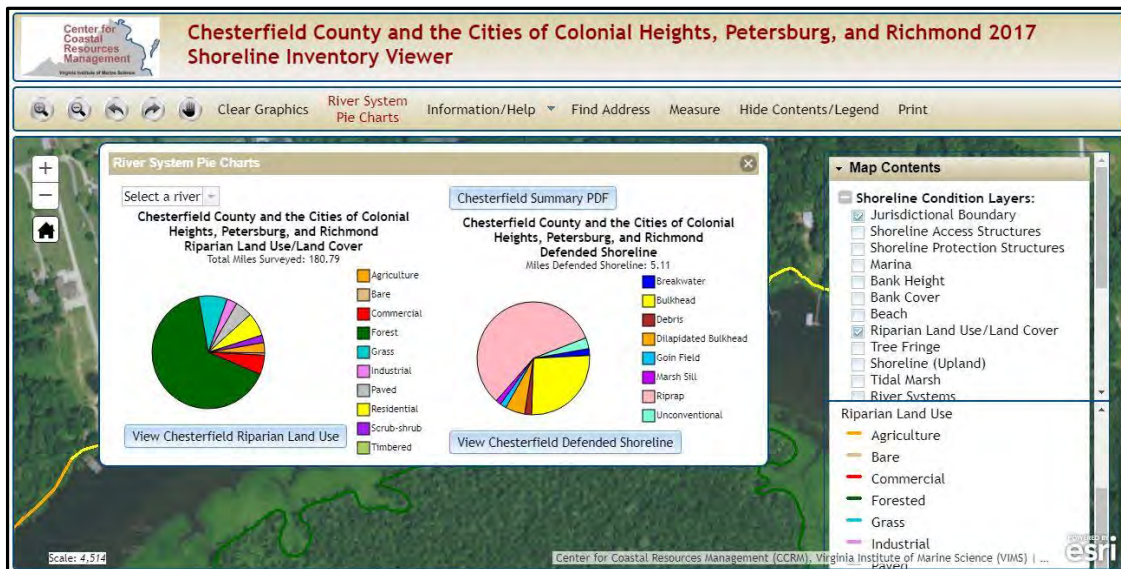
Figure 7. Pie charts display land use and shoreline hardening statistics for each tributary.

The top toolbar also includes tabs to access some important status information for the locality. By clicking on the “River System Pie Charts” button, users can obtain a statistical summary distribution of the riparian land use and amount of hardened shoreline for a specific water body selected from the drop down menu in the upper left (Figure 7). More detailed results in table format can be found by clicking the Chesterfield County Summary PDF button also in the window. The summary statistics are reported by river systems (Figure 2).

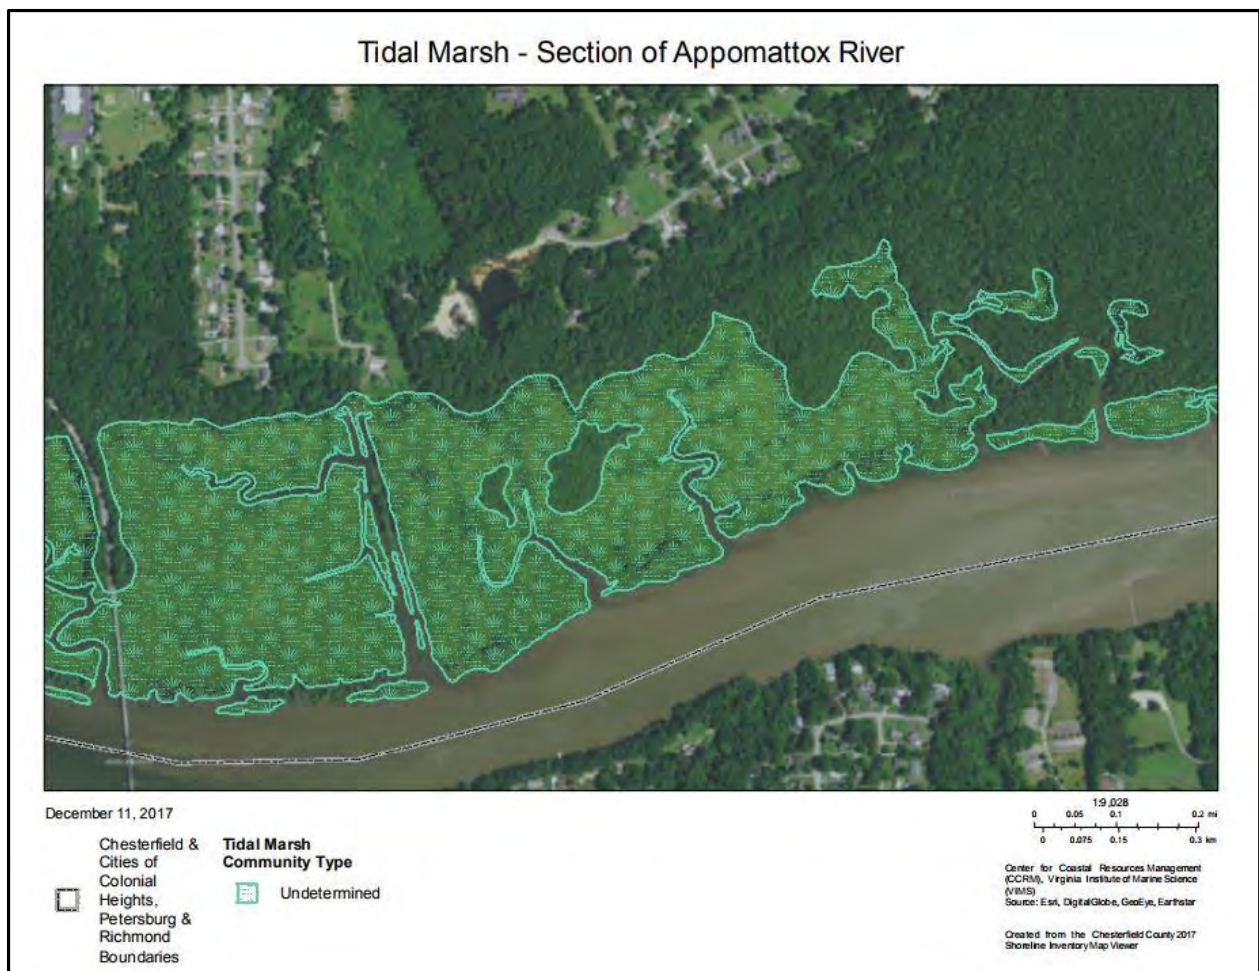
Finally, users have the option to personalize their own maps (i.e. map extent, data displayed, map title, etc.) and save them as a pdf file by clicking “Select Print Layout” button. The page can be set up for printing to 8.5 x 11 portrait or landscape style. Figure 8 is an example of a customized map generated for a section of the Appomattox River. Here the tidal marsh communities are displayed, and the community type is reported in the legend beside the illustration.

Figure 8. Customized print window for a section of the Appomattox River
