Essex County, Virginia Shoreline Inventory Report Methods and Guidelines

Prepared By:
Comprehensive Coastal Inventory Program
Center for Coastal Resources Management
Virginia Institute of Marine Science, College of William and Mary
Gloucester Point, Virginia
September 2018

Special report in Applied Marine Science and Ocean Engineering No. 472 of the Virginia Institute of Marine Science

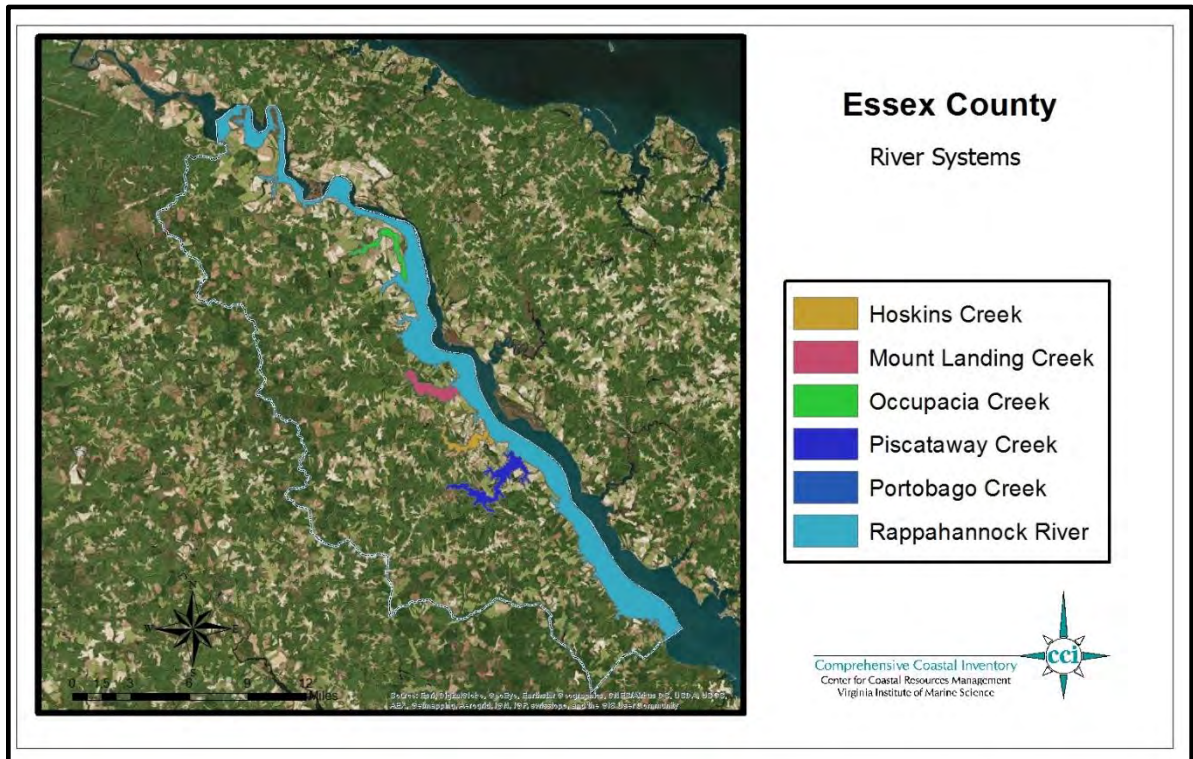
Figure 2. River Systems in Essex County

Summary tables (Tables 4-7) quantify conditions observed on the basis of river systems (Figure 2). Refer to Figure 2 for the location of these rivers systems. Note, river systems do not correspond to watershed boundaries. They were developed for convenience in reporting data.

The top toolbar also includes tabs to access some important status information for the locality. By clicking on the “River System Pie Charts” button, users can obtain a statistical summary distribution of the riparian land use and amount of hardened shoreline for a specific water body selected from the drop down menu in the upper left (Figure 7). More detailed results in table format can be found by clicking the Essex County Summary PDF button also in the window. The summary statistics are reported by river systems (Figure 2).

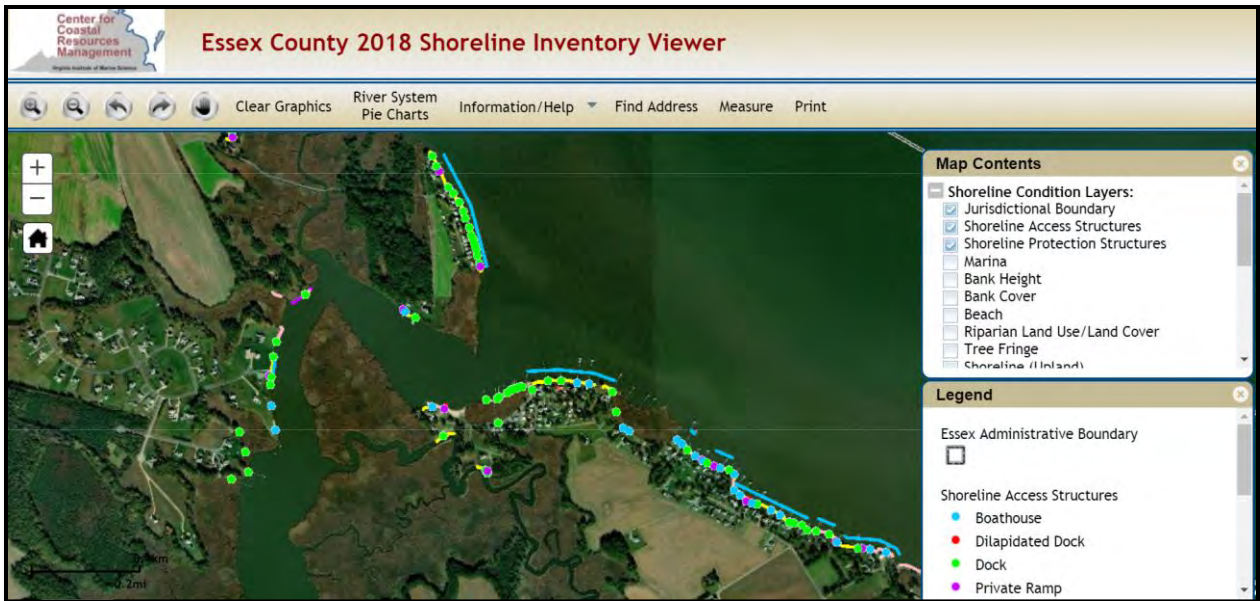
Figure 4. Map Viewer illustrates Shoreline Access and Protection Structures for a section of Essex County.

In Figure 4 Shoreline Access Structures, and Shoreline Protection structures are selected. Shoreline Access structures are point features that includes piers and boat ramps. The actual footprint of these structures is not measured; only their location. Shoreline Protection Structures are line features and are mapped and illustrated in the viewer to show where they occur along the shoreline. Figure 5 illustrates riparian land use in the riparian zone for the same section of the County.
