Nansemond River:
Study of Leased Oyster Grounds in the
Vicinity of the US 17 Bridge
(Before Construction)

Conducted for the
Virginia Department of Highways and Transportation
Project 6017-061-103, PE-101

Dexter S. Haven and Paul C. Kendall
Virginia Institute of Marine Science
Gloucester Point, Virginia 23062

January, 1979

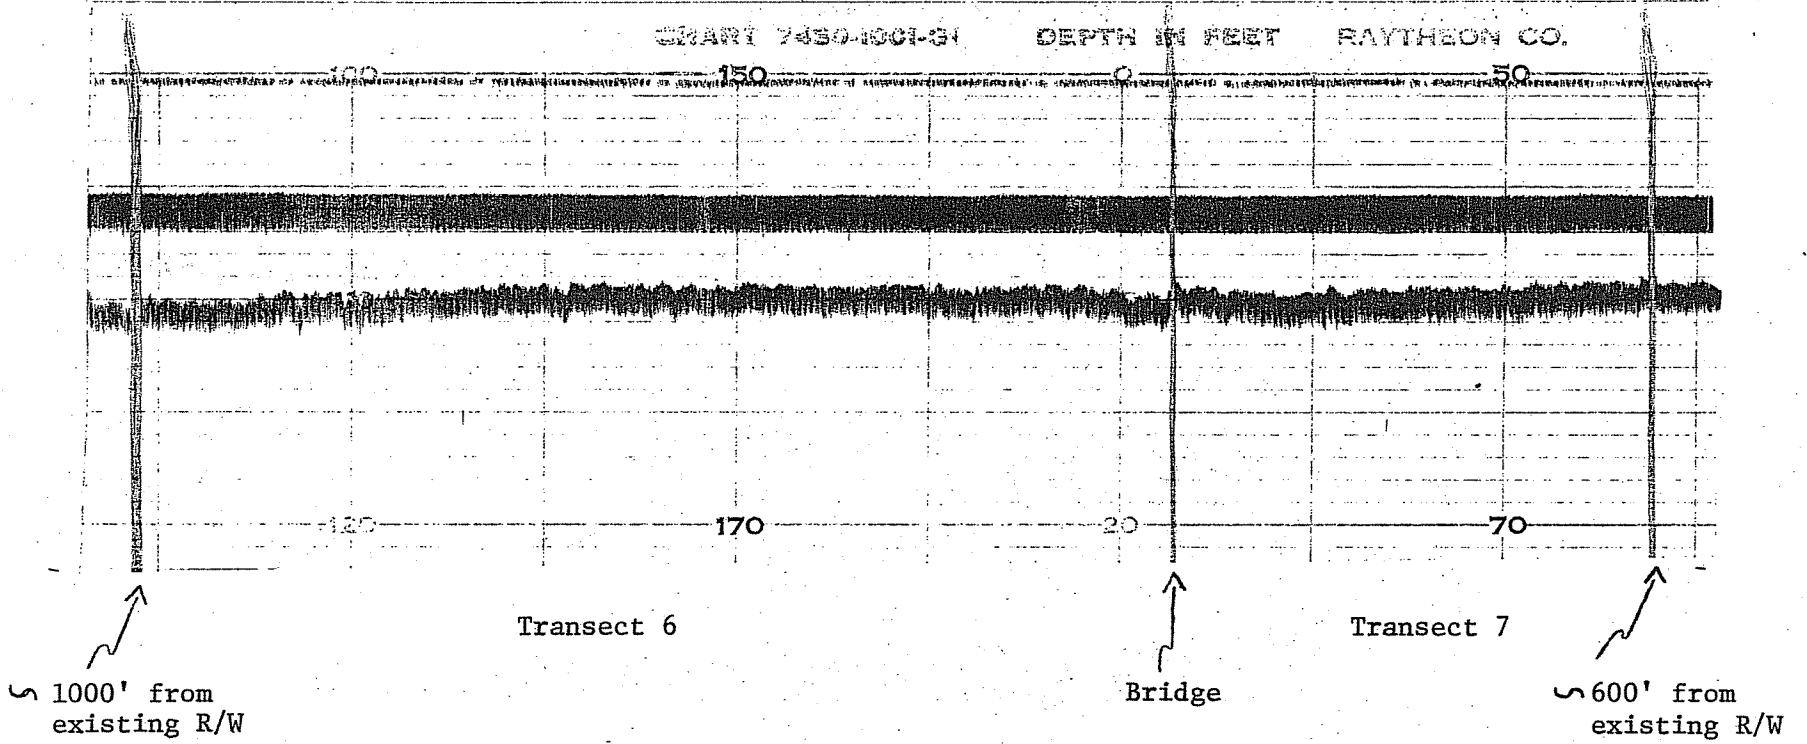
Transect 6 - Adams and Transect 7 - Parker

Bottom Profile Recorded by Fathometer - 12 Jan. 1979

Fathometer recordings of the bottom profile in the proposed right-of-way area along transects 3, 4, 7 and 8 (Figure 2 & Appendix) indicate a fairly even bottom. No large holes in the bottom were observed. Depths here were between 4 and 5 feet with the offshore transect being 7 feet.

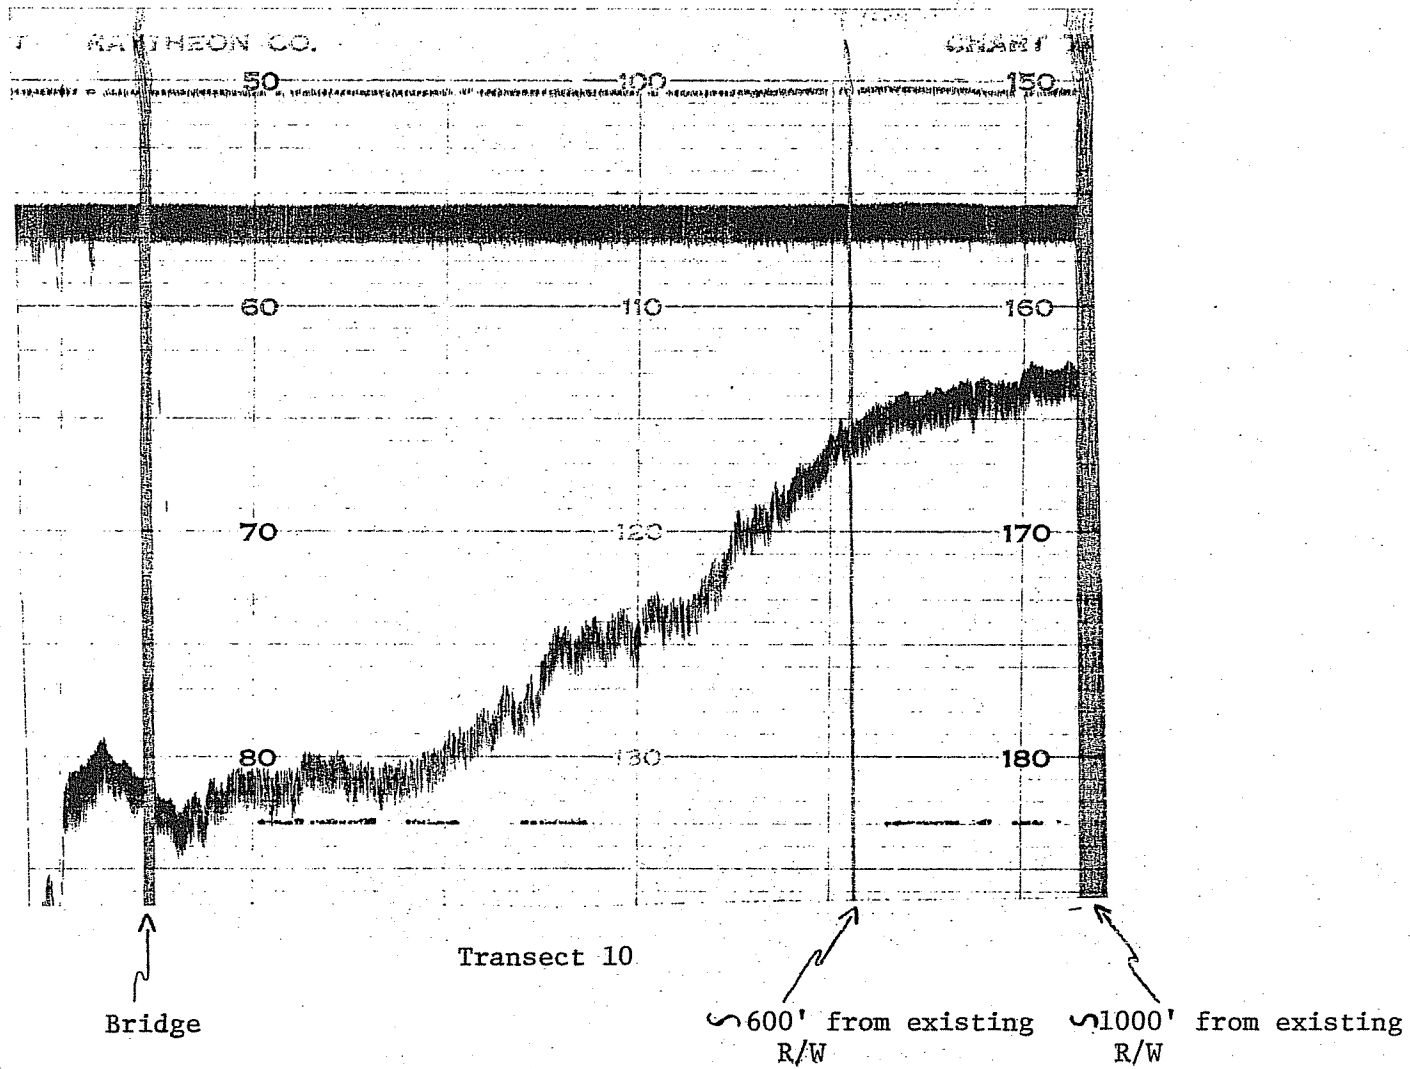
Transect 10 - Parker (between B & C) and Vacant (between A & B)

Bottom Profile Recorded by Fathometer - 12 Jan. 1979

The fathometer revealed a generally even bottom on the two inshore leases and a sloping bottom on the offshore lease (Figure 2; Appendix, Transects 3, 4, 7, 8 and 10). No large holes in the bottom were observed. Depths ranged from 4 to 6 feet on the inshore two leases, while on the offshore lease, the bottom sloped from 7 to 11 feet.

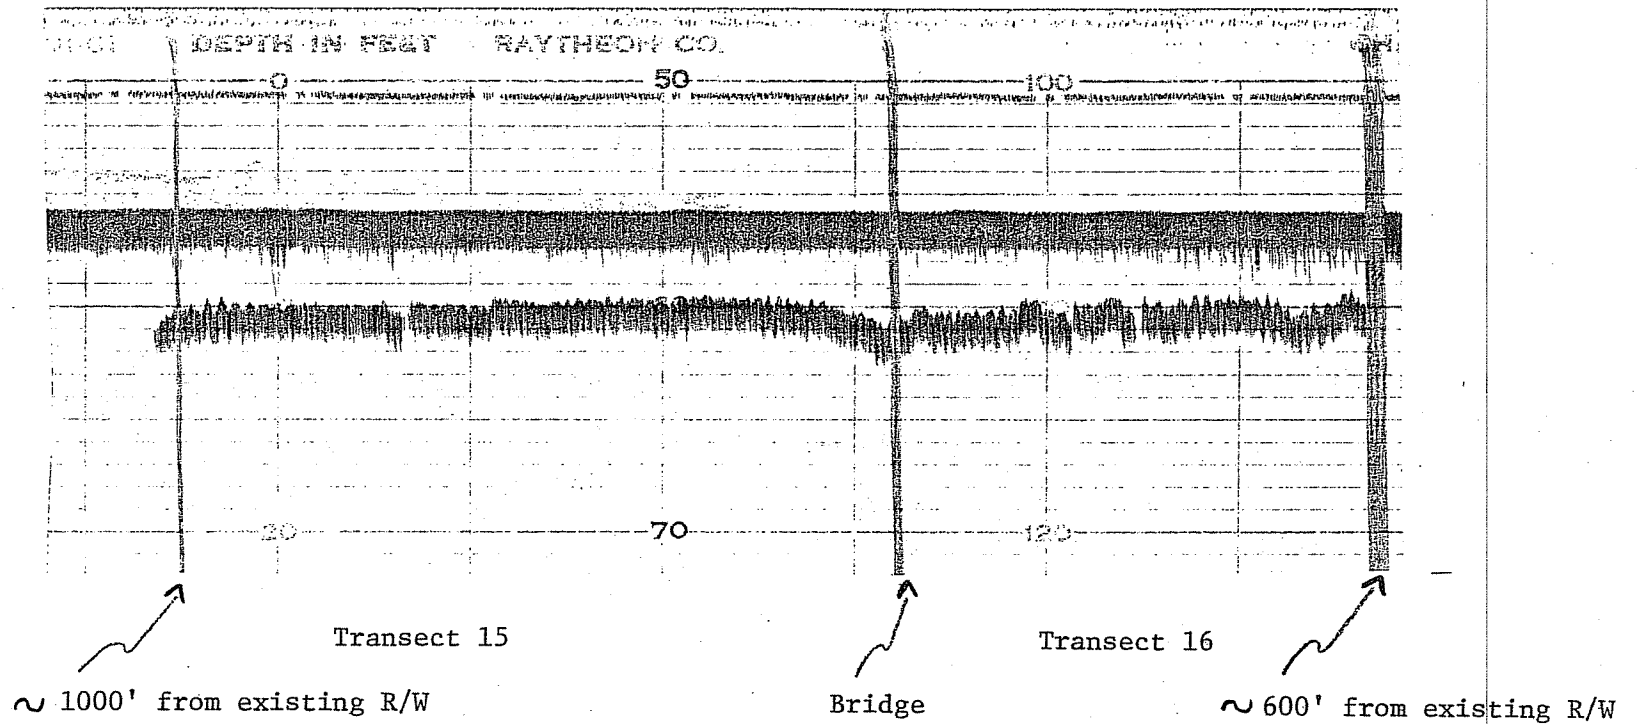
Transect 15 - Adams, and Transect 16 - Newman

Bottom Profile Recorded by Fathometer - 12 Jan. 1979

Shell was present only at the station farthest from the bridge; here one-half quart were taken by the tongs (Table 11). The bottom just offshore of the inshore line of stakes was level and had a depth of about 5½ feet (Appendix, Transect 15).
