York County, Virginia Shoreline Inventory Report Methods and Guidelines

**Comprehensive Coastal Inventory Program
Center for Coastal Resources Management
Virginia Institute of Marine Science, College of William and Mary
Gloucester Point, Virginia
November, 2013**

Special report in Applied Marine Science and Ocean Engineering No. 439 of the Virginia Institute of Marine Science

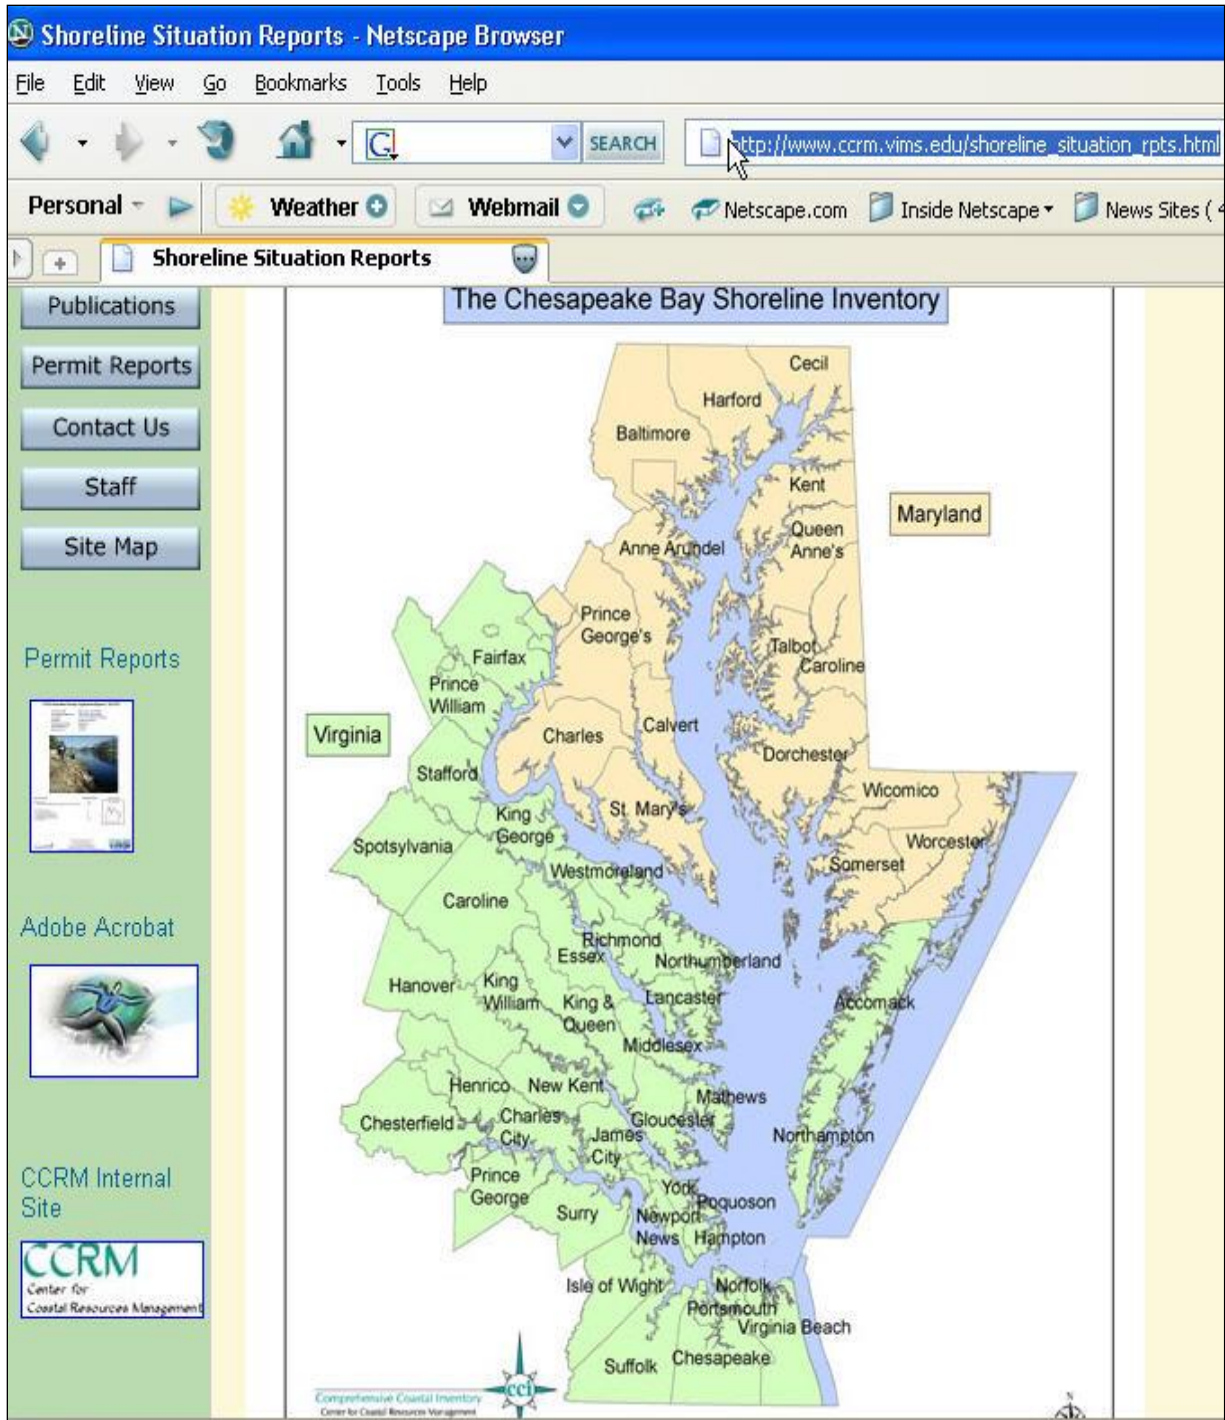
Figure 1. Shoreline Inventory Website

2.4c.) Map Viewer and Summary Tables: The York County Shoreline Inventory is delivered to the end user through a website; http://ccrm.vims.edu/gis_data_maps/shoreline_inventories/index.html (Figure 1.), by clicking on York County in the map or list of localities. The format for this inventory includes a map viewing tool rather than individual maps as in previous inventories. The map viewer allows users to interact with the datasets within a familiar “google” type map service that was developed in a Flex/Flash framework. Here they can view data of their choice and customize map products for printing themselves. Access to the GIS data, summary tables and methods report is also available through this website.

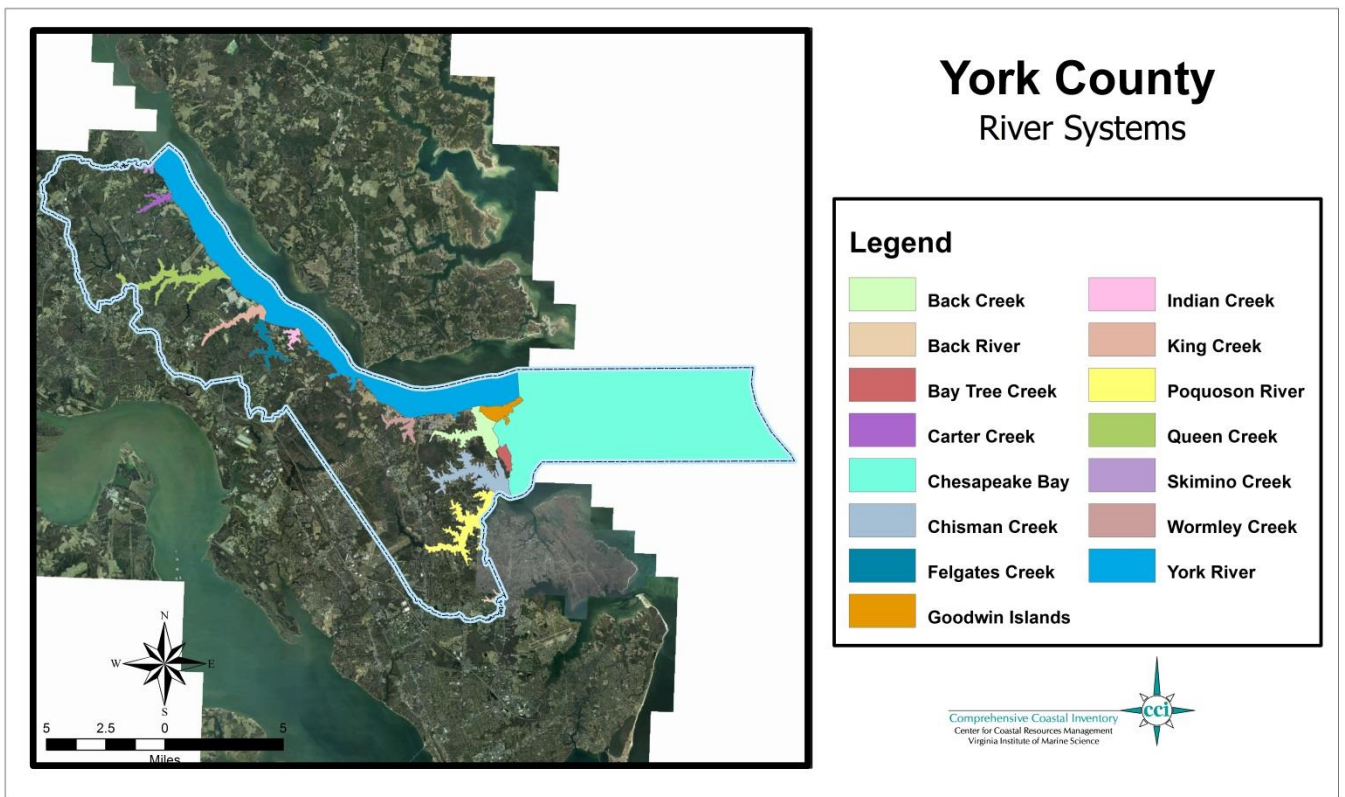
Figure 2. River Systems in York County

Summary tables (Tables 4-8) quantify conditions observed on the basis of river systems (Figure 2). In York County, 223.50 miles of shoreline were remotely updated. All these areas

are noted in Table 4 along with the original survey field dates. Refer to Figure 2 for the location of these rivers systems.

The top toolbar also includes tabs to access some important status information for the locality. By clicking on the “River System Pie Charts” button, users can obtain a statistical summary distribution of the riparian land use and amount of hardened shoreline for a specific water body which is selected from the drop down menu in the upper left (Figure 7). More detailed results in table format can be found by clicking the York County Summary PDF button also in the window. The summary statistics are reported by river systems (Figure 2).

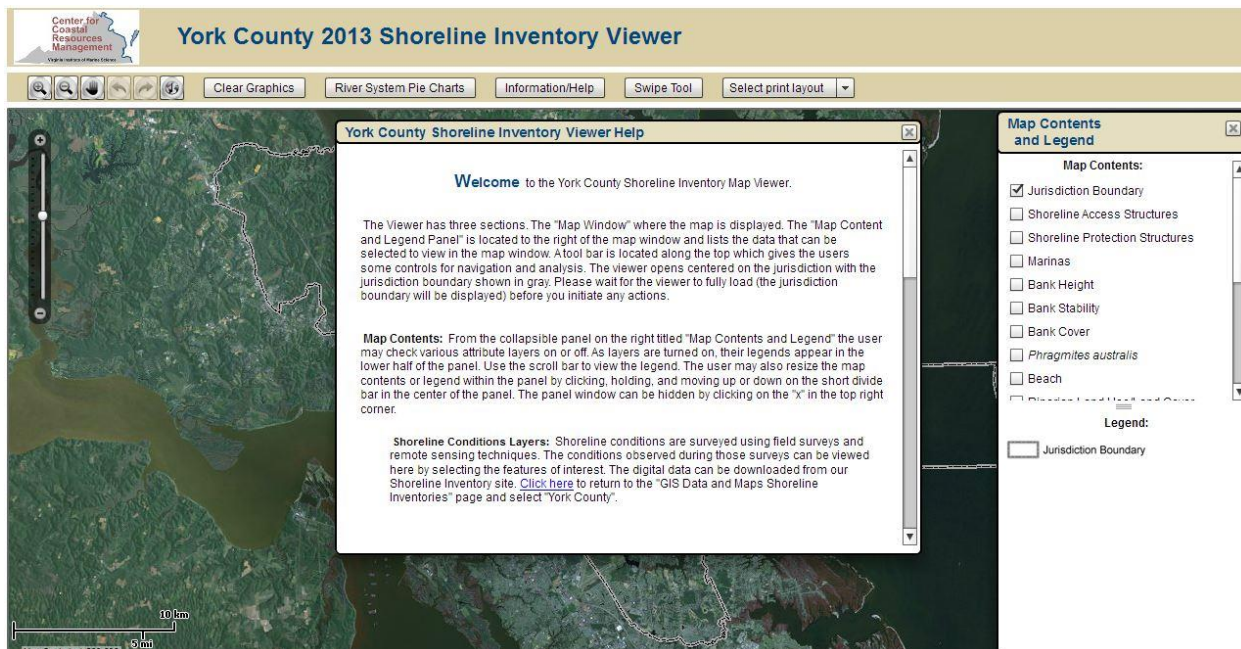
Figure 3. Opening page for the York County Shoreline Inventory Viewer

The Viewer has two panels: “Map Window”, where the map is displayed and “Map Contents and Legend”, where data that can be selected and viewed in the map window are listed. A tool bar is located along the top of the “Map Window” which gives users some controls for navigation and analysis (Figure 3.).

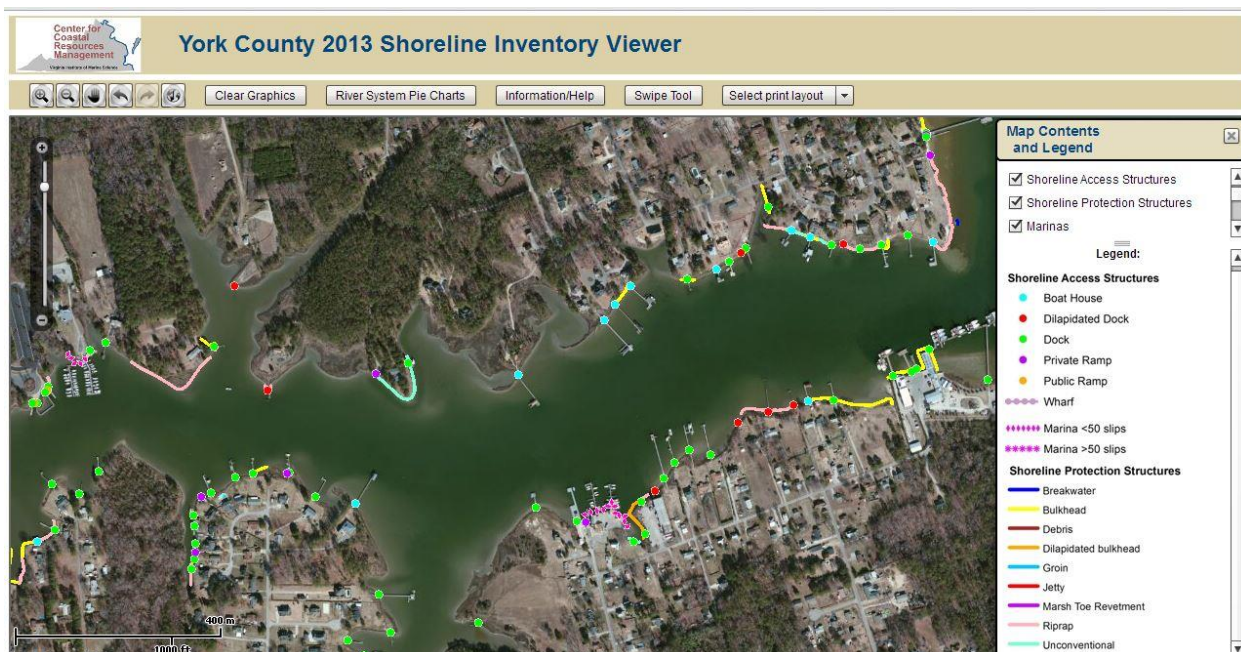
Figure 4. Map Viewer illustrates Shoreline Access and Protection Structures.

In Figure 4 Shoreline Access Structures, and Shoreline Protection structures are selected along with the boundary. Shoreline Access structures are point features that includes piers and boat ramps. The actual footprint of these structures is not measured; only their location. Shoreline Protection Structures are line features and are mapped and illustrated in the viewer to show where they occur along the shoreline. Figure5 illustrates riparian land use.

From the “Map Contents and Legend” the user may check various attribute layers on or off. The user must use the scroll bar on the far right to see the complete list of attributes available. When layers are turned on, the corresponding legend appears in the lower half of the panel, and the data are displayed in the “Map Window” (Figure 4).

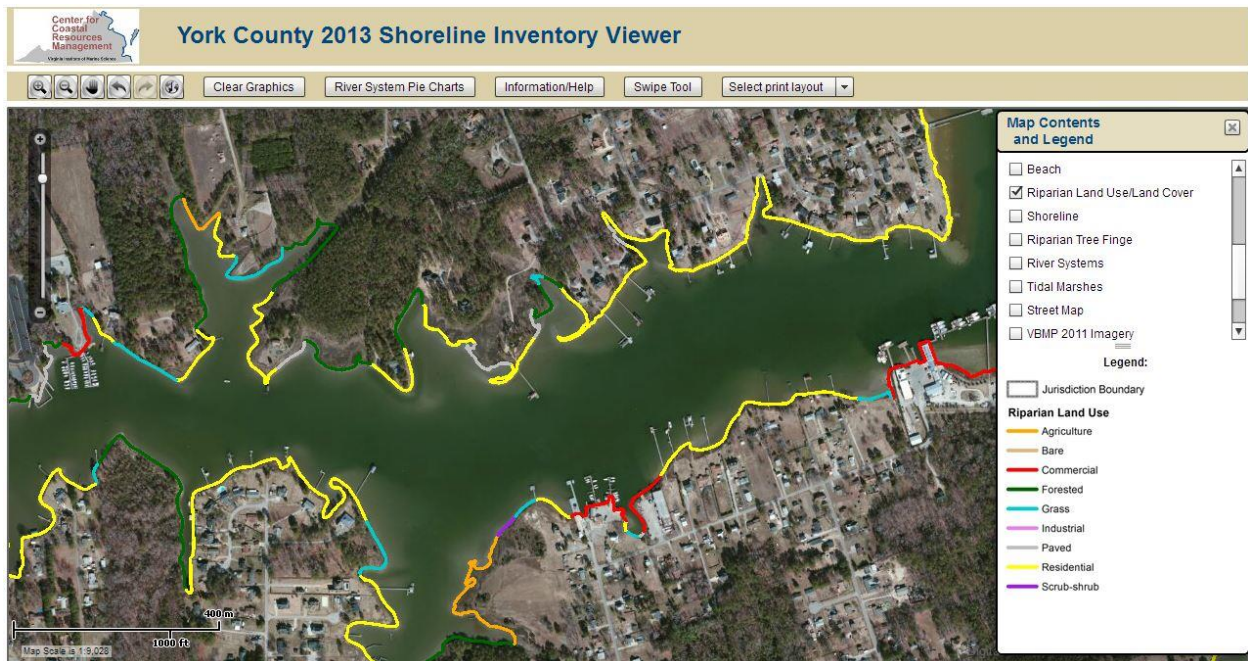
Figure 5. Distribution of land use in the riparian zone is displayed for this region of the County.

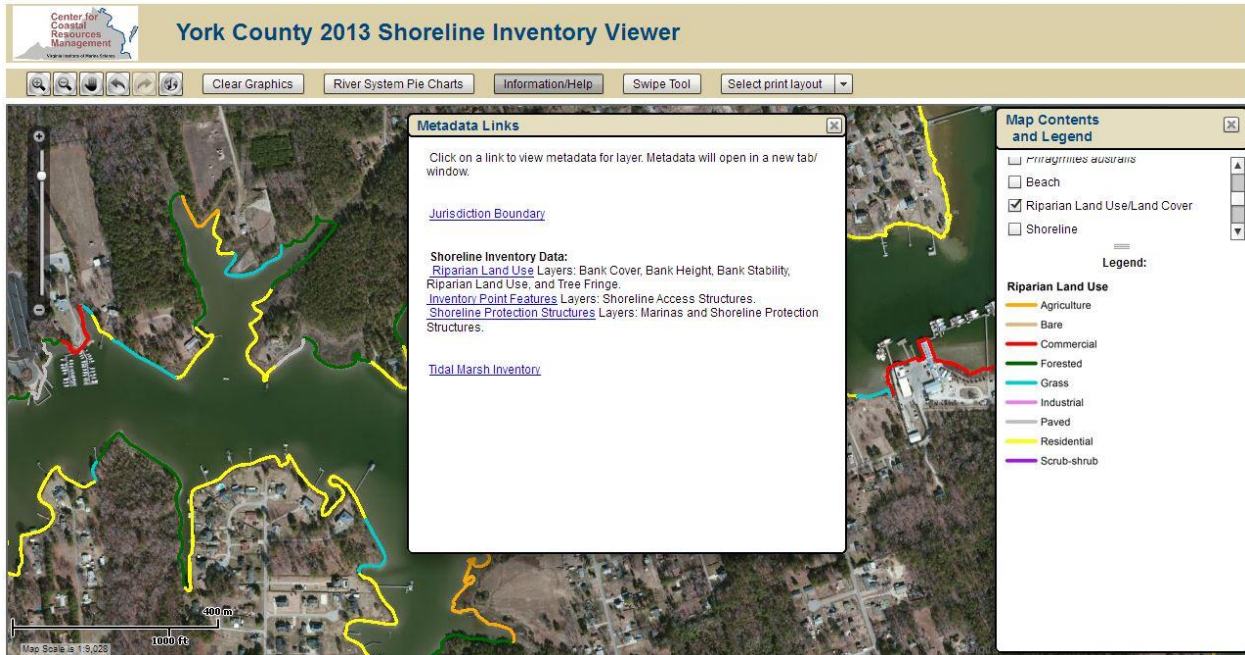
Figure 6. Link to Metadata records has been selected from the top Information tab in the toolbar.

The user can use the zoom and pan tools from the top toolbar or the slide bar on the left side of the map window to change their map extent. If the map resolution is exceeded the window will become illegible. Detailed information can be obtained about the data by selecting the “Information/Help” tab at the top of the map viewer. From here the inventory glossary and metadata records can be easily accessed. In Figure 6 the selection for metadata has been made and 5 possible records can be retrieved.

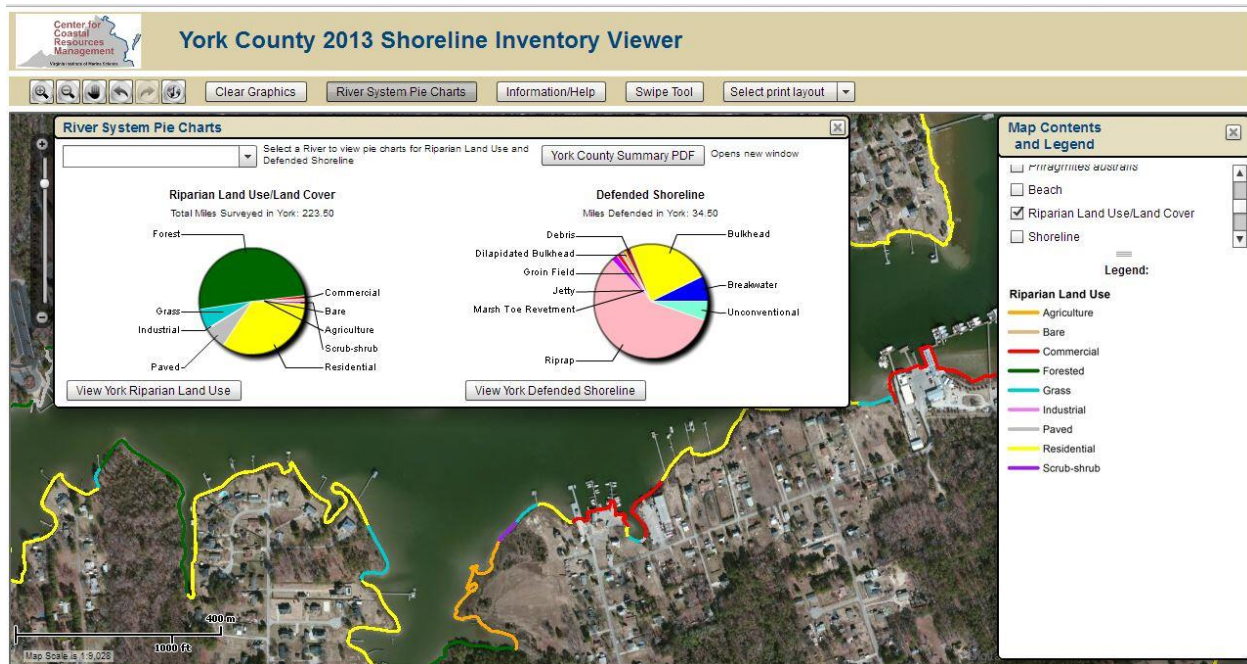
Figure 7. Pie charts display land use and shoreline hardening statistics for each tributary.

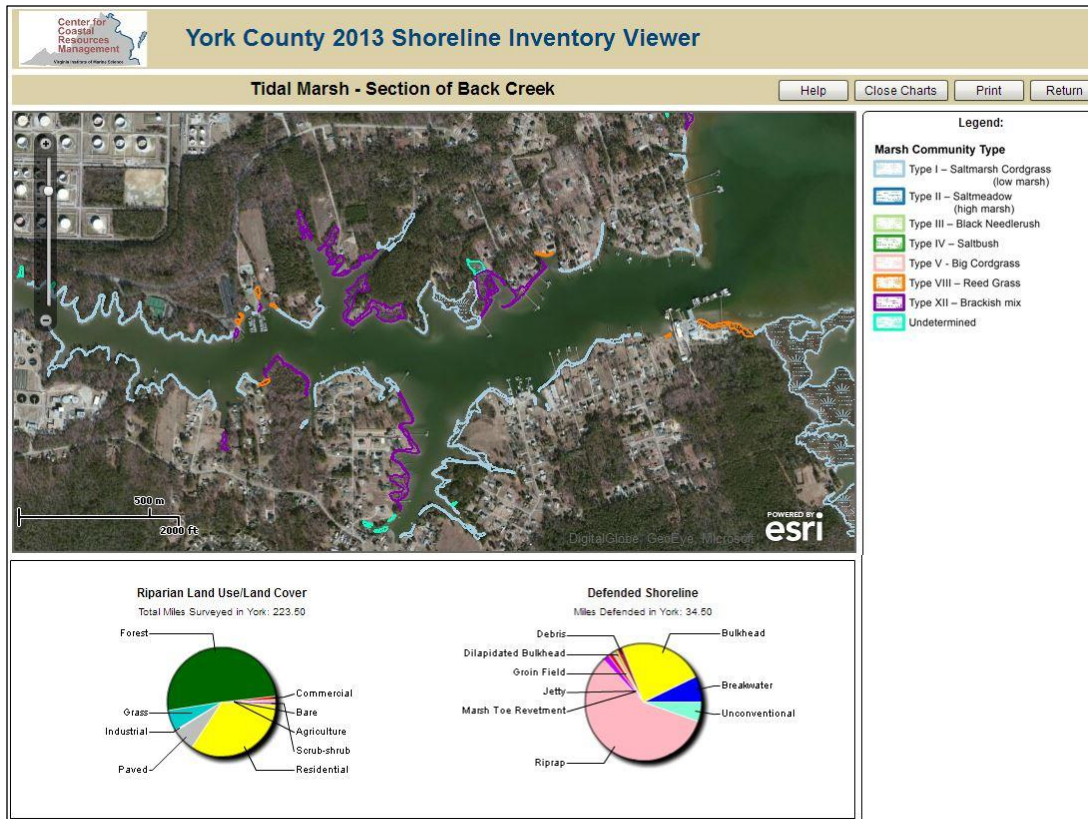
Figure 8. Customized print window for a section of Back Creek.

Finally, users have the option to personalize their own maps (i.e. map extent, data displayed, map title, etc) and print them by clicking “Go to Print” button. The map legend and the charts display below the map. The page can be set up for printing to 8.5 x 11 portrait or landscape style. Figure 8 is an example of a customized map generated for a section of the Back Creek. Here the tidal marsh communities are displayed, and the community type is reported in the legend beside the illustration. Also illustrated are the summary pie charts showing land use and shoreline hardening along the entire County.
