Surry County, Virginia Shoreline Inventory Report Methods and Guidelines

Prepared By:
Comprehensive Coastal Inventory Program
Center for Coastal Resources Management
Virginia Institute of Marine Science, College of William and Mary
Gloucester Point, Virginia
September 2017

Special report in Applied Marine Science and Ocean Engineering No. 462 of the Virginia Institute of Marine Science

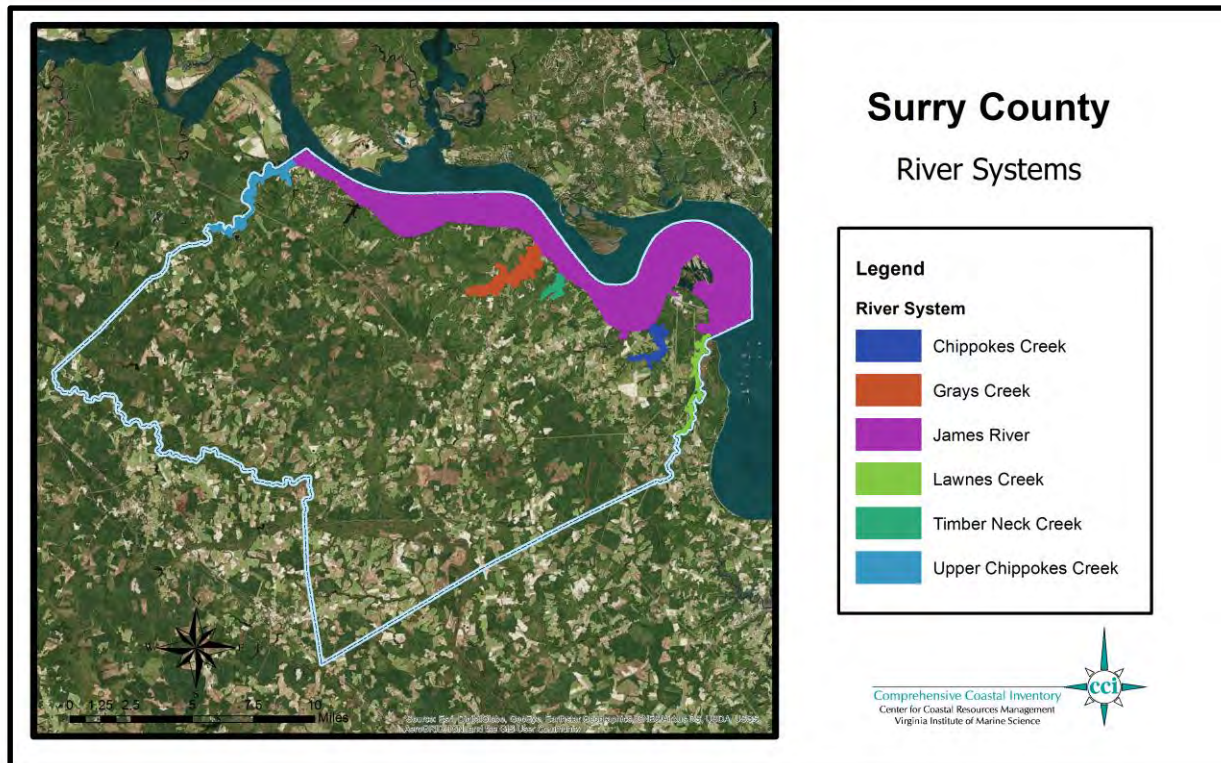
Figure 2. River Systems in Surry County

Summary tables (Tables 4-7) quantify conditions observed on the basis of river systems (Figure 2). Refer to Figure 2 for the location of these rivers systems. Note, river systems do not correspond to watershed boundaries. They were developed for convenience in reporting data.

The top toolbar also includes tabs to access some important status information for the locality. By clicking on the “River System Pie Charts” button, users can obtain a statistical summary distribution of the riparian land use and amount of hardened shoreline for a specific water body selected from the drop down menu in the upper left (Figure 7). More detailed results in table format can be found by clicking the Surry County Summary PDF button also in the window. The summary statistics are reported by river systems (Figure 2).

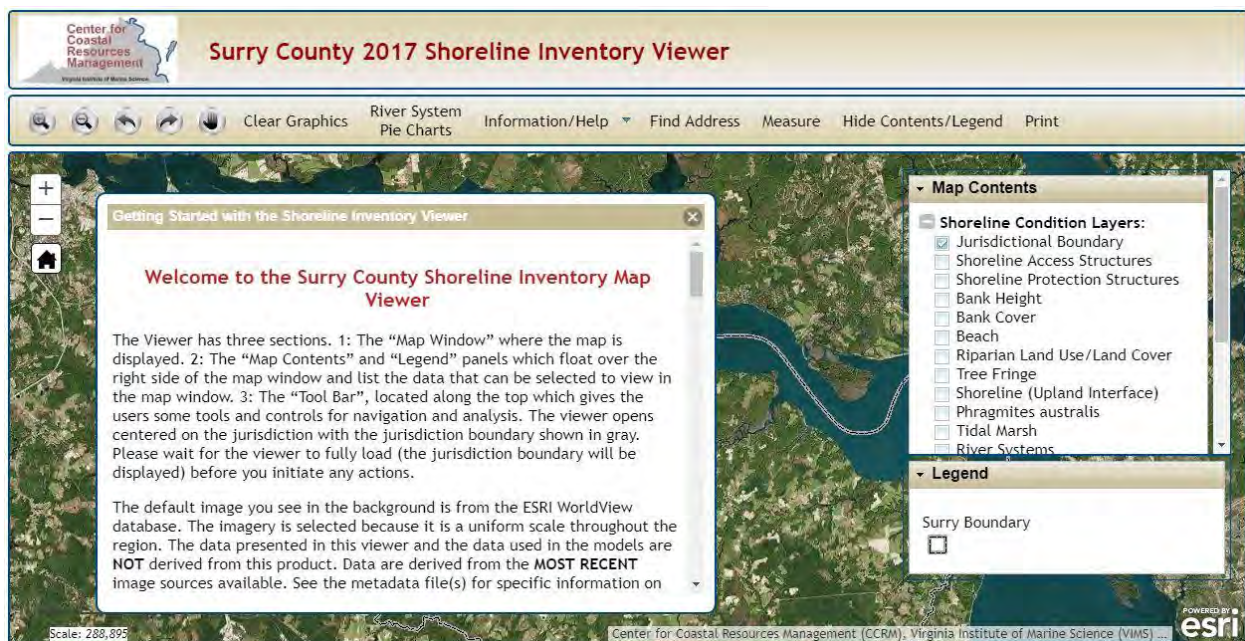
Figure 3. Opening page for the Surry County Shoreline Inventory Viewer

The Viewer has two panels: “Map Window”, where the map is displayed and “Map Contents and Legend”, where data that can be selected and viewed in the map window are listed. A tool bar is located along the top of the “Map Window” which gives users some controls for navigation and analysis (Figure 3.).

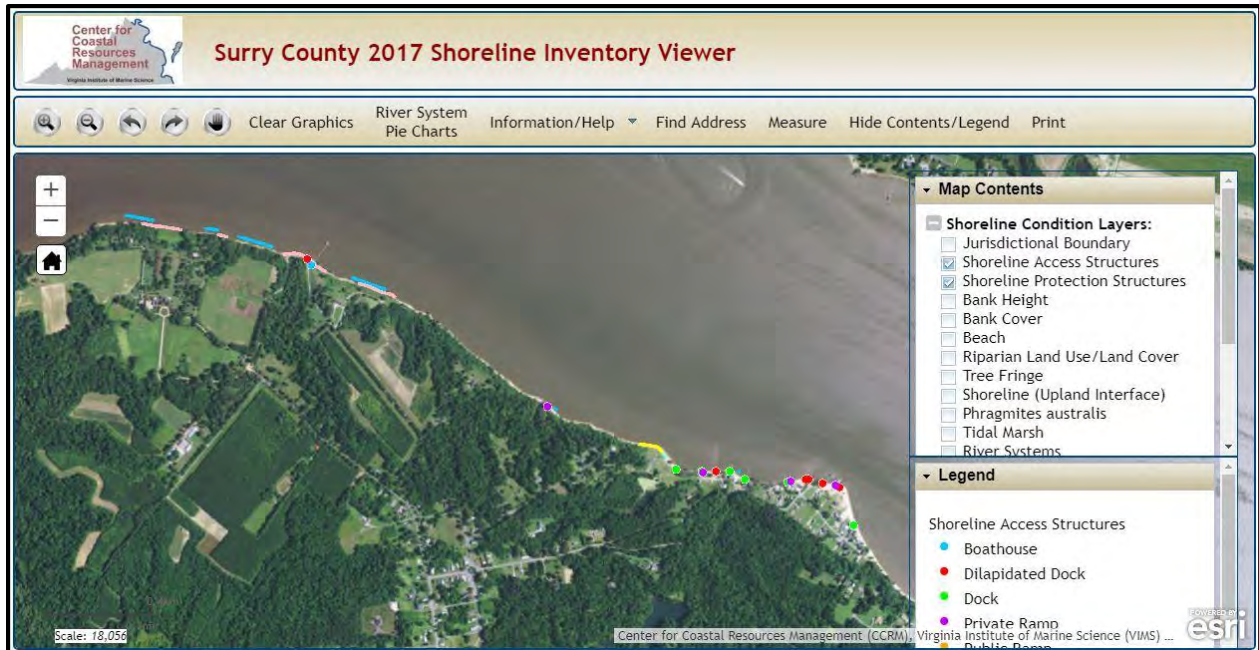
Figure 4. Map Viewer illustrates Shoreline Access and Protection Structures for a section of Surry County.

In Figure 4 Shoreline Access Structures, and Shoreline Protection structures are selected. Shoreline Access structures are point features that includes piers and boat ramps. The actual footprint of these structures is not measured; only their location. Shoreline Protection Structures are line features and are mapped and illustrated in the viewer to show where they occur along the shoreline. Figure 5 illustrates riparian land use in the riparian zone for the same section of the County.

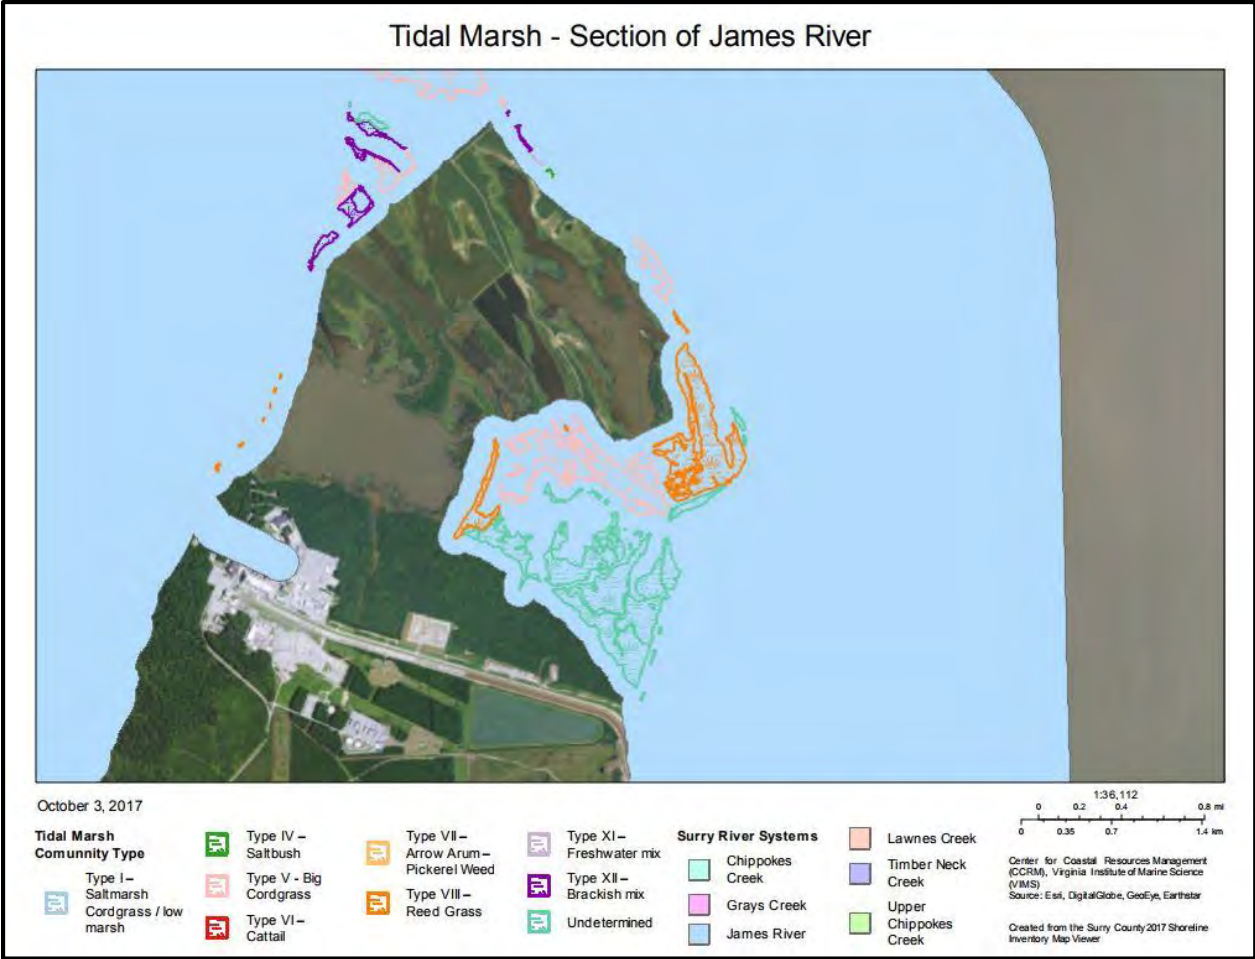
Figure 8. Customized print window for a section of the James River.

Finally, users have the option to personalize their own maps (i.e. map extent, data displayed, map title, etc.) and save them as a pdf file by clicking “Select Print Layout” button. The page can be set up for printing to 8.5 x 11 portrait or landscape style. Figure 8 is an example of a customized map generated for a section of the James River. Here the tidal marsh communities are displayed, and the community type is reported in the legend beside the illustration.
