Living Shoreline Sea-Level Resiliency: Performance and Adaptive Management of Existing Sites

November 2018

Living Shoreline Sea-Level Resiliency: Performance and Adaptive Management of Existing Sites Summary Report

Shoreline Studies Program
Virginia Institute of Marine Science
William & Mary

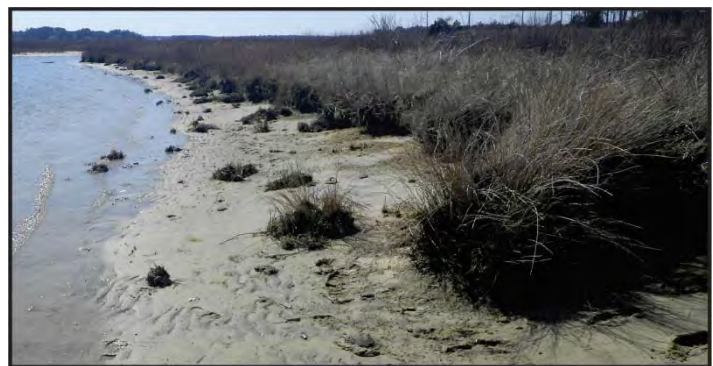
CSRA is set within the low lying landscape that surrounds the Mobjack Bay. The tidal shoreline is eroding marsh dominated by *Spartina patens* and black needle rush (Figure 4-1-2). Significant shore recession has occurred in front of the main house which has erosion rates of about 0.6 ft/yr. The tide range is 2.5 feet at the mouth of the Severn River. The project was designed to address shoreline erosion along the project coast. There is a fetch to the west of about 2.5 miles and the southwest of 1.8 miles, low medium energy exposure. The upper elevation of sand fill was set at +3.0 ft MLW and extends on a 10:1 slope to about mean tide level at the back of the proposed stone sills. Once established the project will provide an erosion-control marsh fringe. A new pier recently was built along the shoreline.

Figure 4-1-2. Conditions at Captain Sinclair before the project. Photo: Shoreline Studies Program, 1 April 2015.

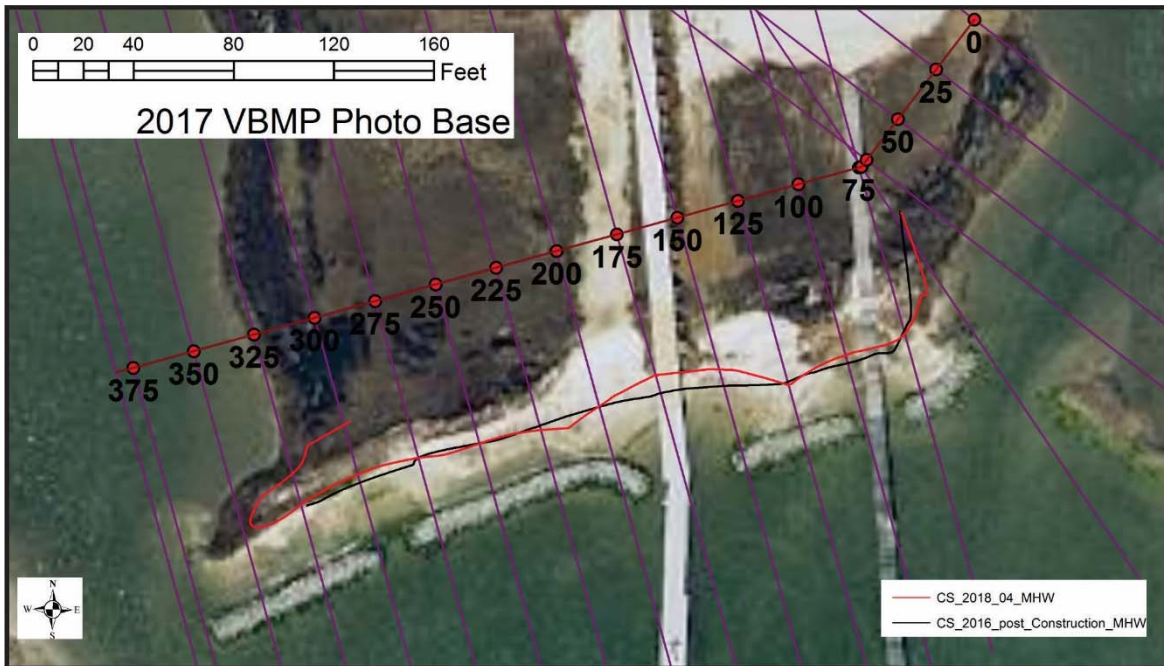
Site surveys show the main change is in backshore elevation (Figures 4-1-6 and 4-1-7). The backshore berm has increased in height and apparently not at the expense of the lower beach face. It appears that elevation changes are due mostly to vertical growth of the high marsh, *S. patens*, along the entire length of the project. An increase of almost one foot at profile 250. This bodes well for future adaptation to SLR.

Figure 4-1-6. Basemap for Captain Sinclair showing the profile baseline and the position of mean high water in 2016 and in 2018.

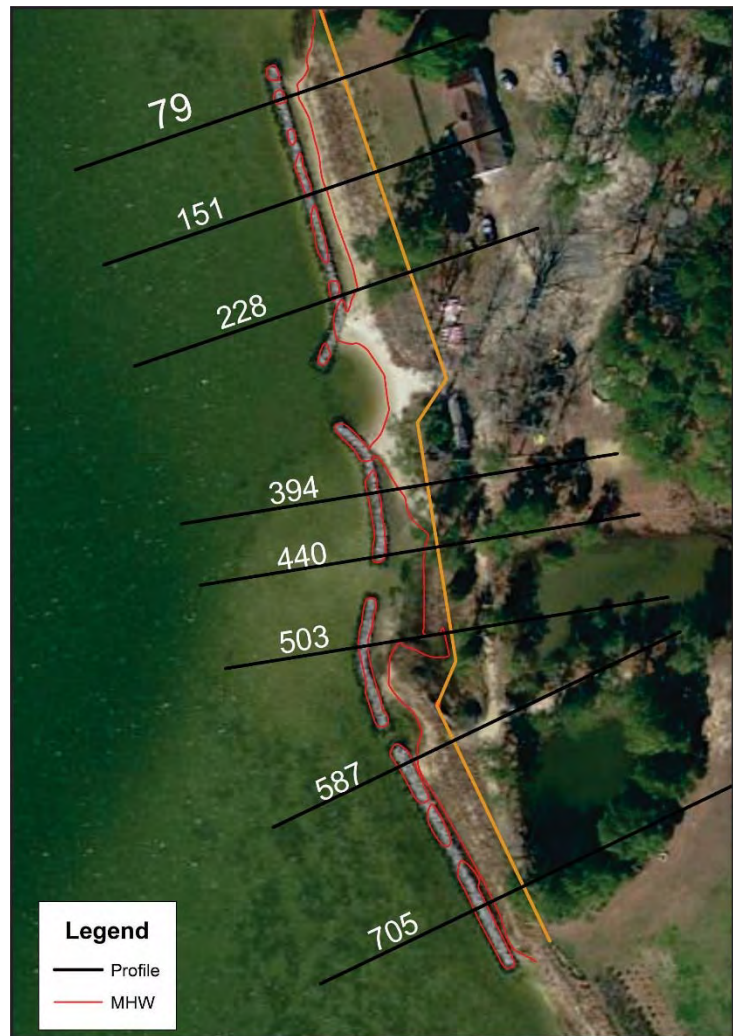
Survey data shows Reach 1 sill (ZZ) with elevated substrate from the sand fill in sections P587 (Figure 4-2-7 and Figure 4-2-8). The upland bank edge was graded slightly to the back of the sand fill. Reach 2, Sill 1 shows the mouth of the tidal creek has shifted and deepened slightly (P503). The tidal creek flat behind sill # 3, P440 has remained relatively stable transitioning to the sand fill going north, P 394. Reach 3 sections P151 and P79 show the graded bank and wide stable sand fill.

Figure 4-2-7. Location of cross-sectional profiles at Occohannock and the 2018 surveyed position of mean high water.

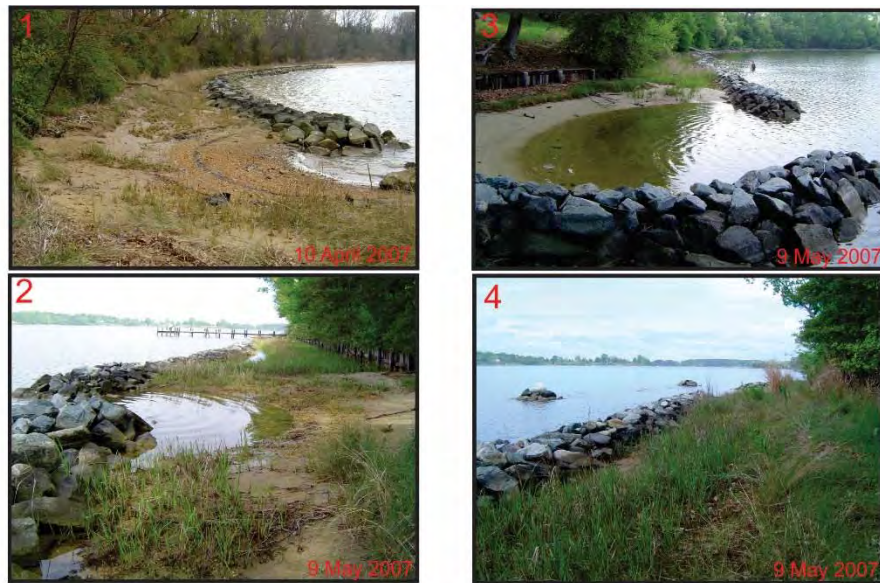
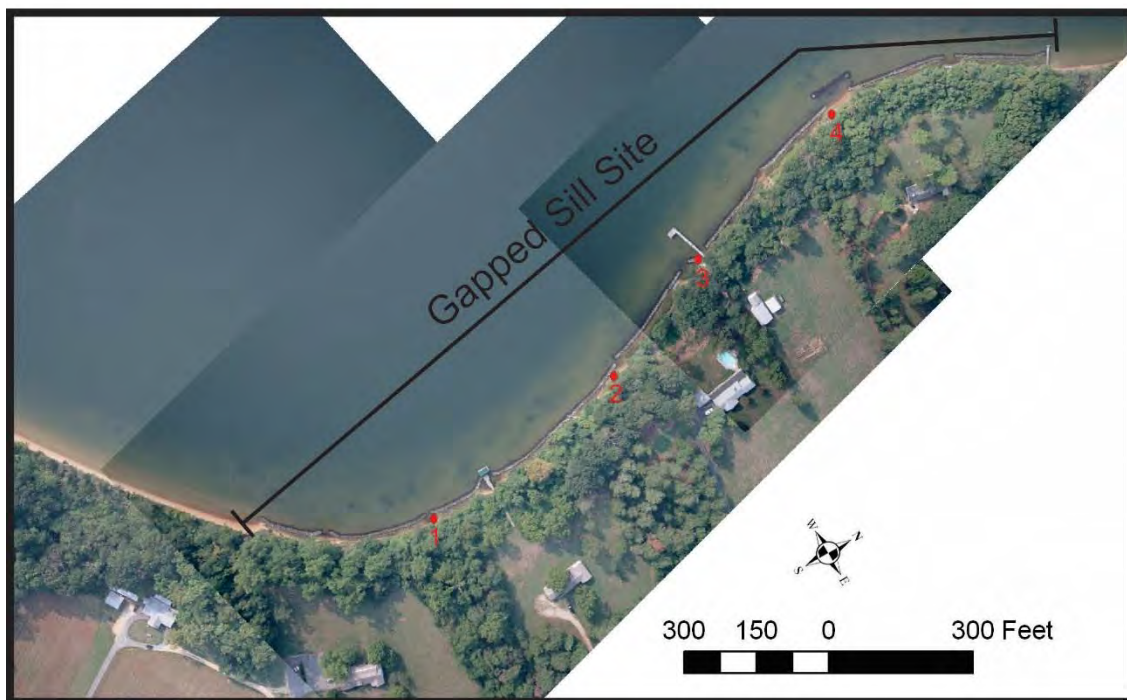
Figure 4-3-2. A photo mosaic of the St. Mary's City, Maryland shoreline on August 24, 2007 indicating the four sites of gapped fill projects and ground photographs of each site.

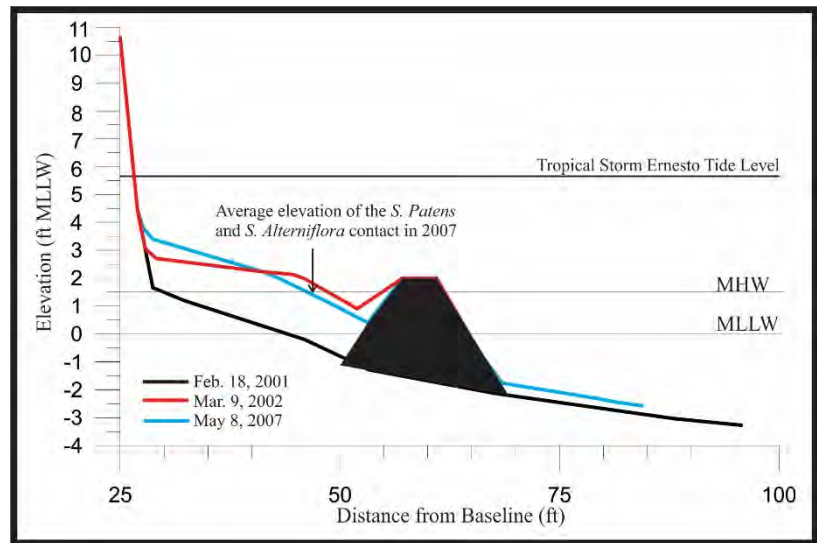
The Shoreline Studies Program monitored the project in 2007 and 2009 (Hardaway *et al.*, 2007 and 2009). Results indicated a general steepening of the marsh terrace with bank slumping and the slight reduction of sand grade behind the sills and slight accretion on the river side (Figure 4-3-3). The base of bank sand intersection increased about 0.5 ft from a +3.0 to a +3.5 ft MLW. The sill sand intersection decreased about 0.5 ft from a +1.0 to a +0.5 ft MLW with the resulting slope going from about a 10:1 to a 6:1 but still stable.

Figure 4-3-3. Typical St. Mary's City sill profile from survey data.

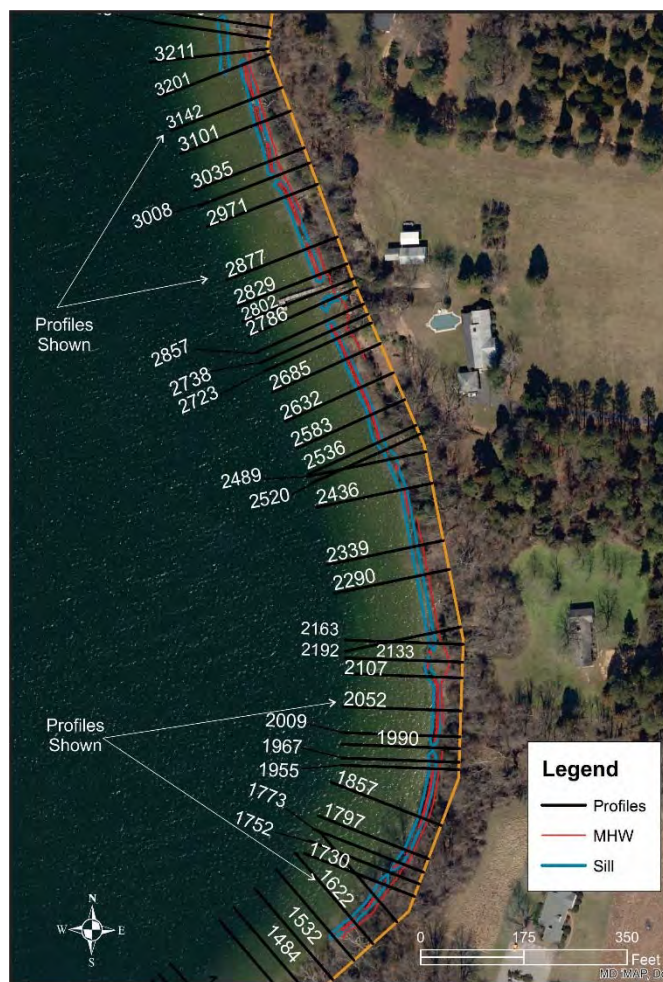
The survey showed that there were gradient adjustments between construction and the 2008 survey, but since then the net change across the stable vegetated backshore has very been little with some areas of reduction usually between +1 ft and +2 ft. This is the high water swash zone, where grasses are under the most stress from wave impact. Changes are in the order of 0.1 to 0.3 ft. Little new sediment enters the system either from the upland banks because they are very stable or from offshore due to the rock sill barrier.

Along Sill #1, there were slight decreases in the lower limit of *S. alterniflora* and in the nearshore (1622). Sill #2 (P1955), the backshore remained stable while behind Sill #3 (P2052) there was a slight increase, +0.3 ft from the back of the sill to about +2.5 ft at the edge of the heavy backshore vegetation. Further up at Sill #6 (P3142) shows no change across the backshore. We estimate almost 10

Figure 4-3-10. Cross-sectional profile baseline. Also shown are the outline of the sill structures (blue) and the 2018 mapped mean high water line.

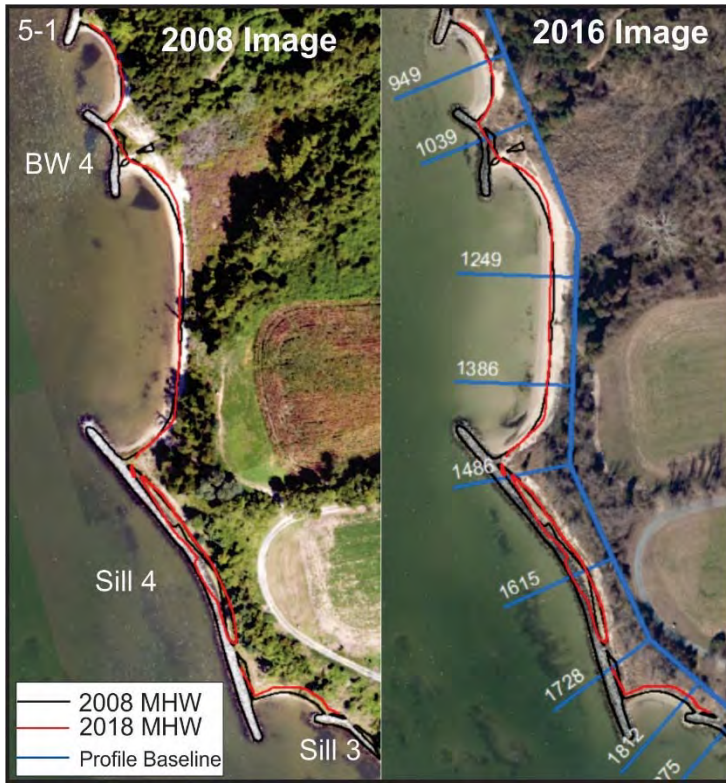
Figure 4-4-8. Aerial photos taken in 2008 and 2016 showing the cross-sectional profile locations and the surveyed position of mean high water in 2008 and 2018.

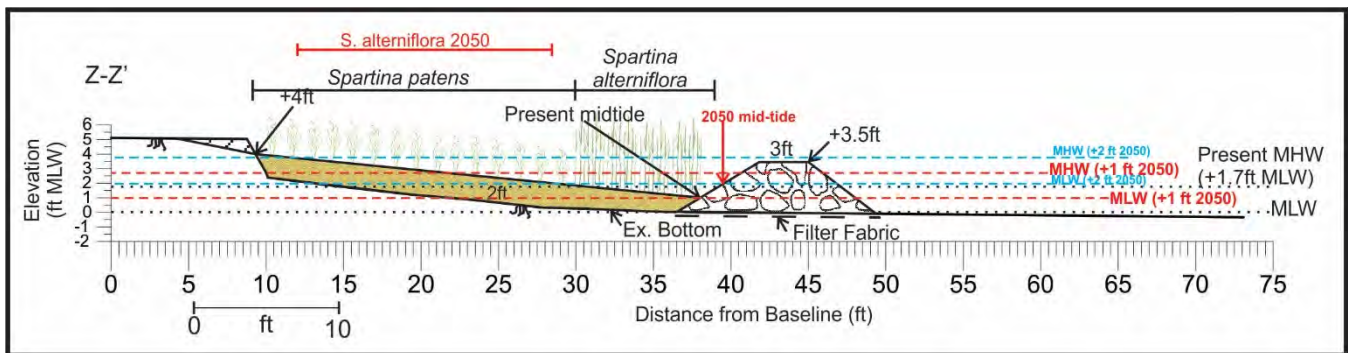
By 2050 with a 1 projected one-foot rise in sea level, impacts will have different impacts to the various Camp shorelines. In Reach 1, the sill should still be functioning to attenuate waves because it is still exposed at high water. However, the low marsh fringe will recede 8 to 10 feet (Figure 5-2-1). The high marsh and salt bush will occupy a narrower corridor. One more foot of SLR will submerge the sill at high water and drown much of the high marsh leaving only a narrow section of low marsh and

Figure 5-2-1. Sea-level rise scenarios modeled at Occhohannock, Reach 1, and depicted on a typical cross-section.

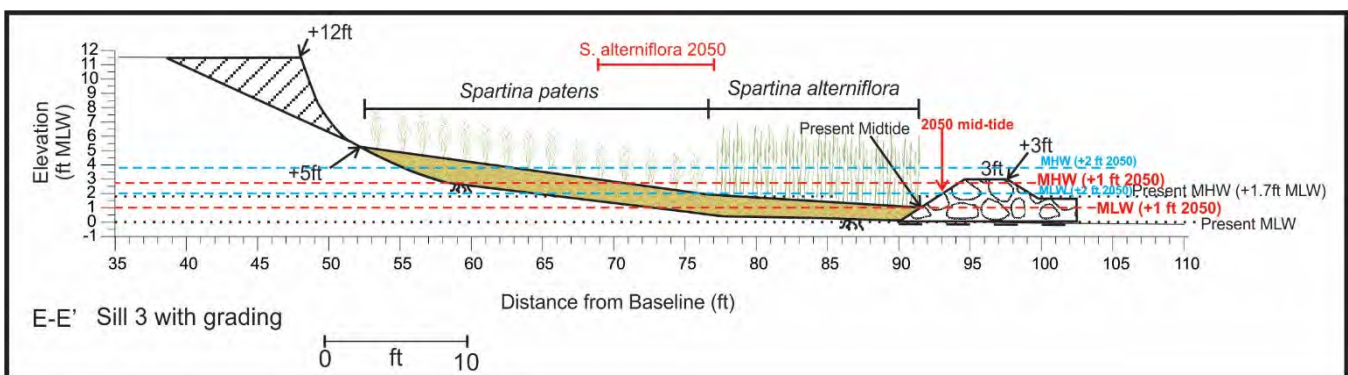
The upland bank along Reach 3 under the 1 SLR will still be protected by the marsh fringe even though MHW and the low marsh will move landward 5 to 7 feet and the rock sill will be almost submerged at high water (Figure 5-2-2). Much of the lower marsh area today will become intertidal non-vegetated wetlands, and only a small area of *S. alterniflora* will exist because of the steeper elevation between the low marsh and the bank. A 2 foot SLR may warrant the addition of rock to the sill which will be one foot underwater at high tide because the marsh fringe and base of upland bank may also become compromised because of increase in wind wave impacts during even modest storm events.

Figure 5-2-2. Sea-level rise scenarios modeled at Occhohannock, Reach 3, and depicted on a typical cross-section.
