*Living Shoreline  
Sea-Level Resiliency:  
Performance and Adaptive  
Management of Existing Sites*

*November 2018*

# Living Shoreline Sea-Level Resiliency: Performance and Adaptive Management of Existing Sites Summary Report

Shoreline Studies Program  
Virginia Institute of Marine Science  
William & Mary

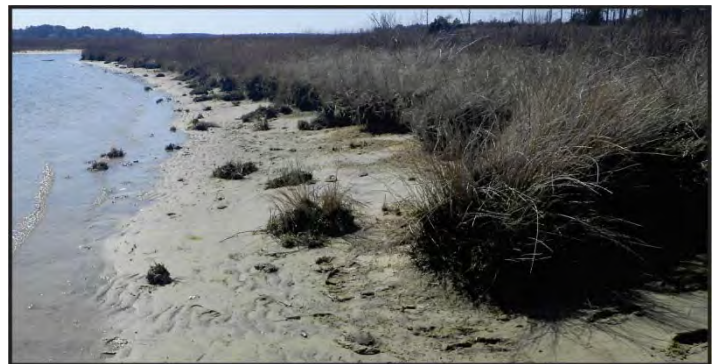
CSRA is set within the low lying landscape that surrounds the Mobjack Bay. The tidal shoreline is eroding marsh dominated by *Spartina patens* and black needle rush (Figure 4-1-2). Significant shore recession has occurred in front of the main house which has erosion rates of about 0.6 ft/yr. The tide range is 2.5 feet at the mouth of the Severn River. The project was designed to address shoreline erosion along the project coast. There is a fetch to the west of about 2.5 miles and the southwest of 1.8 miles, low medium energy exposure. The upper elevation of sand fill was set at +3.0 ft MLW and extends on a 10:1 slope to about mean tide level at the back of the proposed stone sills. Once established the project will provide an erosion-control marsh fringe. A new pier recently was built along the shoreline.

Figure 4-1-2. Conditions at Captain Sinclair before the project. Photo: Shoreline Studies Program, 1 April 2015.

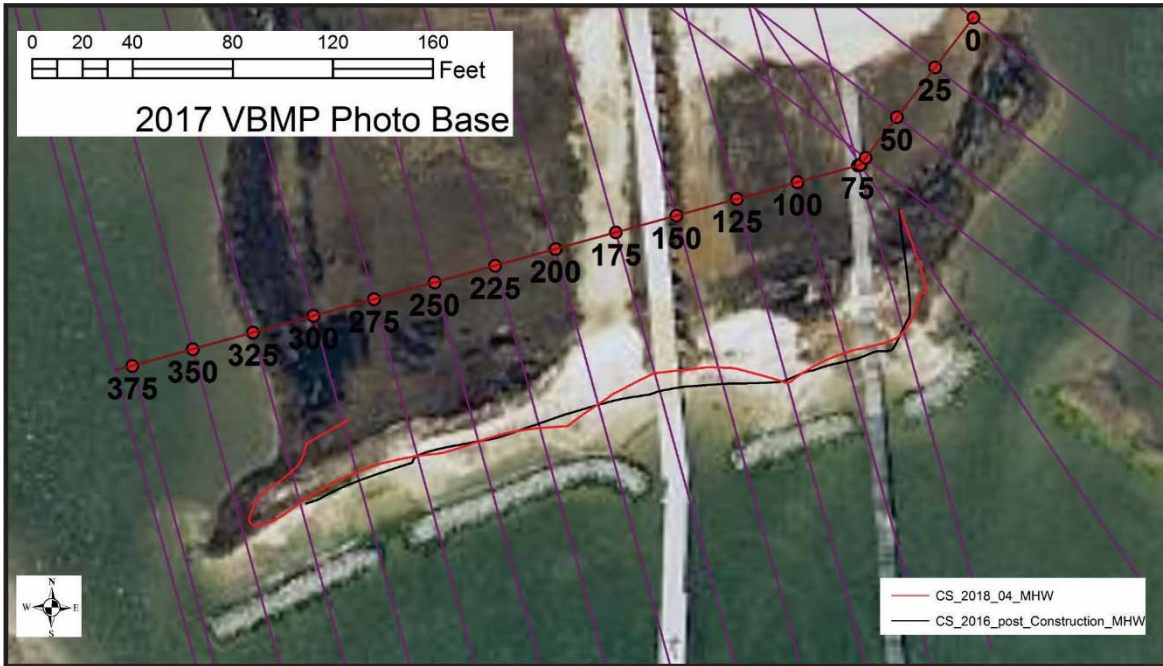
Site surveys show the main change is in backshore elevation (Figures 4-1-6 and 4-1-7). The backshore berm has increased in height and apparently not at the expense of the lower beach face. It appears that elevation changes are due mostly to vertical growth of the high marsh, *S. patens*, along the entire length of the project. An increase of almost one foot at profile 250. This bodes well for future adaptation to SLR.

Figure 4-1-6. Basemap for Captain Sinclair showing the profile baseline and the position of mean high water in 2016 and in 2018.

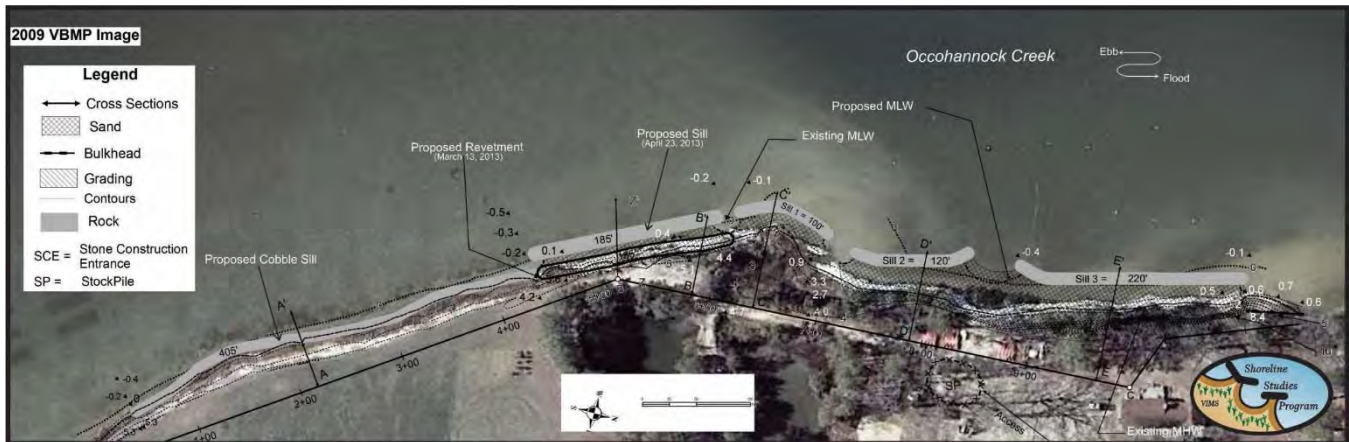
Figure 4-2-2. Camp Occohannock living shoreline plan.

A 1 foot SLR along Reach 2 will submerge the low rock sill at high water (Section C; see Figure 4-2-2) and cause the lower limit of low marsh to retreat landward. The low marsh along Section DD will also retreat landward leaving non-vegetated intertidal and subtidal flat. The high marsh and remaining low marsh fringe may move landward if the trees are removed. A 2 foot SLR will mostly submerge the rock sill except for very crest which would appear at low water.

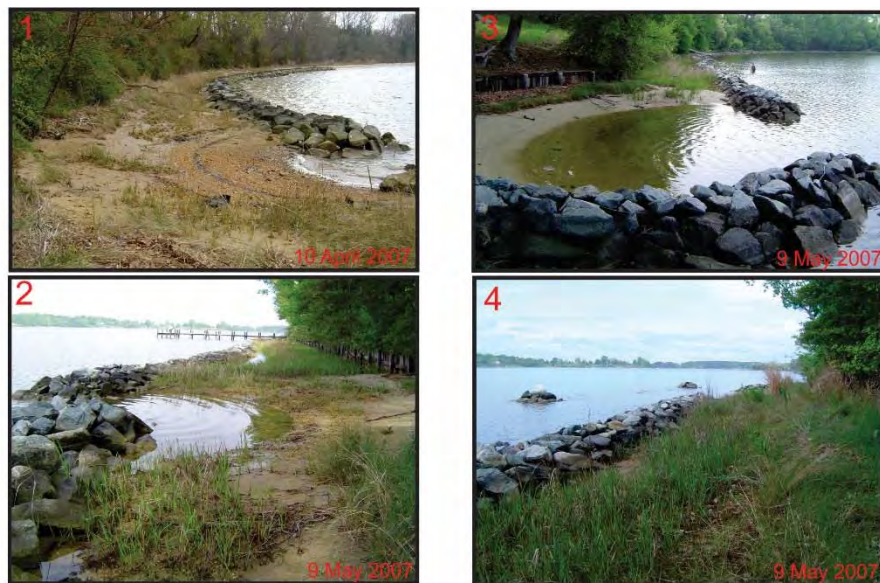
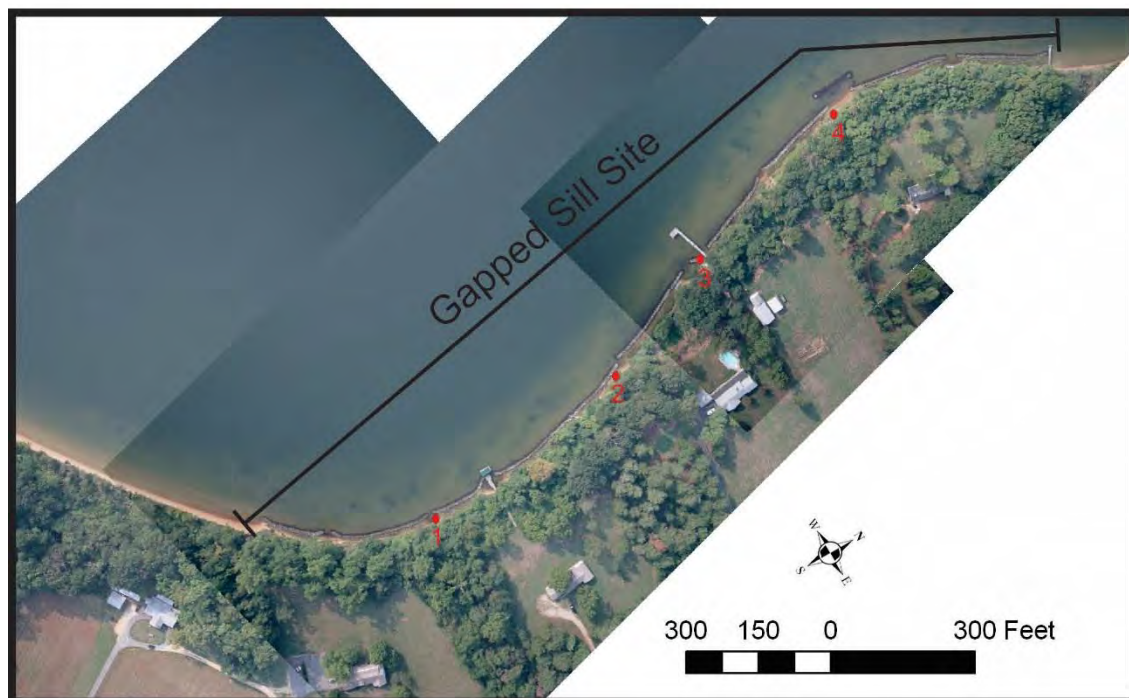
Figure 4-3-2. A photo mosaic of the St. Mary's City, Maryland shoreline on August 24, 2007 indicating the four sites of gapped fill projects and ground photographs of each site.

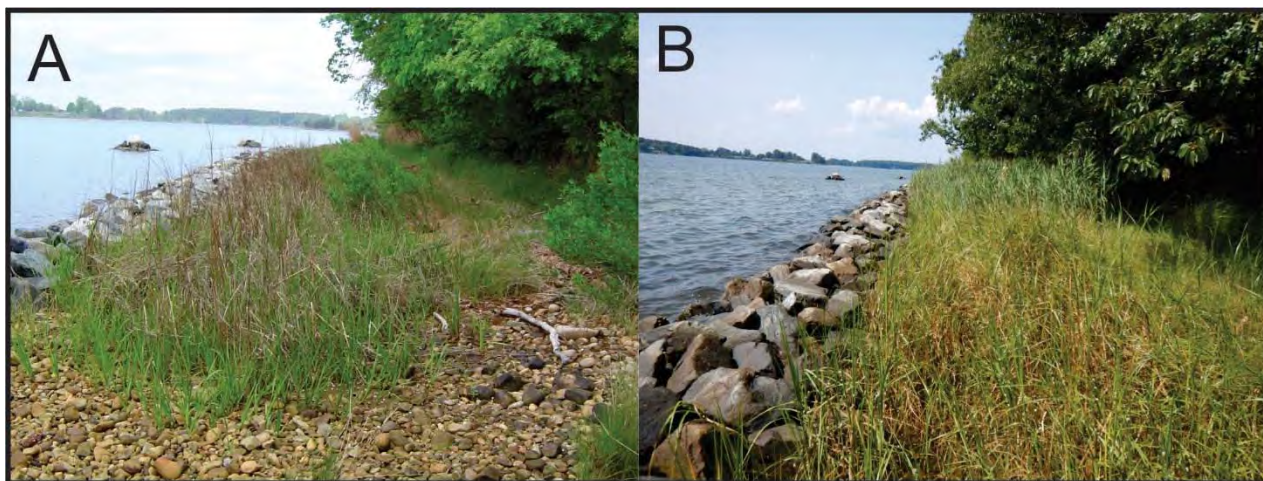
The evolution of the site vegetation over time can be seen in along Sill #7 looking north toward Window #8 with the offshore breakwater defined by two sentinel stones (Figure 4-3-6A). In 2007, the high and low marsh fringe is intact with a few salt bushes coming in and modest tree limb cover. By 2018 the low marsh in the foreground is very robust, but *Phragmites* has overcome both species farther along shore and significant limb growth occurs such that the shading inhibits any vegetation growth under that canopy.

Figure 4-3-6. Gap and sill at St. Mary's A) five years after construction (9 May 2007), B) 16 years after construction (15 Aug 2018).

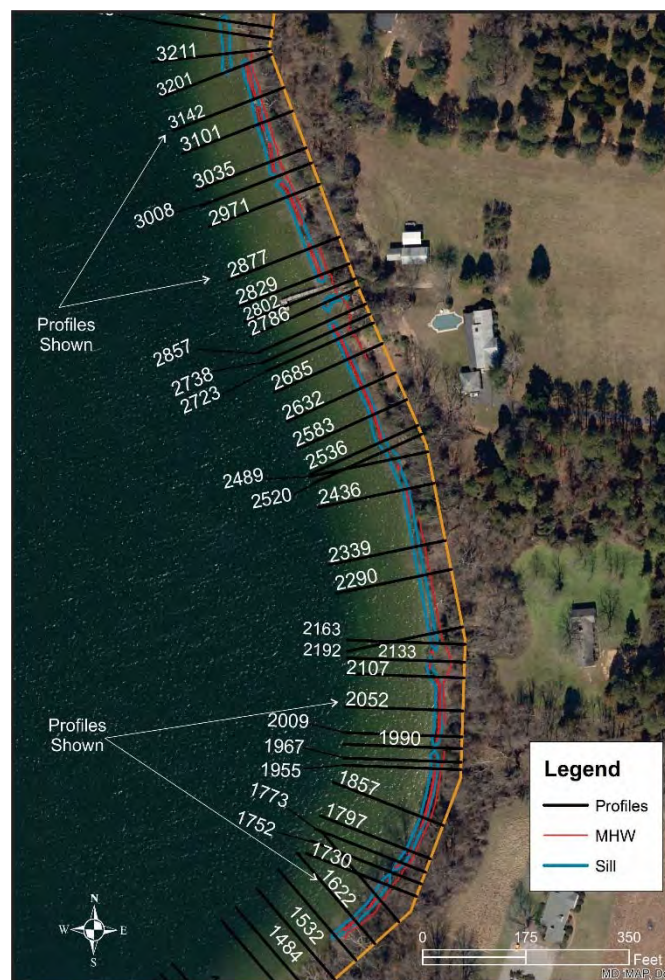
Along Sill #1, there were slight decreases in the lower limit of *S. alterniflora* and in the nearshore (1622). Sill #2 (P1955), the backshore remained stable while behind Sill #3 (P2052) there was a slight increase, +0.3 ft from the back of the sill to about +2.5 ft at the edge of the heavy backshore vegetation. Further up at Sill #6 (P3142) shows no change across the backshore. We estimate almost 10

to 15% of the surveyed shoreline had Phragmites. The overhanging tree limbs just about the entire shoreline and negatively impacts the high marsh growth.

Figure 4-3-10. Cross-sectional profile baseline. Also shown are the outline of the sill structures (blue) and the 2018 mapped mean high water line.

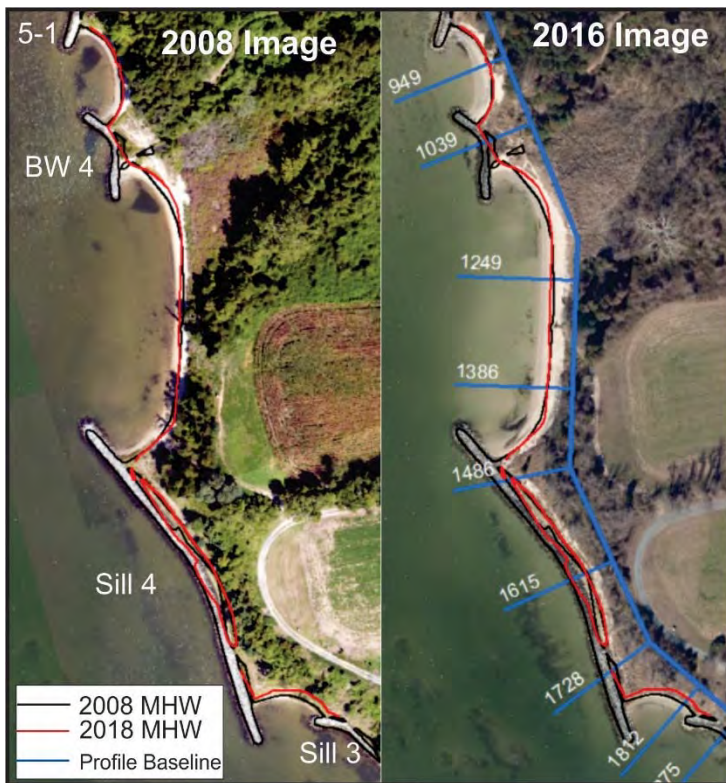
Figure 4-4-8. Aerial photos taken in 2008 and 2016 showing the cross-sectional profile locations and the surveyed position of mean high water in 2008 and 2018.
