Timberneck Creek Dredge Channel Data Report

**Shoreline Studies Program
Virginia Institute of Marine Science
William & Mary**

December 2020

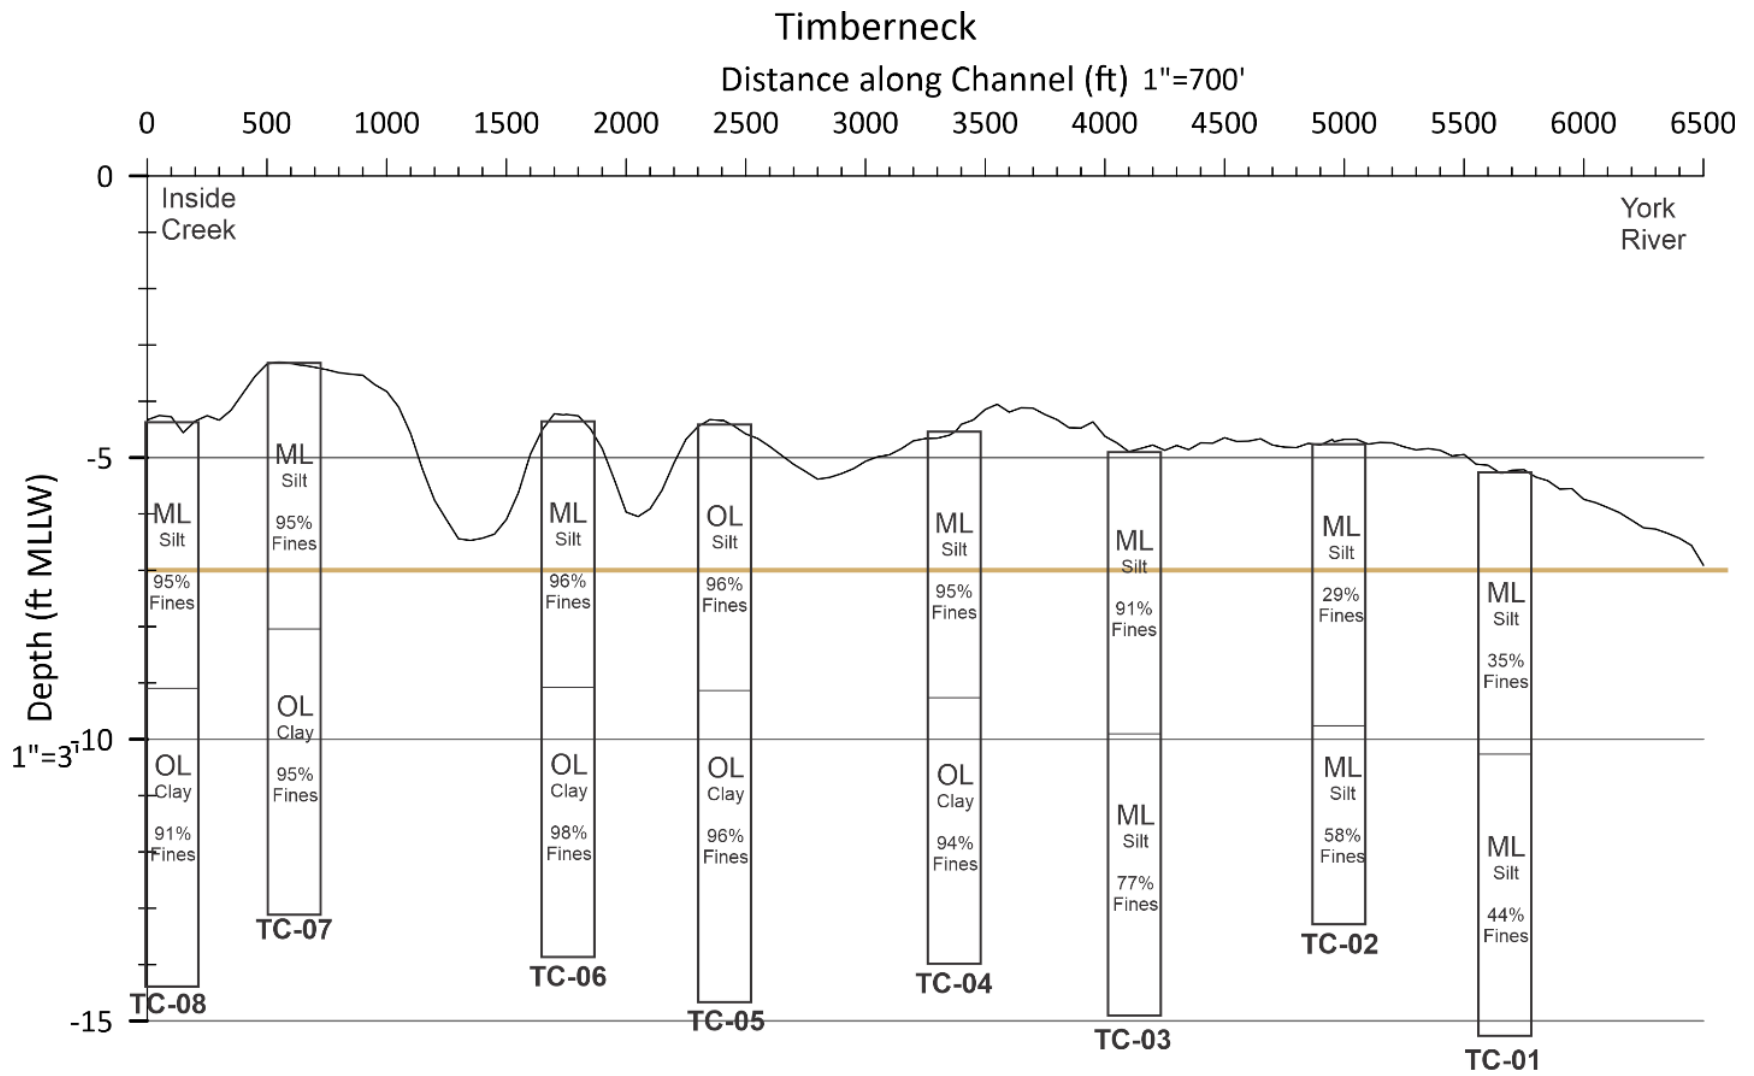
Figure 12. Along-channel cross-section showing the position of the cores and the type of material in the core. The dredge depth is -7 ft MLLW.

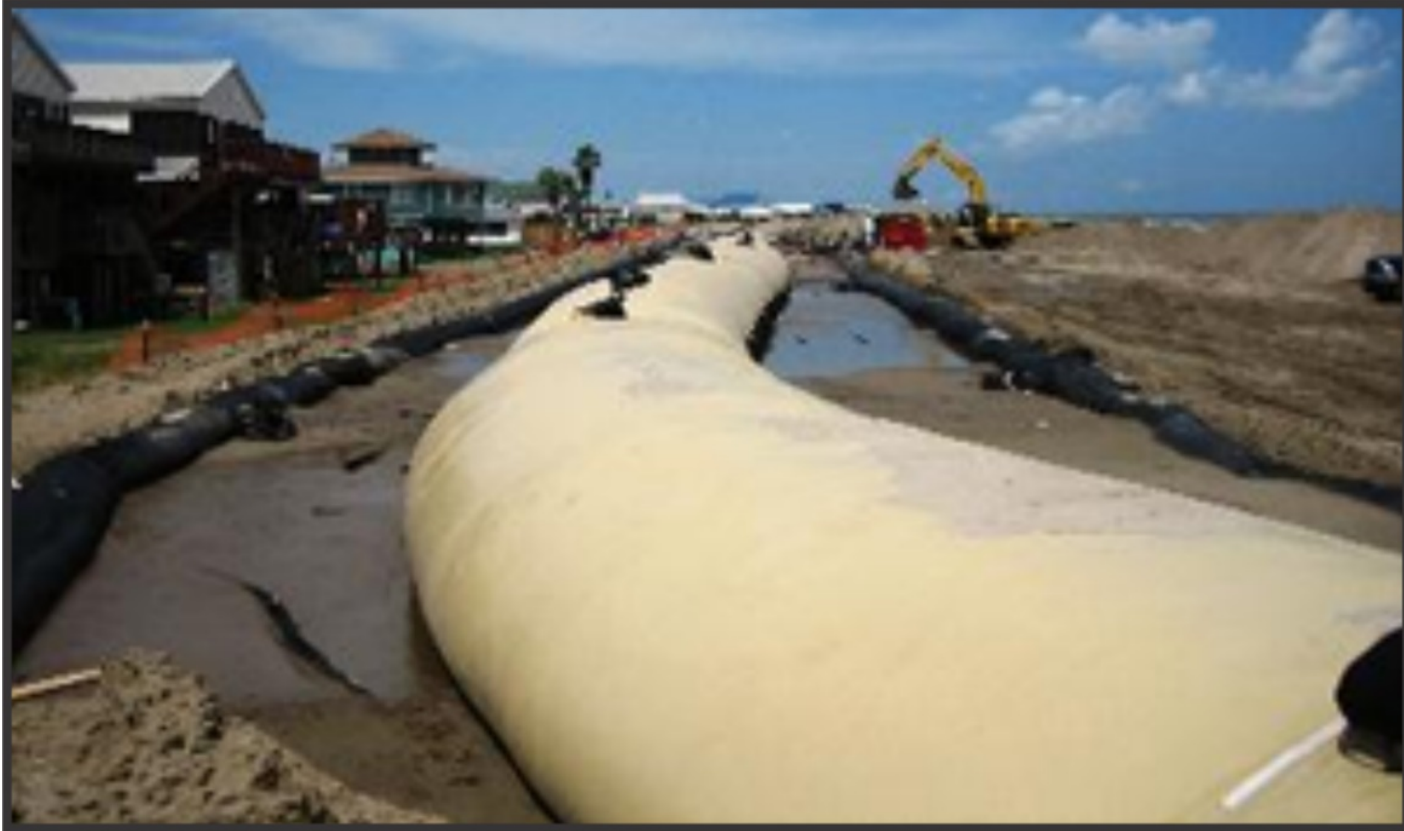
Figure 14. Example photo of a Geotube used for sediment containment. Source: TenCate website

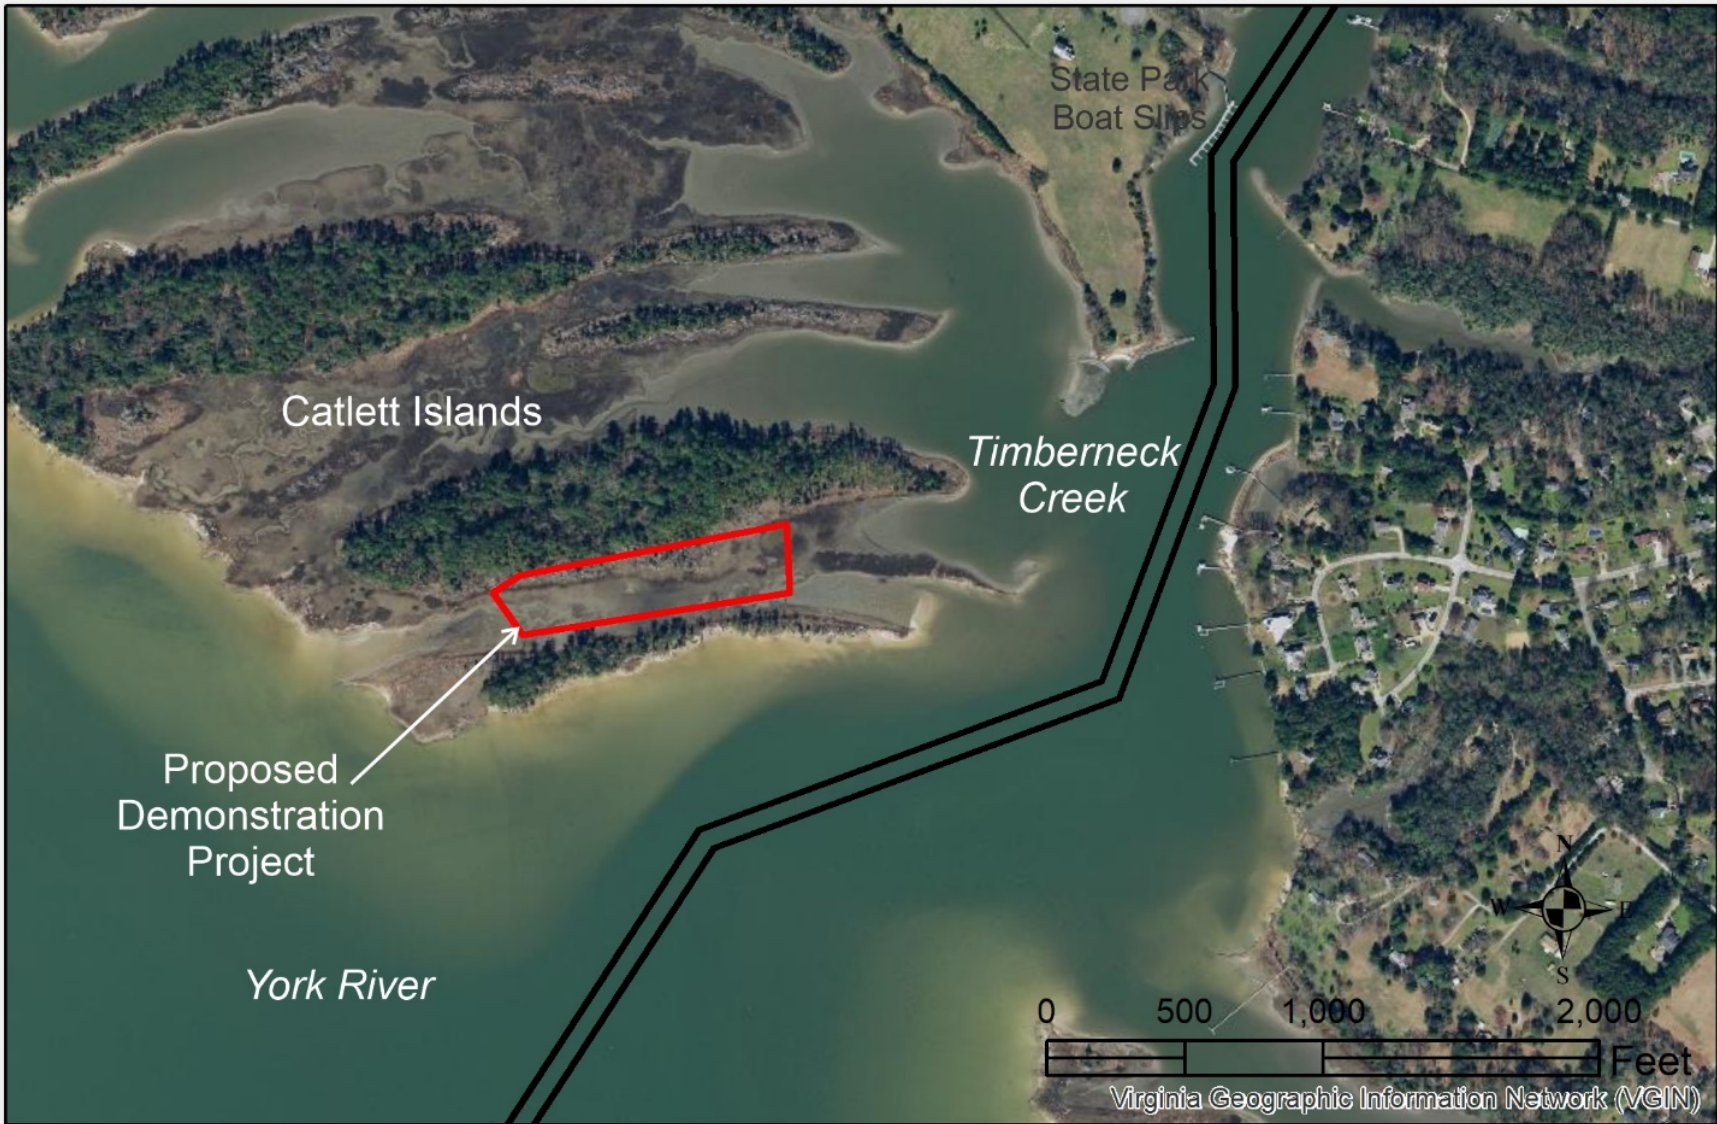
Figure 16. Location of proposed demonstration project at Catlett Islands using material from Timberneck dredging.

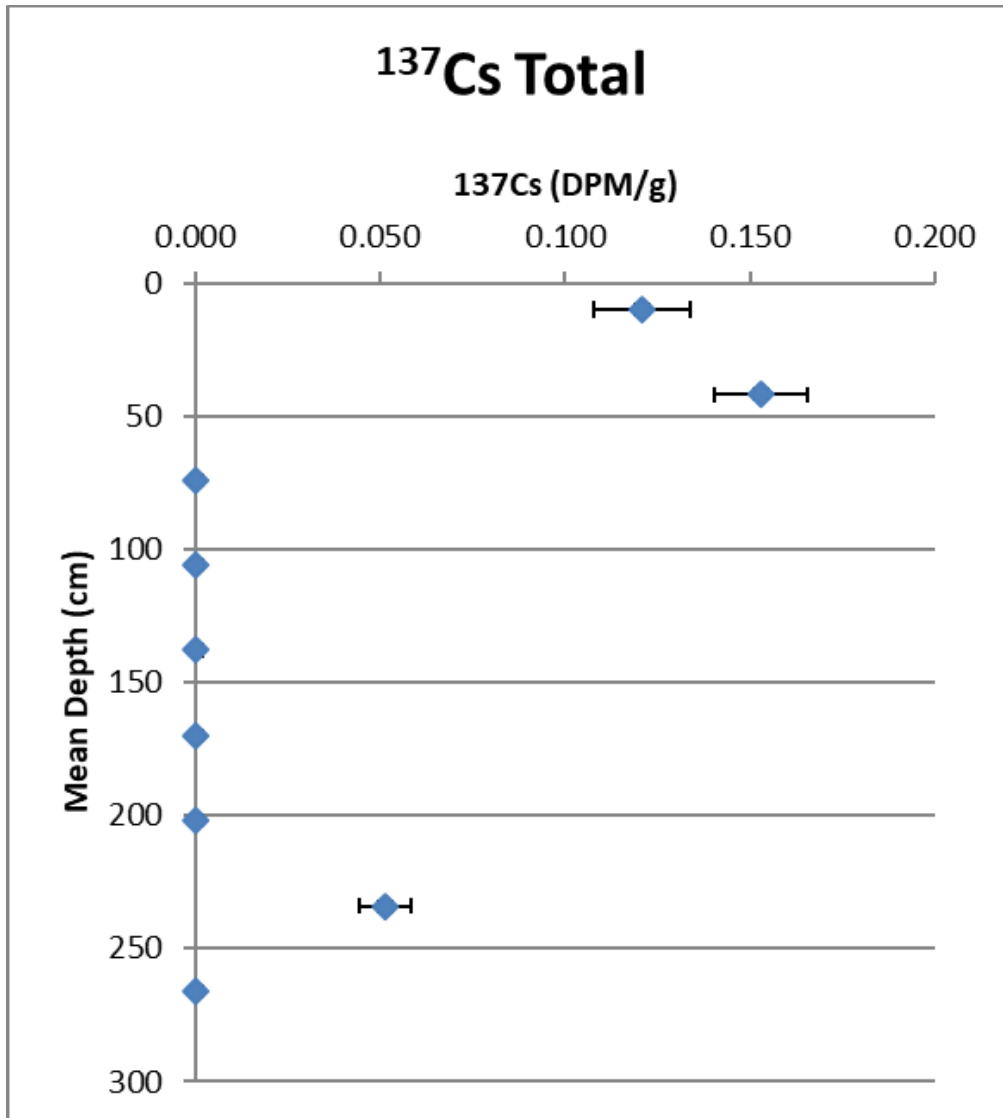
Figure F-4. Total ^{137}Cs from the sample at Timberneck Creek.
