## **Aberdeen Creek Dredge Channel Data Report**

**Shoreline Studies Program  
Virginia Institute of Marine Science  
William & Mary**

**December 2020**

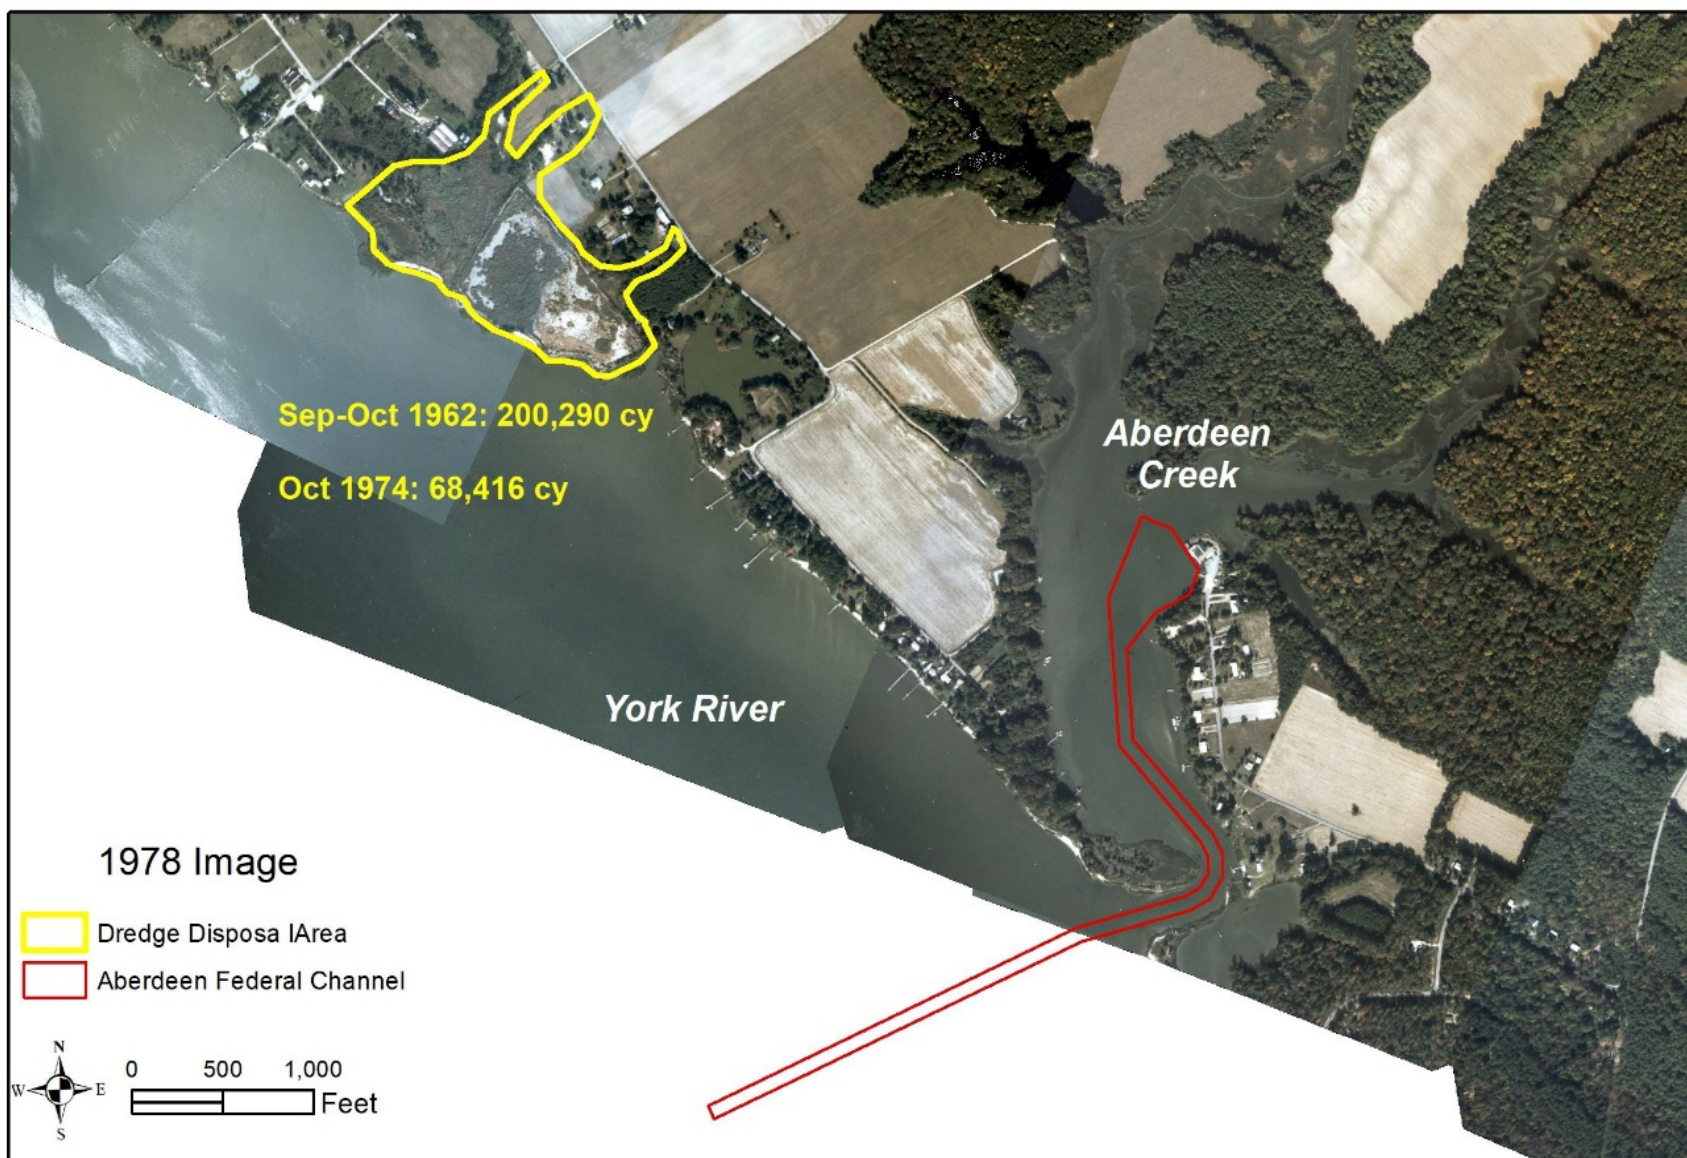
Figure 3. Aberdeen Creek channel outline on a 1978 image showing the placement of dredge material upriver at an upland placement site.

A Federal navigation channel from the York River into Aberdeen Creek was established in 1962 at which point the one-mile channel was dredged to 80 ft wide with a controlling depth of 6 ft MLLW (Figure 2). Approximately 200,290 cubic yards of dredge material was placed in a tidal marsh complex about one mile upriver. Maintenance dredging was performed in 1974 when 68,416 cubic yards (cy) of material was placed upriver (Figure 3). No substantive maintenance dredging has occurred since.

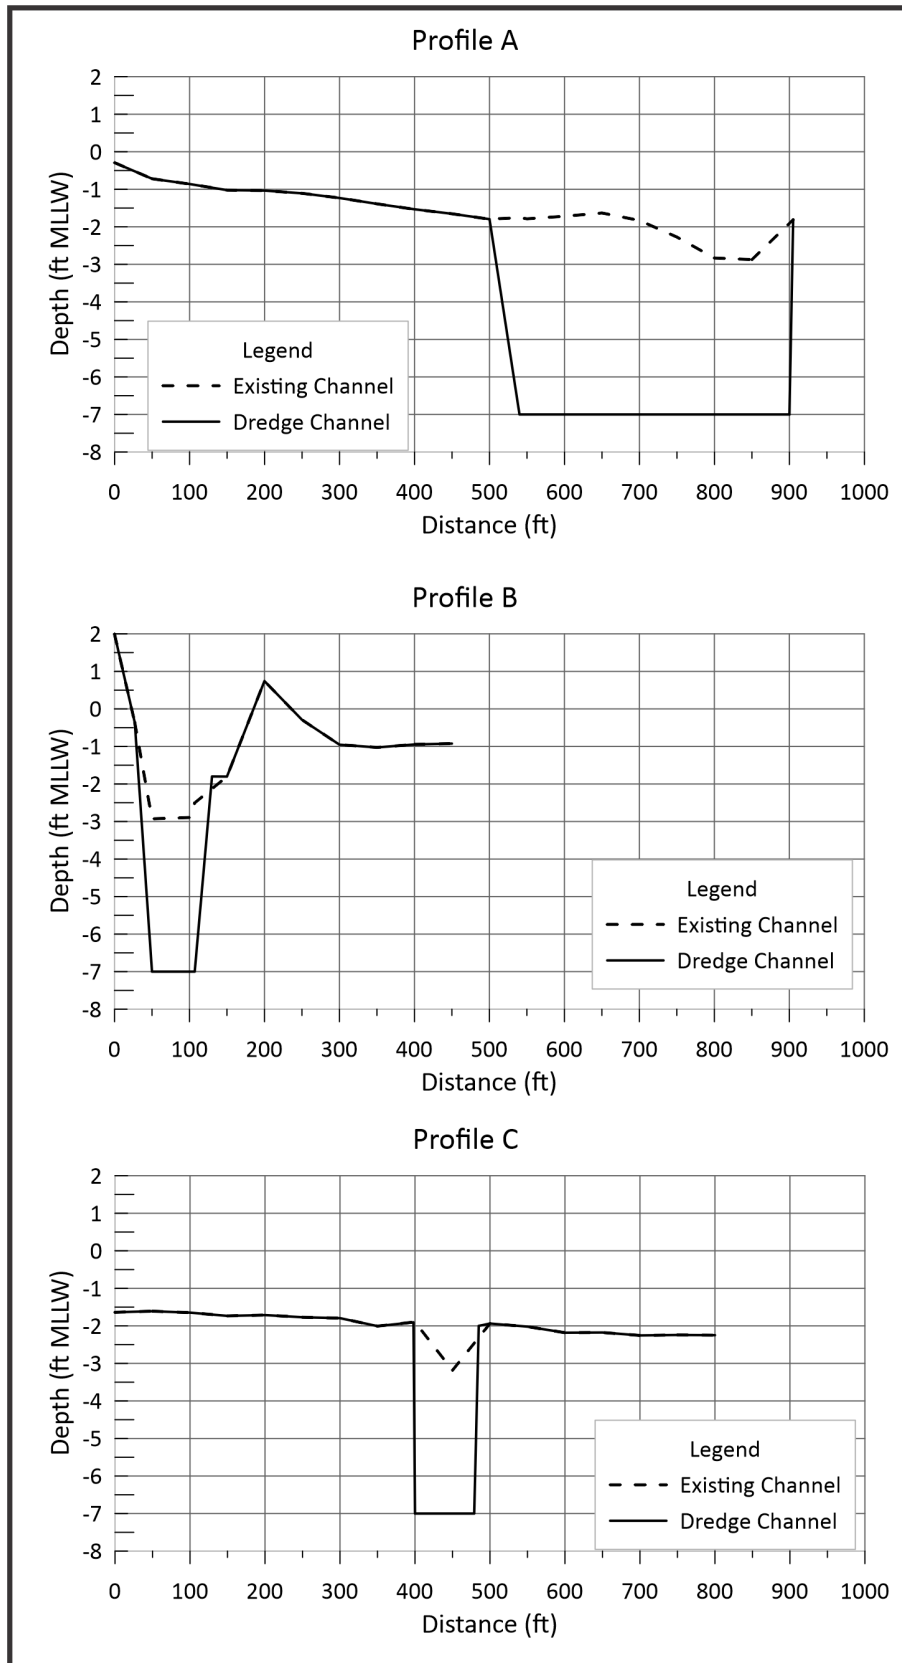
Figure 11. Typical channel cross-sections at Aberdeen Creek. Their location is shown on Figure 10.

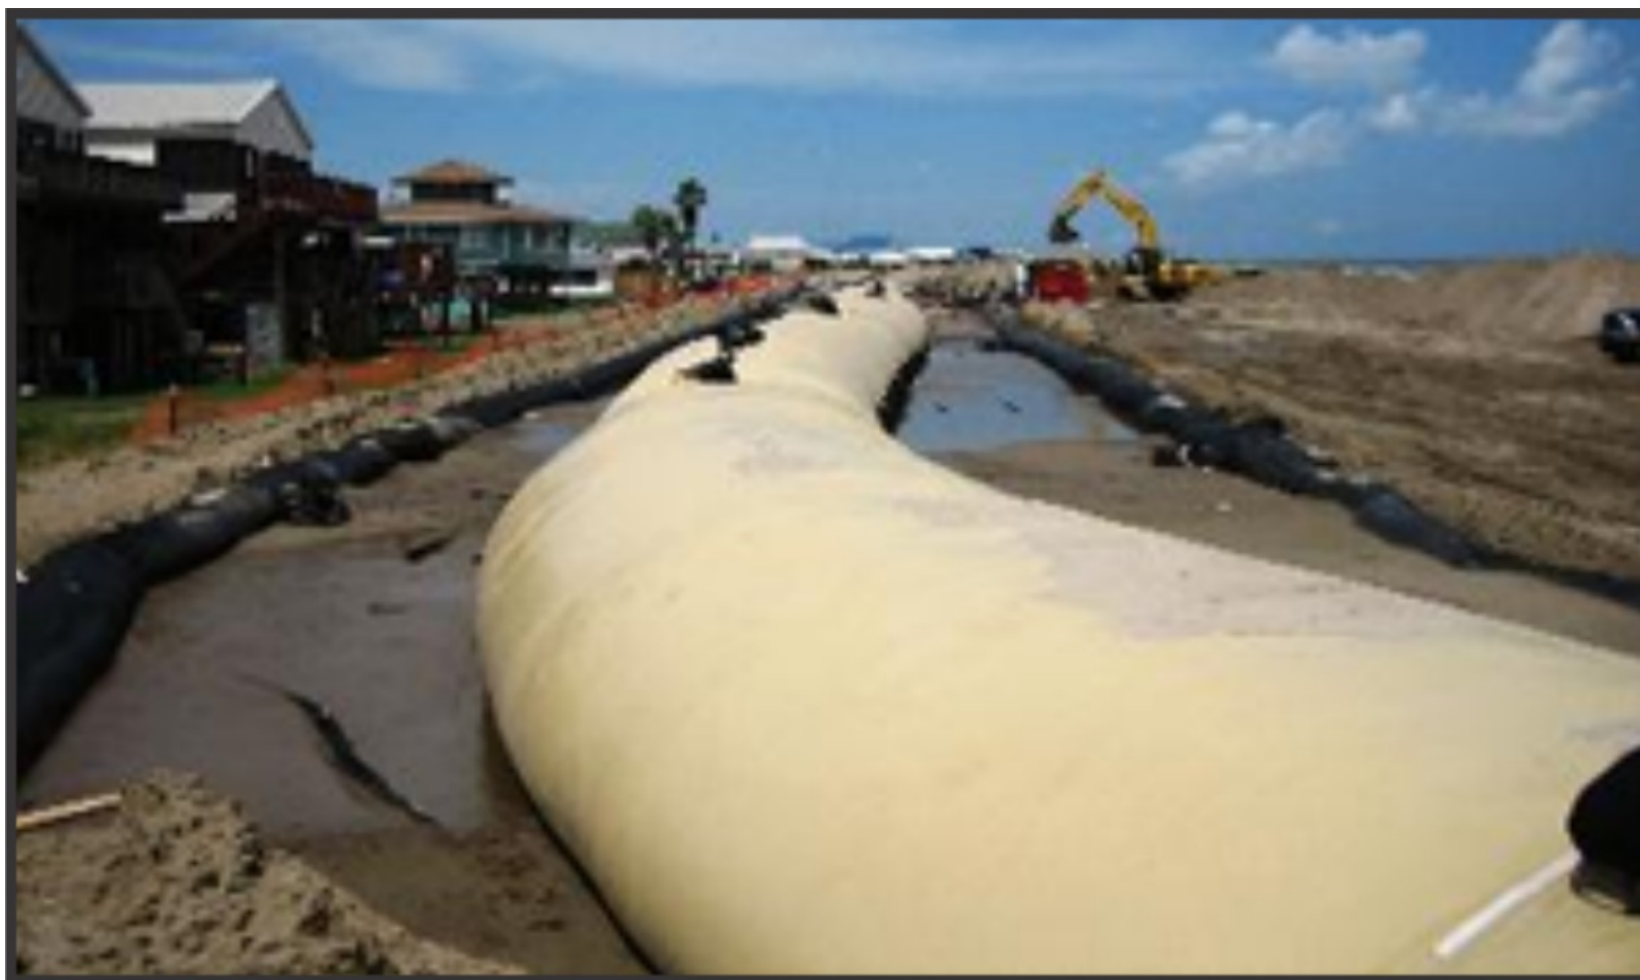
*Figure 14. Example photo of a Geotube® used for sediment containment. Source: TenCate website.*
